## ***Stream Erosion***

The illustrations depict common examples of stream erosion and demonstrate the necessity for systematic attention being given to the river systems throughout the State.

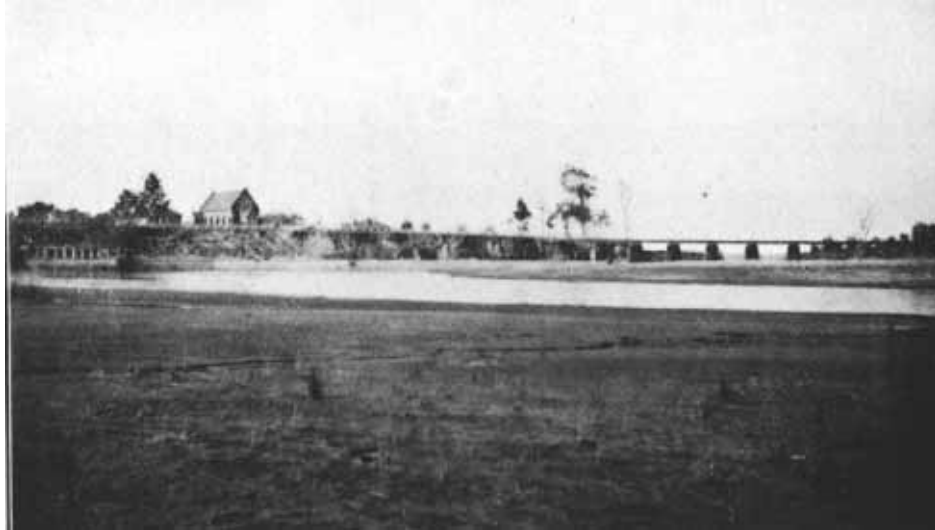
21. Avon River at Stratford. Most of this was once surveyed into small holdings, but is now only sand and shingle. Costly works have been necessary to protect the township and the bridge of the Prince's Highway.

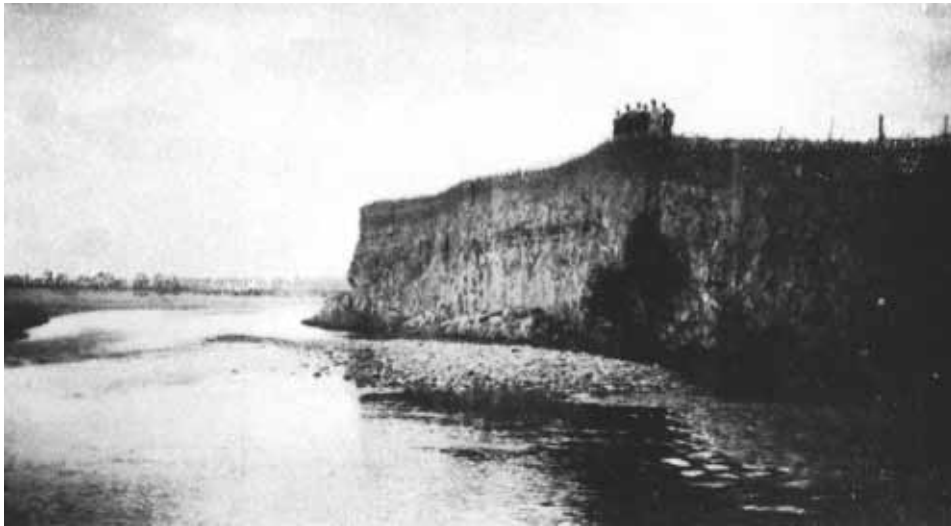
22. High eroding bank, Avon River near Boisdale. Party is standing in lucerne paddock.

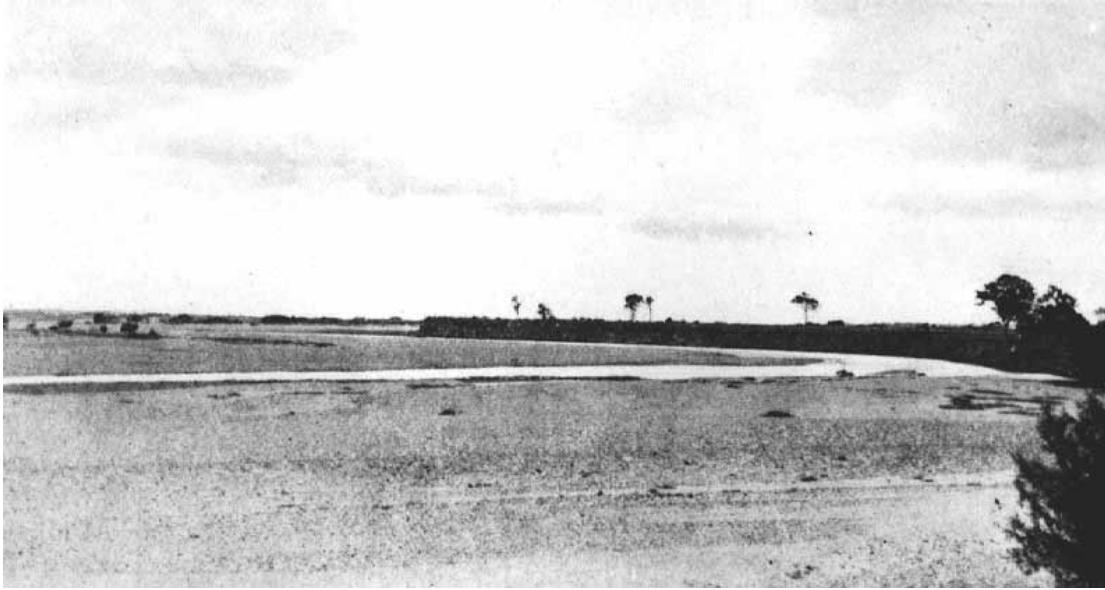
23. Avon River near Boisdale, showing a waste of sand and shingle twenty chains wide where formerly good land existed. The high eroding bank in the background marks the present edge of the flats, which are irrigated for lucerne and maize growing, and are worth £40 to £50 per acre.

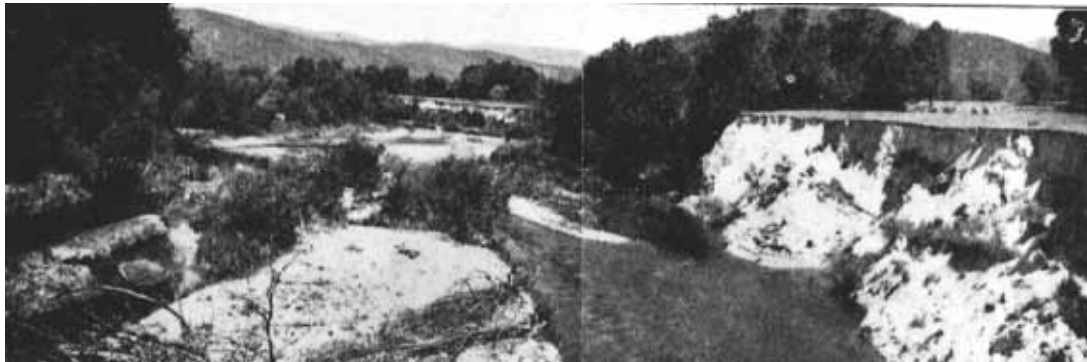
24. A section of Nariel or Cudgewa Creek, in the Hume Catchment, Upper Murray, showing the typical lateral stream movement, eroding good flats on one side and leaving useless shingle beds and wattles on the other.

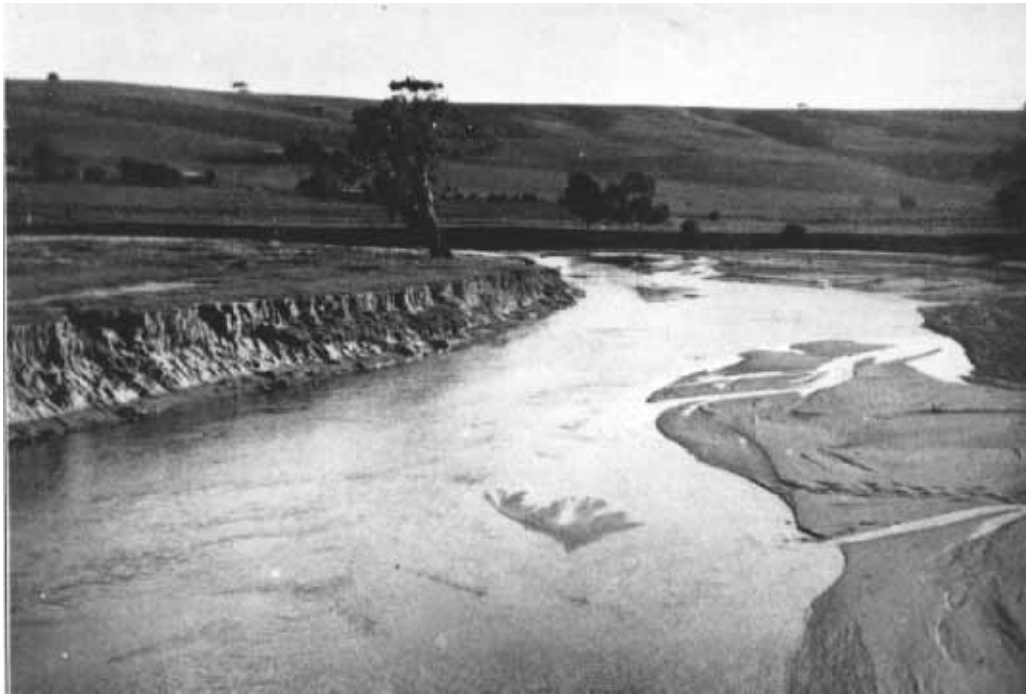
25. Near Coleraine, showing typical stream erosion and siltation.

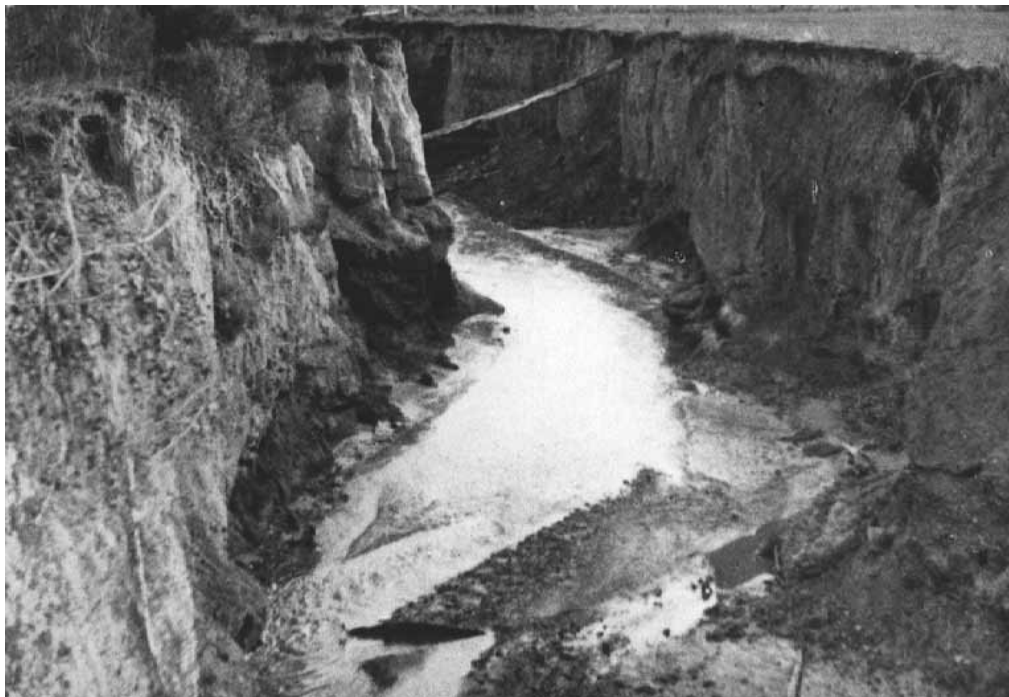
26. Eaglehawk Creek, near Glengarry, Gippsland. It is said that this creek originally spread over a wide swampy area, and that a drain a few feet wide and deep was constructed to confine the flow. This has now scoured into a canyon up to 40 feet wide and 30 feet deep. The debris from this has nearly choked bridges on the main Traralgon-Maffra road and railway, and has smothered many acres of land.

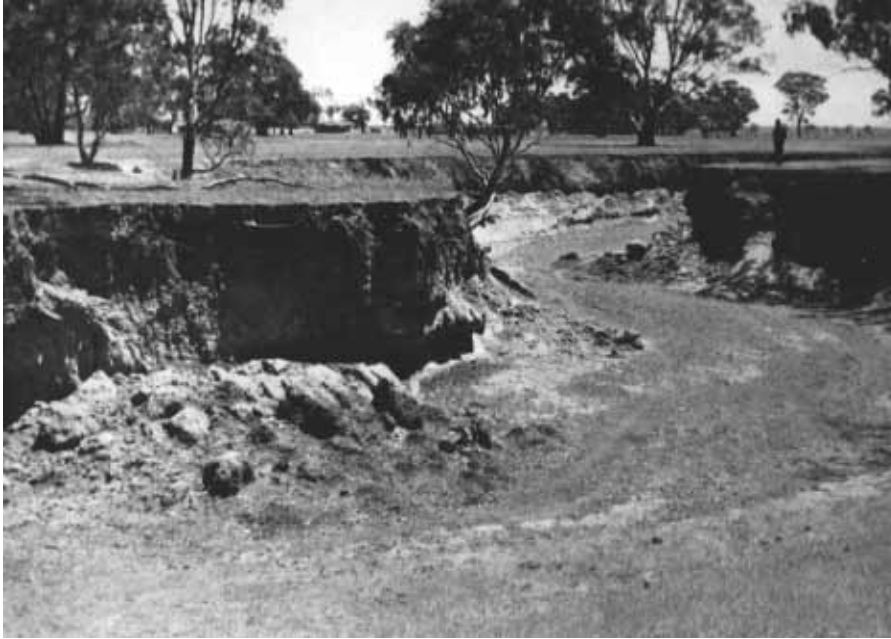
27. Bullock Creek, north of Marong. The debris from this has silted up the creek lower down blocking bridge and increasing flooding problems on the flatter land.

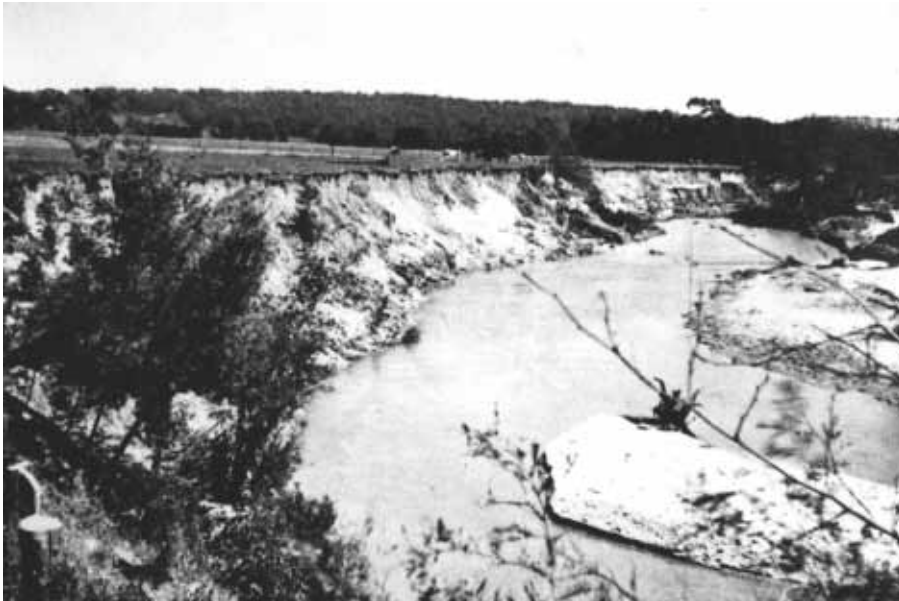
28. The Bunyip River just below the Prince's Highway, showing erosion of flats, and also sandbanks on their way to silt up the Koo-wee-rup Main Canal.
