## 4. FIELD STUDIES

### 4.2 *Site Investigation of Selected Landslides*

### 4.2.3 Observations of Selected Landslides

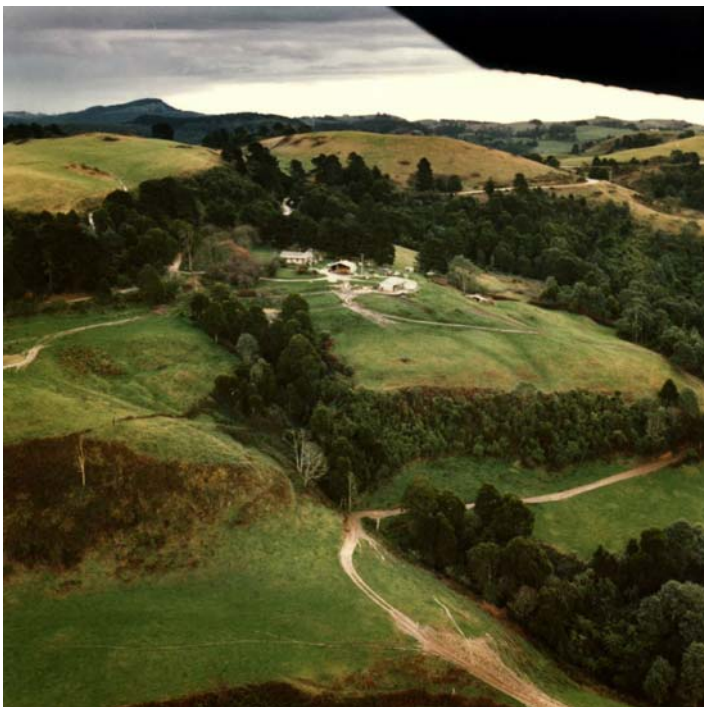
Landslide No. 7 is located on the Mirboo-Yarragon Road as shown in Figure 3.5. Bores 25, 26 and 27 were drilled where the landslide crossed the roadway at the positions shown in Appendix 4.1. The landslide is a slump-earth flow, reported by local people to have occurred about 30 years ago. The slump zone is entirely above the road in the steep hillside which was cut into when the road was constructed. The slump zone has been successfully stabilised by tree planting. However, approximately 100 metres of the roadway across the earth flow zone continues to move following periods of heavy rain. The damage caused by the landslide varies from winter to winter, but a few years ago the damage was serious enough to temporarily close the road and damage a new farm dam below the road. Movement is always associated with heavy rain, but the initial road cutting would certainly have lowered the overall stability of the hillside, and impeded drainage along the roadway would have subsequently contributed to the on-going movement. The major features of the landslide are shown in Figure 4.1.

The landslide occurs entirely within the silty clay, silty fine sand and clayey silt of the weathered Lower Cretaceous rocks. The depth of the landslide along the road was difficult to establish, but bore 27 indicated a depth of approximately 4 metres which is consistent with the seismic refraction results obtained by the Country Roads Board (pers. com. A. Muir, 1978).

**Figure 4.1 - Landslide No. 7, Mirboo-Yarragon Road looking east**

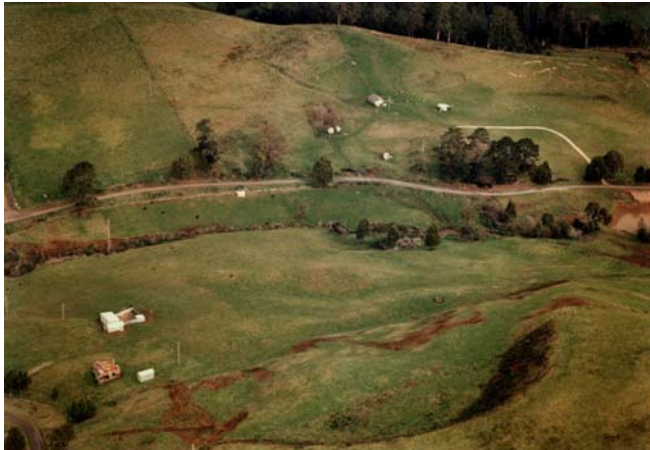
Landslide No. 9 is located 0.5 km west of Narracan on the Narracan Connection Road as shown in Figure 3.5. Bores 7, 14 and 17 were drilled along the roadway at the positions shown in Appendix 4.1. A section of the road is affected by movement in the earth flow zone of a large slump – earth flow type landslide. Contributing factors to the movement are impeded drainage along the roadway and ongoing removal of earth from this toe zone by the creek. The creek also undercuts the toe of a similar earth flow on the opposite side of the valley. The Shire have improved the drainage along the road, but movement still occurs. The major features of the landslides and the damaged section of road are shown in Figure 4.2.

Both the Older Volcanics and the Childers Formation soils are involved in the landsliding. Drilling indicated that the landslide was 4.5 m thick where the road crossed it.

**Figure 4.2 – Landslide No. 9. Narracan Connection Road, looking South.**

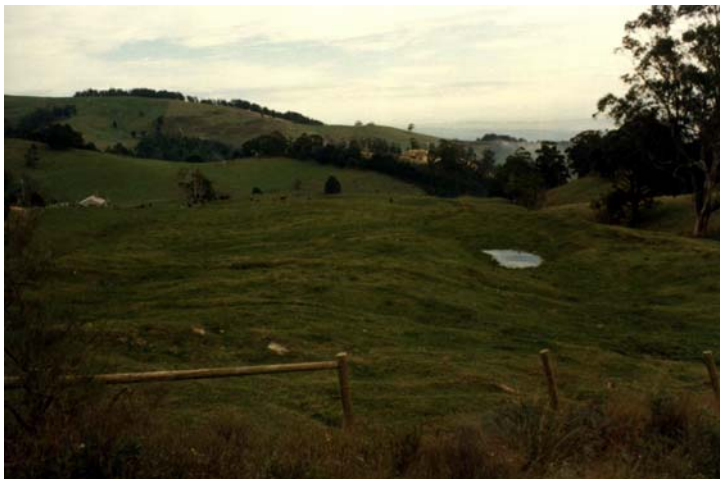
Landslide No. 10 is a large slump-earth flow which crosses the Trafalgar-Thorpdale Road just north of Ryans Road. The slump zone extends for approximately a kilometre above the road and the earth flow zone continues for a similar distance downhill from the road. The landslide exhibits all the classic features of slump – earth flows, including large arcuate depressions at the head of the slide, narrowing of the slide in the transition from the slump to the earth flow zone, and hummocky terrain with pools of water in the earth flow zone. These features are shown by Figures 3.8 and 4.3.

**Figure 4.3 – Looking west from the road onto the hummocky earth flow zone of landslide no. 10. Trafalgar-Thorpdale Road, immediately north of Ryans Road.**

The landslide causes the road to subside and to move laterally to the west following periods of heavy rain. A major contributing factor to the movement must be the very poor drainage that exists along part of the uphill side of the road. Improving the road drainage may lessen the damage, but would be unlikely to entirely eliminate movement of the earth flow across the road easement.

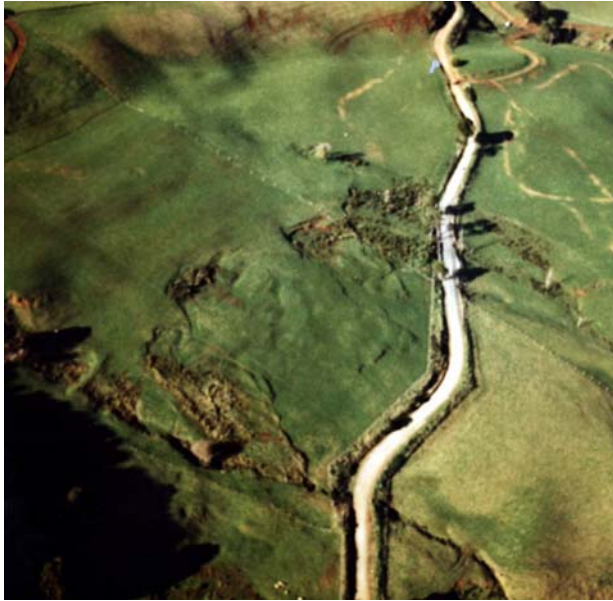
Landslide No. 13 is a relatively small slump – earth flow incorporating zones of translational movement. It is located within a larger landslide complex on the Childers Settlement Road, 1.5 km west from McDonalds Track as shown in Figure 3.5. In 1978, the Shire constructed a retaining wall, improved the drainage and planted trees to prevent the earth flow from covering the road. Figure 4.4 is an oblique aerial view of the landslide and Figure 4.5 shows the retaining wall during construction. Bore 24 was drilled on the downhill side of the roadway as shown in

Groundwater flowed out of the bore, thus indicating that further drainage would assist the stability of the slope.

***Figure 4.4 – Oblique aerial view of landslide no. 13, Childers Settlement Road. Numerous tussocks indicate wet ground.***

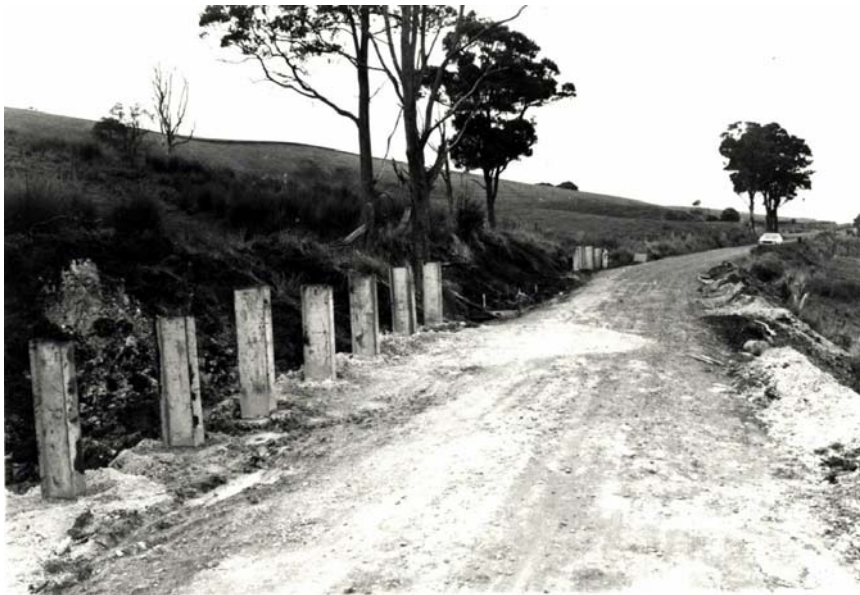
***Figure 4.5 – Landslide No. 13, looking east along the Childers Settlement Road.***

Earth flow material has been cut back from the road. Steel joists are set in concrete in pre-bored holes to provide anchorage and lateral resistance for the retaining wall which was built between the columns. The ground in the vicinity of the roadway is saturated. April 1978.

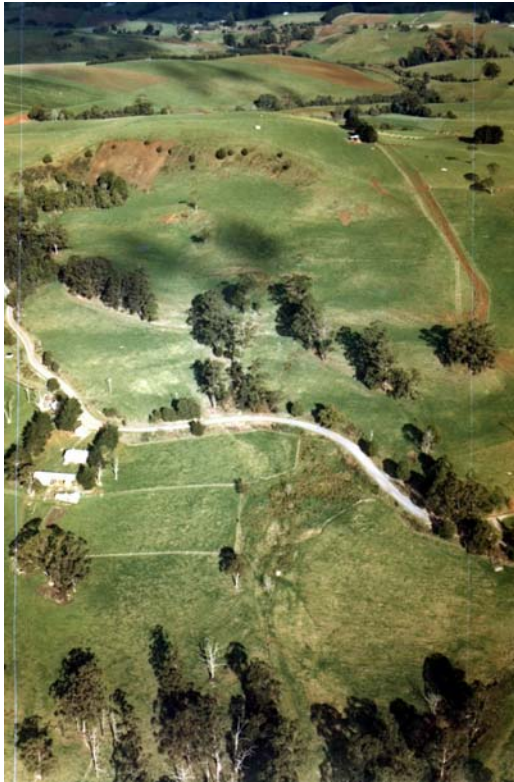
**Figure 4.6 - Landslide No. 15 on the Trafalgar-Narracan Road, looking south onto a large landslide complex.**

A small active slump-earth flow is causing approximately 50 metres of roadway to subside.

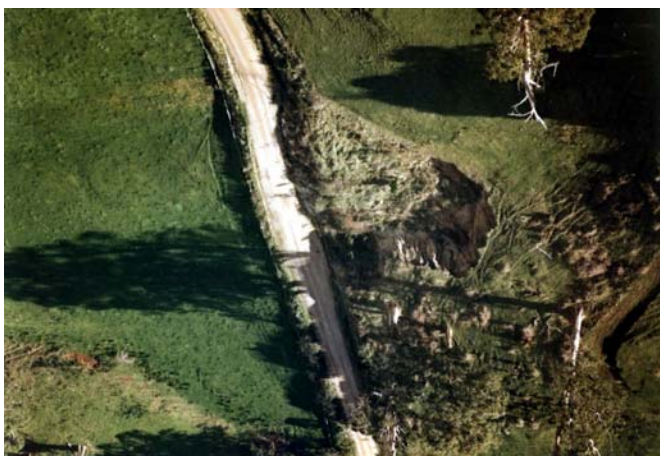
Landslide No. 16 is a recent small slump-earth flow which is encroached on the Trafalgar-Coalville Road as shown in Figures 3.5 and 4.7. It is located within a larger slump-earth flow complex. The soil consists of coarse sands and gravels of the Childers Formation, and in this respect it differs from the other landslides studied. Bores 10 and 11 were drilled at the locations shown in Appendix 4.1. The major cause of failure is attributed to the steep road cutting which crosses the slope at this location. The road has been re-established through the earth flow. Willow trees have been planted and the drainage improved to minimize the risk of further landslide movement.

**Figure 4.7 – Landslide No. 16, Trafalgar-Coalville Road**

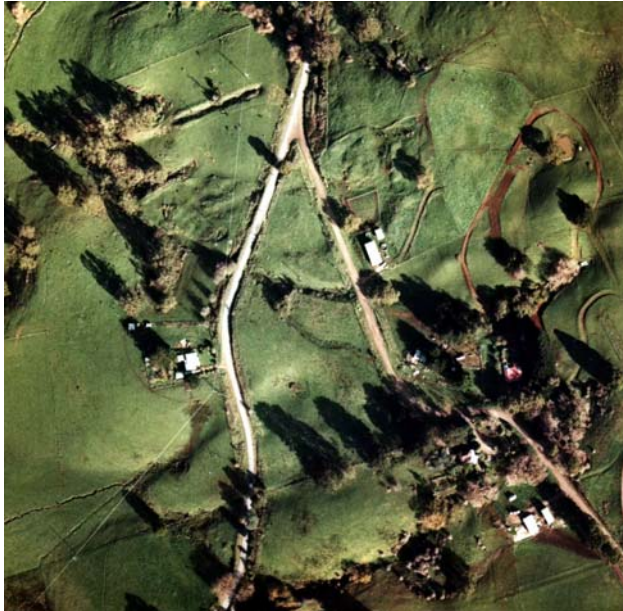
Landslide No. 17 is moving slowly across the junction of the Trafalgar-Coalville Road with the Moe-Thorpdale Road. It is essentially a translational earth flow with some minor rotational shear displacement. It occurs within a larger old slump-earth flow complex and involves soils of the Older Volcanics and the underlying Childers Formation as shown in bores 7, 14 and 17 which were drilled at the locations shown in Appendix 4.1. The location and features of the landslide are shown in Figures 3.5 and 4.8 respectively. The damage consists of earth flowing onto the Trafalgar-Coalville Road and subsidence of the Moe-Thorpdale Road. The drainage has been improved along the Moe-Thorpdale Road in an attempt to lessen the damage. The relatively new house shown in Figure 4.8 is located just to the north of the active landslide zone.

**Figure 4.8 – Landslide No. 17, crossing the junction of the Trafalgar-Coalville Road with the Moe-Thorpdale Road.**

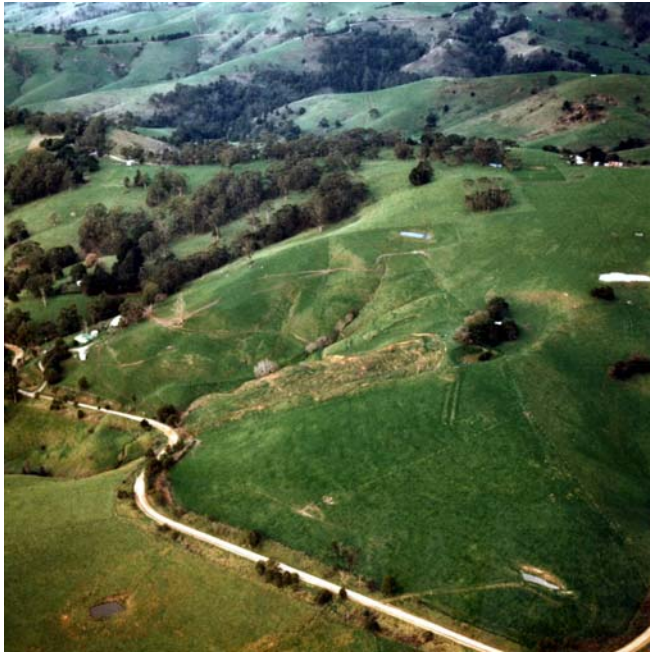
The head of the “Klevans” landslide is high above the Leongatha-Yarragon Road at the location shown in Figure 3.5. The slump zone grades into a debris flow zone which crosses the road and continues for some distance down the valley as shown in Figures 4.8 and 4.9. Bores 19 and 20 were drilled on the roadway at the locations shown in Appendix 4.1. The head of the recent landslide is shown by the solid red line, while a dashed line delineates the head of an older passive slump-debris flow. A dam (marked by arrow) is located in the slump zone of the old landslide immediately above the head of the recent landslide. The landslide material above the head of the recent landslide. The landslide material consists of silty clays and clayey silts mixed with weathered rock fragments of the Lower Cretaceous Strzelecki Group.

The landslide has evidently passed through active phases, probably dating back to when the forest was cleared. The most recent movement may be attributed, in part, to the presence of a small dam in the old slump zone above the recent landslide, combined with the effects of heavy rain.

*Figure 4.9 – Oblique aerial view of the Klevans landslide looking NE*

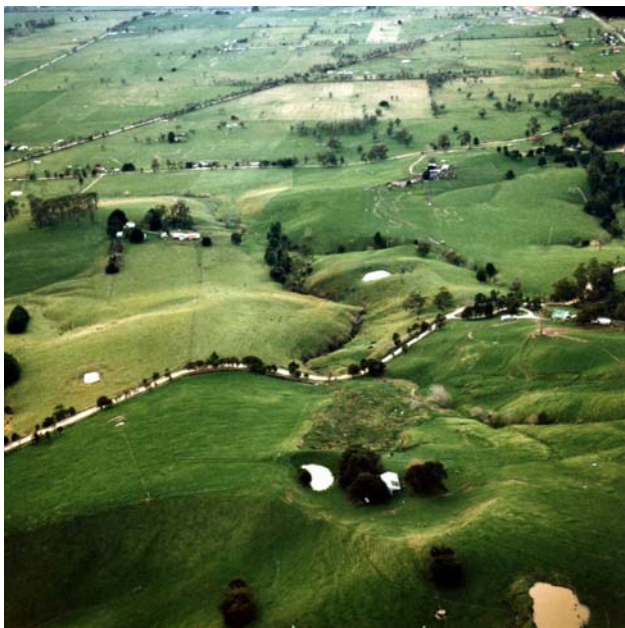
*Figure 4.10 - Down slope view of Klevans landslide showing small farm dam located in old slump above the recent landslide.*

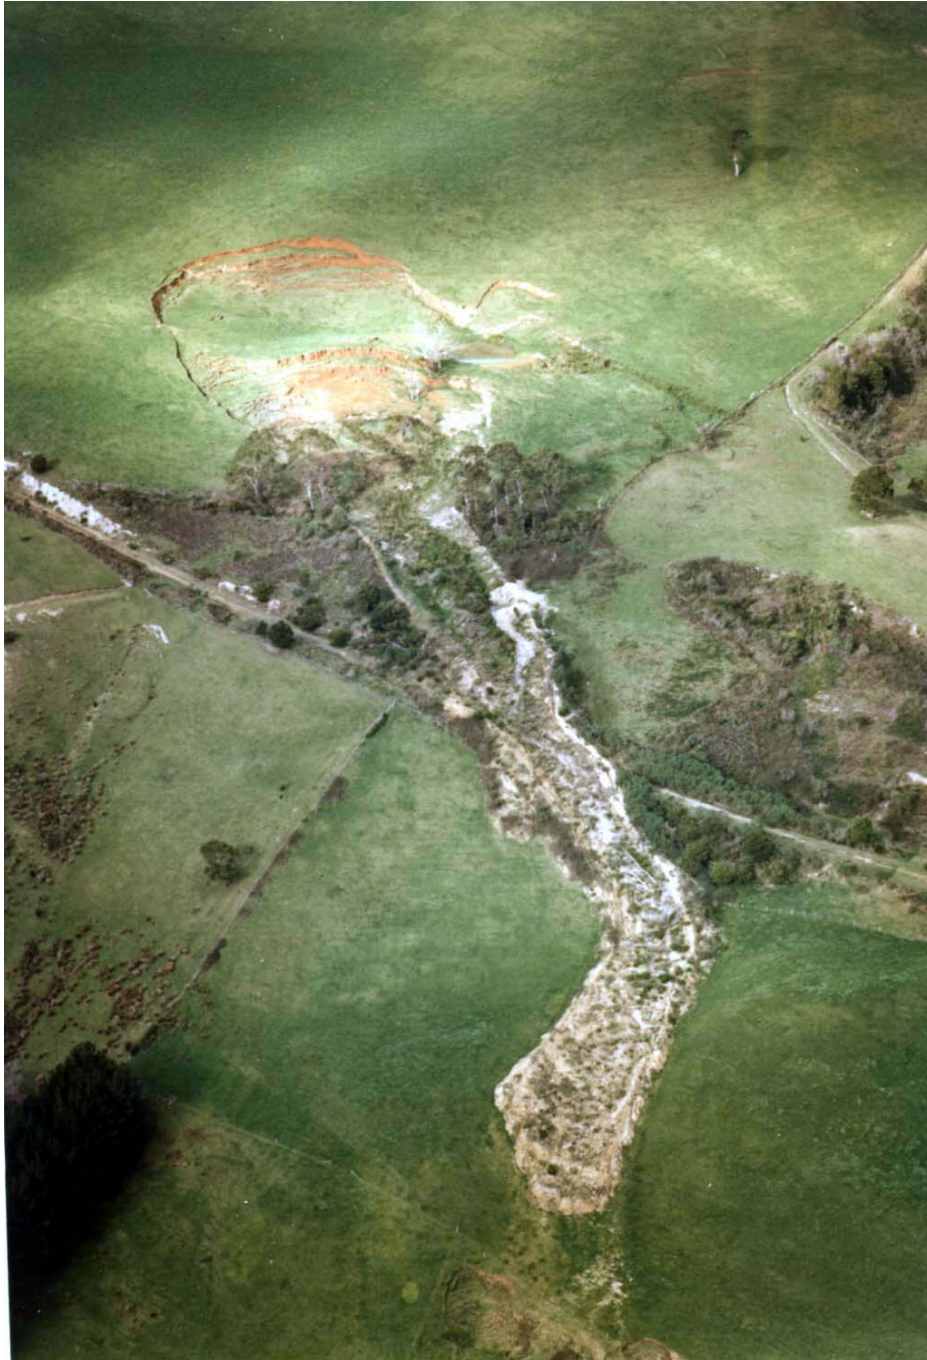
This extensive complex of sump-earth flow type landslides has been described in Section 3.3.4 and is illustrated in Figure 3.10. It is located across the Dingley Dell Road as shown in Figure 3.5. Slope movement involves soils from the Older Volcanics, the Childers Formation and the Strzelecki Group rocks. The site has been investigated by the Country Roads Board of Victoria and recommendations for stabilization are given by Fielding (1975). No drilling was carried out in the present investigation, but several bulk samples of soil were taken for classification testing. The road is presently closed by the two landslides shown in Figures 4.11 and 4.12. The causes of slope movement are complex, with the very large landslides most probably occurring prior to clearing the forest. Subsequent, smaller movement, are probably due to a combination of factors involving clearing, road construction, location of dams, slope, geology, soils and periods of intense rainfall.

*Figure 4.11 – Active slump-earth flow across Dingley Dell Road.*

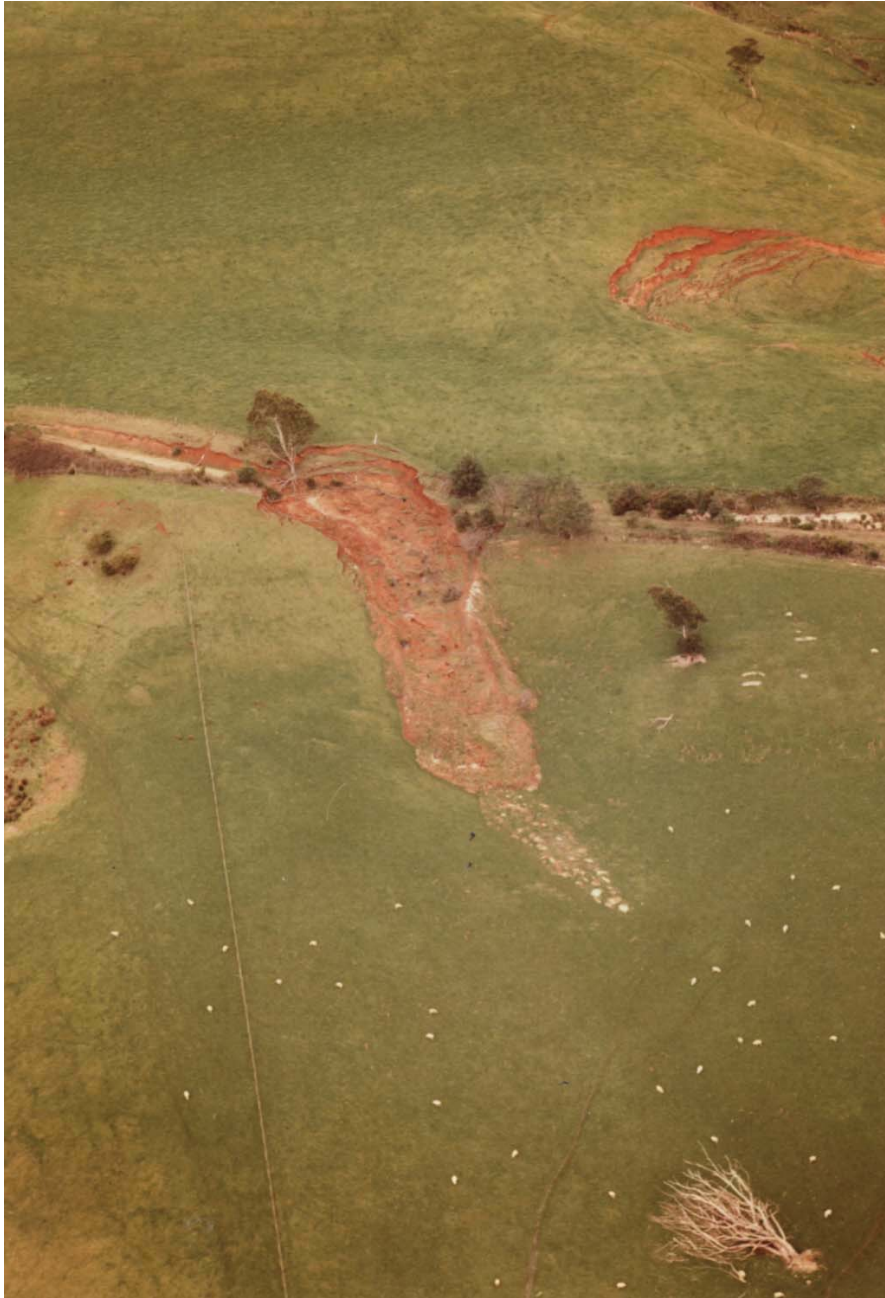
*Figure 4.12 – Active slump-earth flow which has removed a section of the Dingley Dell Road. A large tree in the slump zone remains approximately vertical.*
