# IMPLEMENTING THE AGS LANDSLIDE RISK MANAGEMENT GUIDELINES IN A MUNICIPAL PLANNING SCHEME - A CASE STUDY IN THE COLAC OTWAY SHIRE, VICTORIA.

Peter G. Dahlhaus<sup>1</sup> and Anthony S. Miner<sup>2</sup>

## ABSTRACT

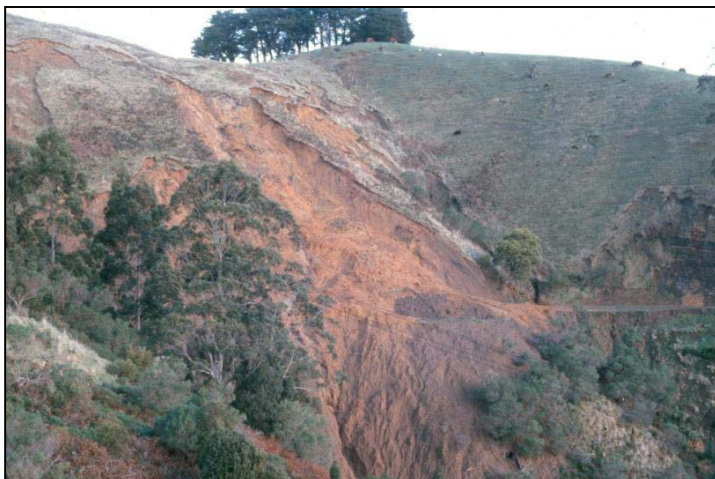
Figure 2. Landslide on Wild Dog Creek Road, 1979.

Apart from the above three landslides, information is limited in consultant reports, poorly documented newspaper articles and Shire records, anecdotal evidence and casual observations. One active landslide, known as “the big slide” is situated on the eastern side of Wild Dog Creek approximately 5.3 km along Wild Dog Road from the Great Ocean Road. The unstable area extends over 16 hectares from Wild Dog Road to Busty Road and has been mapped into four zones, based on activity (P.J. Yttrup & Associates, 2001). Activity is triggered by heavy and/or prolonged rainfall. Debris flows and debris slides from the lower slopes of this large complex landslide have often closed the road during the past 50 years (Figure 2).

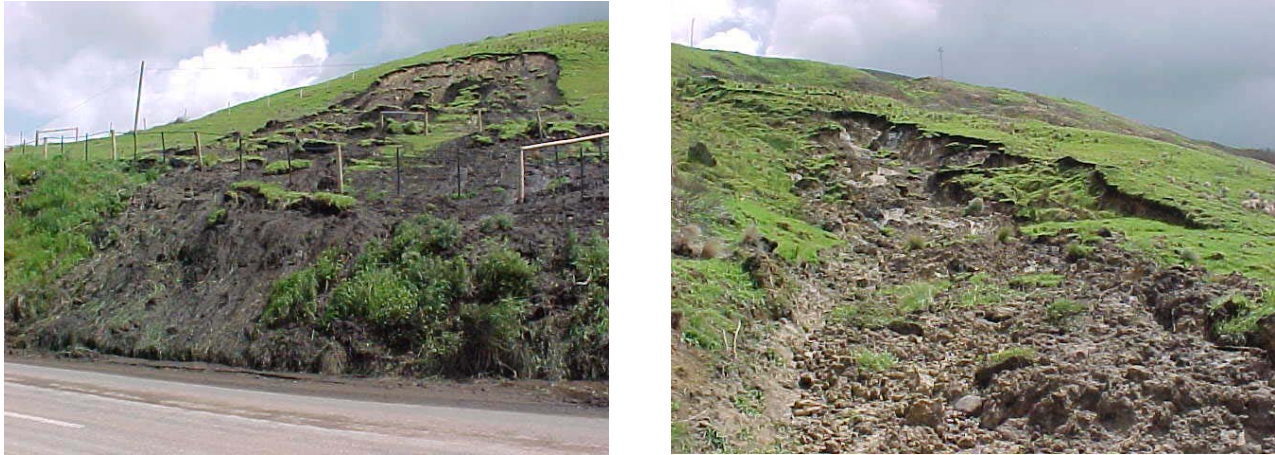
Figure 3. Two adjacent landslides that impacted on the Great Ocean Road, October 2000.

The Great Ocean Road has been subjected to damage from landslides since it was built during the 1930s. Within the Shire boundary landslide debris is seen in outcrop in many cuttings along the road. Many of these slides remain active, especially in the Wongarra area, where recent debris flows have impacted on the road. In October 2000 the road was

covered by debris from two flows which occurred following heavy rain (Figure 3). These rapid, wet, debris flows were initiated in the body of an ancient landslide complex and travelled up to 100 metres to the road.
