DELTA AND SWAMPS

Plate 13 – Latrobe delta (ECF Bird)

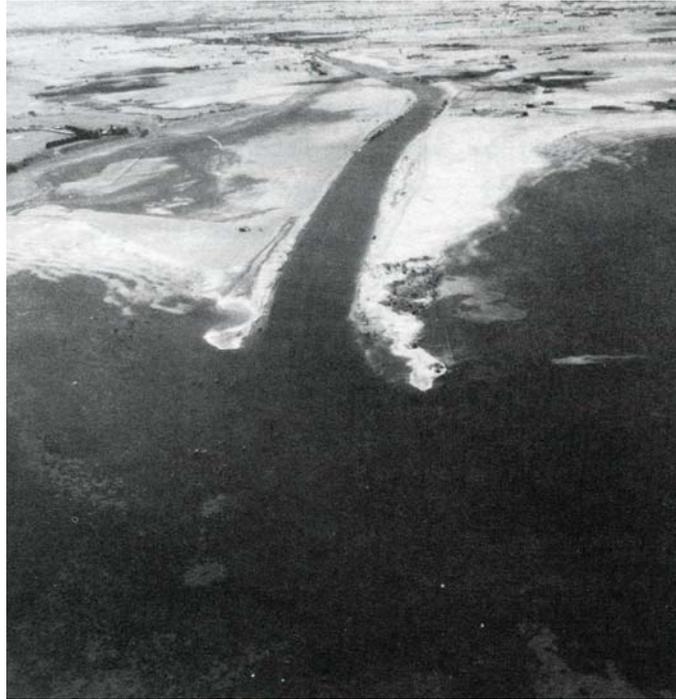
Plate 14 – Tambo delta (N Rosengren)

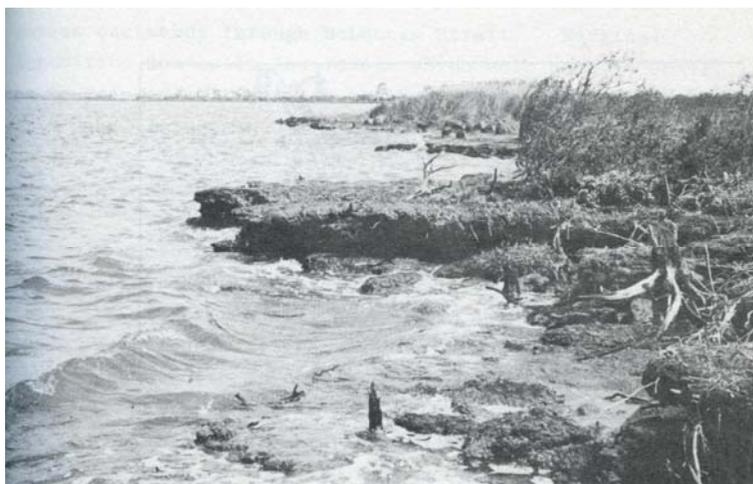
Plate 15 – Eroding shoreline, Mitchell delta (ECF Bird)

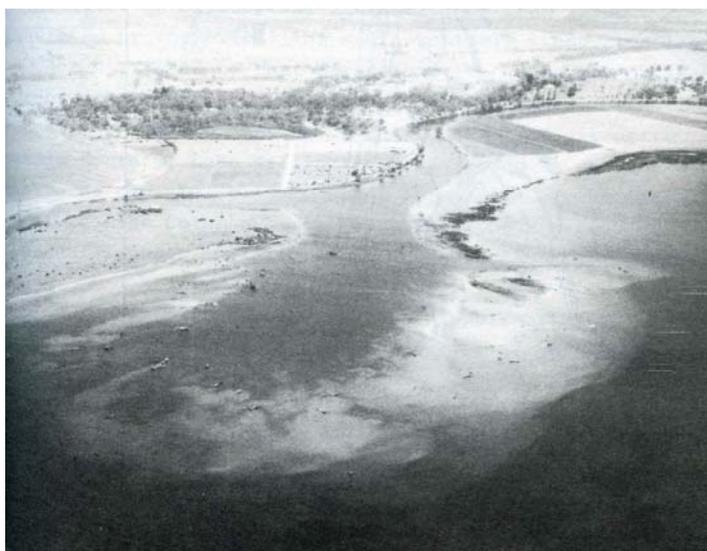
Plate 16 – The Cut, Mitchell delta, showing pattern of deposition in Jones Bay (N Rosengren)

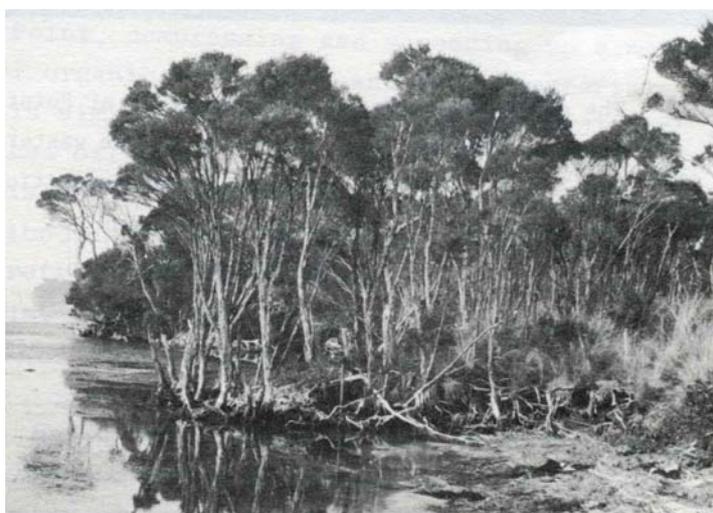
Plate 18 – Eroding swamp scrub land, Lake Victoria (ECF Bird)

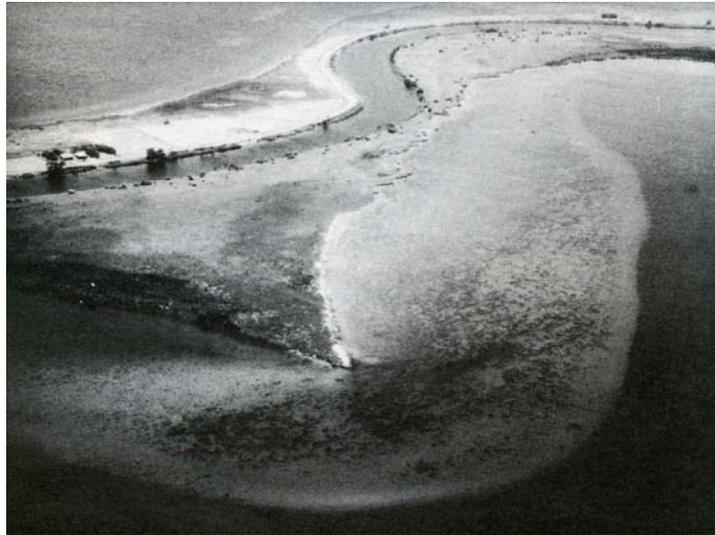
Plate 19 - The north shore of the Mitchell Delta at Point Lardner
Showing beach accretion on the western shore, the pattern of nearshore sand deposition, and irregular erosion in the background (N Rosengren)
