# IrriGate

Sustainable Irrigated Landscapes - North East - Mid and Upper Goulburn Broken

## Vineyard irrigation efficiency performance

# Calculating the distribution uniformity of a travelling irrigator

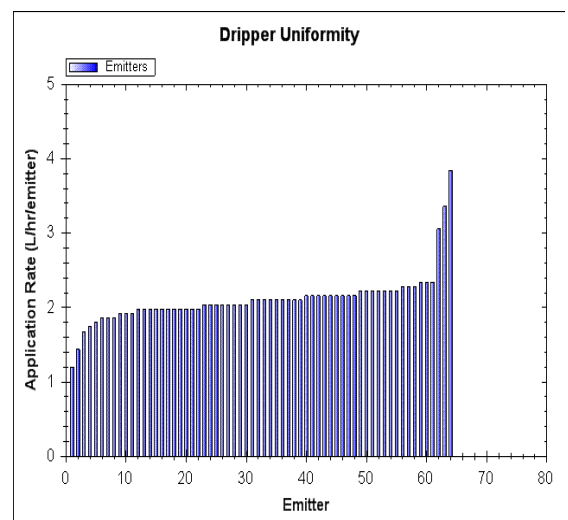
Figure 1: Dripper flow rates from lowest to highest

This can be checked by measuring the flow rate of emitters at a number of locations across the vineyard and checking the 'distribution' or 'dripper uniformity'. The example below (Figure 1) is where we measured this on a seven hectare (Ha) north east Victoria vineyard, irrigated with inline drippers. The flow rate of 64 drippers was measured across the block with the following results.

- The average flow rate from each dripper was 2.1 litres per hour
- Each vine was getting 5.7 litres per hour
- The application over the whole area was 0.7 millilitres per hour
- The dripper uniformity was 86 per cent.

The distribution uniformity was measured at 86 per cent, which is above the 75 per cent level considered adequate, a new system should be operating at 85 per cent or greater. The dripper uniformity in this case provides confidence to the vineyard manager that the vast majority of the vines are getting the same amount of water.

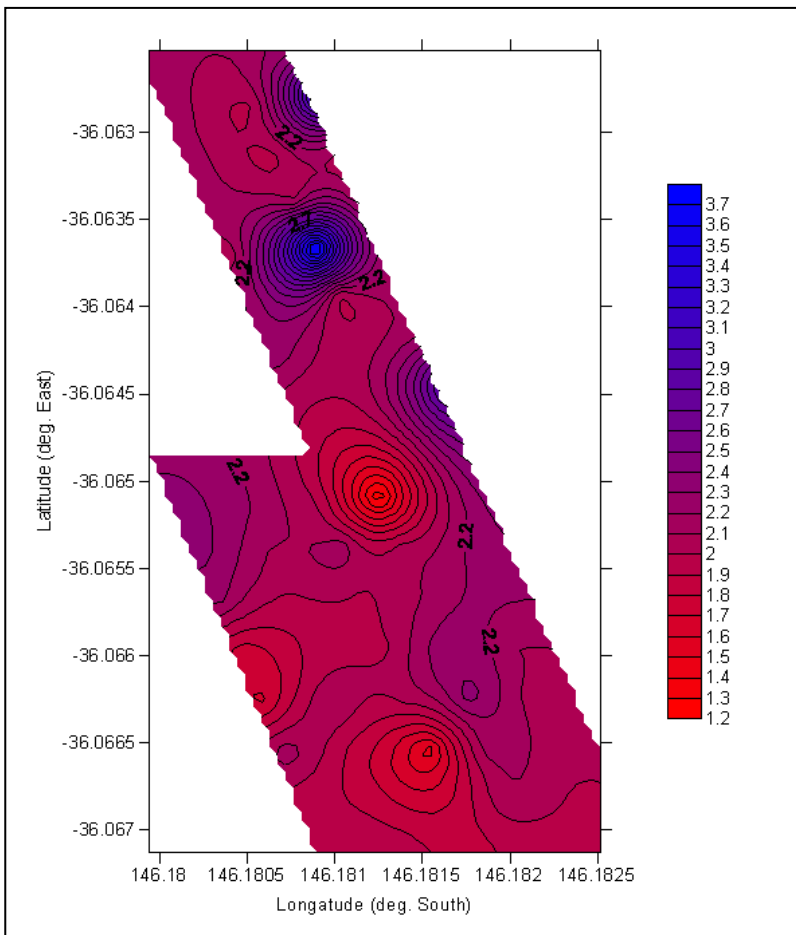
**Figure 2: Drinker uniformity contour map, showing areas likely to get higher or lower amounts of water.**

In this example the measurements were taken one step further by noting where in the vineyard the measurements were taken, so the map in Figure 2 can be produced to identify where across the vineyard the high or low water application is likely to occur.

This allows the vineyard manager to map where the water is being applied and it can also be used to ensure soil moisture monitoring equipment is installed in a representative area of the vineyard.

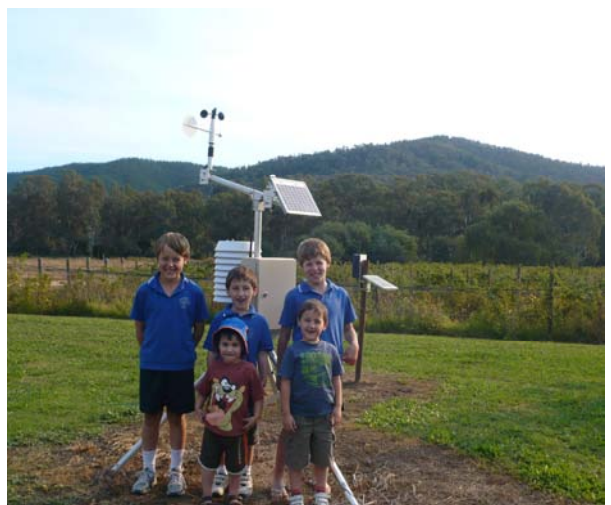
**The weather station on the Caponecchia property at Buffalo River. Back left: Connor, Damian and Fletcher. Front : Luca and Nathan.**

TAFCO Rural Supplies have also used the rebates on behalf of North East Catchment landholders to recently purchase six weather stations. One each located at Kiewa, King and Beechworth and three in the Ovens region. The weather stations monitor conditions such as: evaporation; rainfall; wind speed and direction; humidity and frost. This information will be provided on the internet providing information for all landholders in the area.

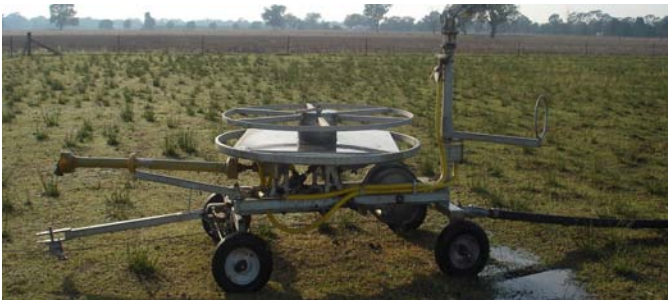
**Figure 4: The travelling irrigator assessed**

A poor distribution uniformity can result in reduced pasture yields or the need for high applications of water. The distribution pattern of the travelling irrigator shown in *Figure 4* was assessed under minimal wind conditions. It throws water to a radius of 37.5 metres (m) applying an average application rate of 15 millilitres (mm), with a distribution pattern shown in *Figure 5*. A distribution uniformity (DU) to aim for is greater than 75 per cent. This travelling irrigator is operating at a distribution uniformity level of 62 per cent without any overlap. To improve this distribution uniformity some overlap should occur.

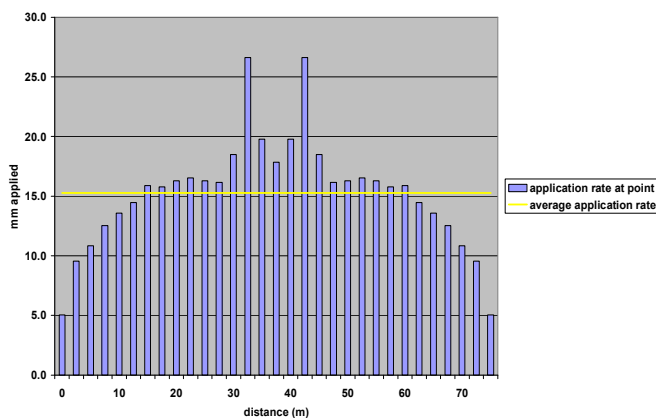
**Figure 5: The distribution pattern of the system DU 62 per cent**

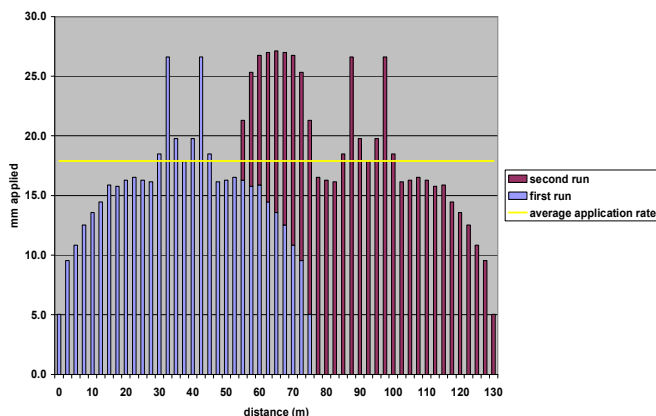
**Figure 6: The current operation with an overlap of 22 m in the middle DU 64 per cent**

**Current operation:** This travelling irrigation system is currently operated by two runs down a paddock creating a 22 m overlap in the middle and none on the edges as shown in *Figure 6*. This increased the average application rate to 18 millilitres, but only increased the distribution uniformity to 64 per cent.

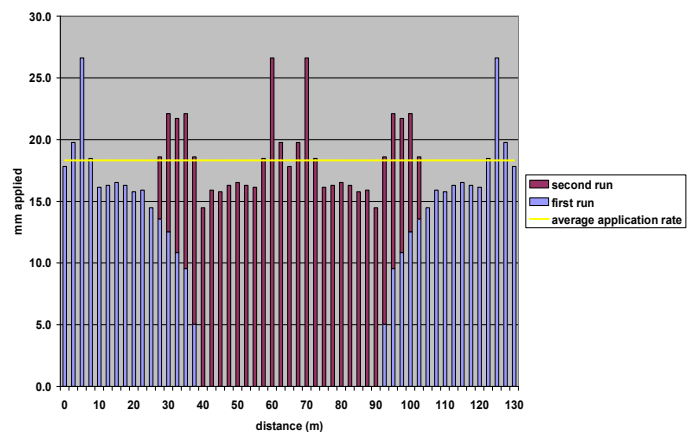
**Figure 7: The current operation with an overlap of 12.5 m DU 84 per cent**

**An improved operation:** A better option to improve the distribution uniformity of this travelling irrigator is to introduce a third run. In this case, to keep within the paddock boundaries a half throw could be run along the edges of the paddock and then a run straight up the middle, providing an overlap of 12.5 m. This maintains the average application at 18 mm but increases the distribution uniformity to a very respectable 84 per cent. (*Figure 7*). It should be noted this set up will increase the labour required by adding an extra shift.

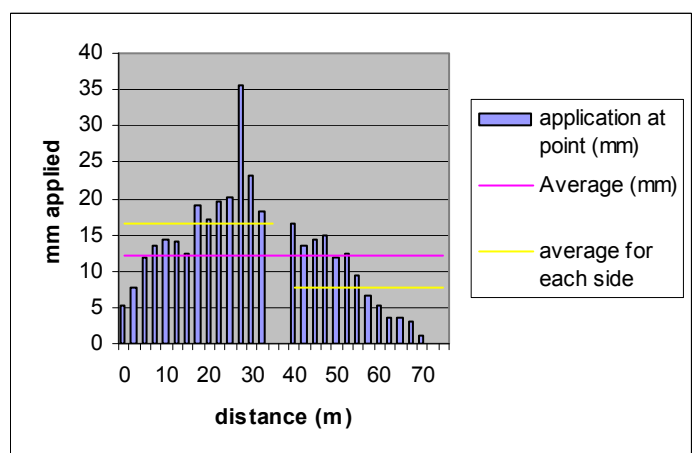
**Figure 8: The affect of a 20 km/hr wind on the distribution uniformity of a travelling irrigator**

**Affect of wind:** A frequent comment with travelling irrigators is the affect of wind and how this really changes the distribution uniformity. This same travelling irrigator (*Figure 1*) was tested during windy conditions. The average wind speed during this assessment was 20 kilometres an hour (km/hr), classified as moderate breeze, with average gusts up to 32 km/hr. The affect of the wind dropped the distribution uniformity to 20 per cent. The average application rate on the down wind side was 17 mm, while up wind the average was eight mm (*Figure 8*).
