Gully Erosion

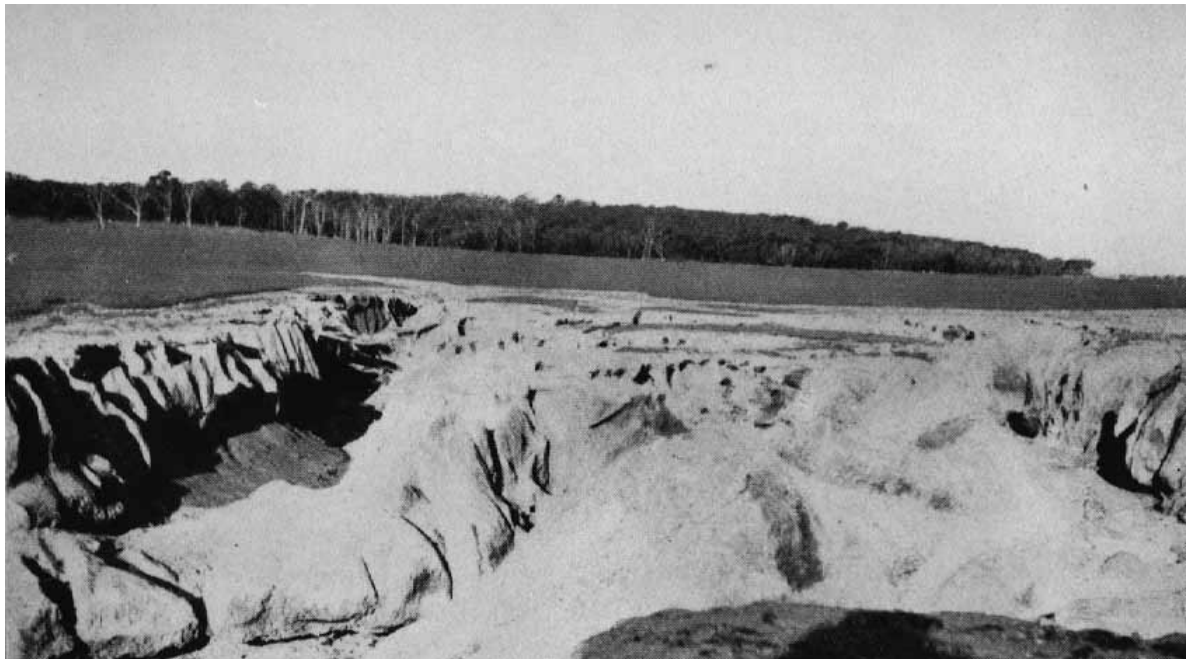
9. Severe gully erosion in wheat paddock near Wychitella. Ploughing with the slope has first caused sheet erosion, though slope is not very steep, and later on gullies have developed along furrows, cutting the paddock into awkward shapes, reducing the cultivable area, and sending down large quantities of silt to cover lands below. Land owners say that production from areas has fallen off considerably.

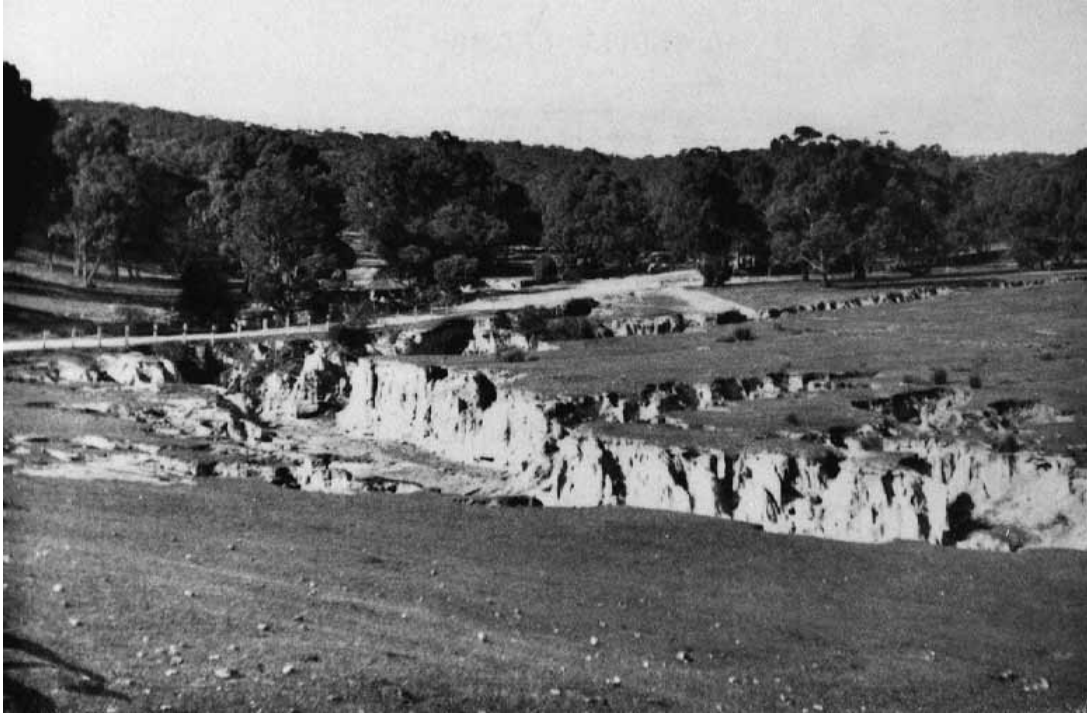
10. Gullying at Vaughan, south-west of Castlemaine, possibly started by prospecting along the streams but now rapidly extending by headward erosion. A good example of secondary effects being more serious than the loss of land; not only is the road threatened, but the debris from this scour is being washed down to the Loddon river, to smother riverflats or choke the Laanecoorie Weir.

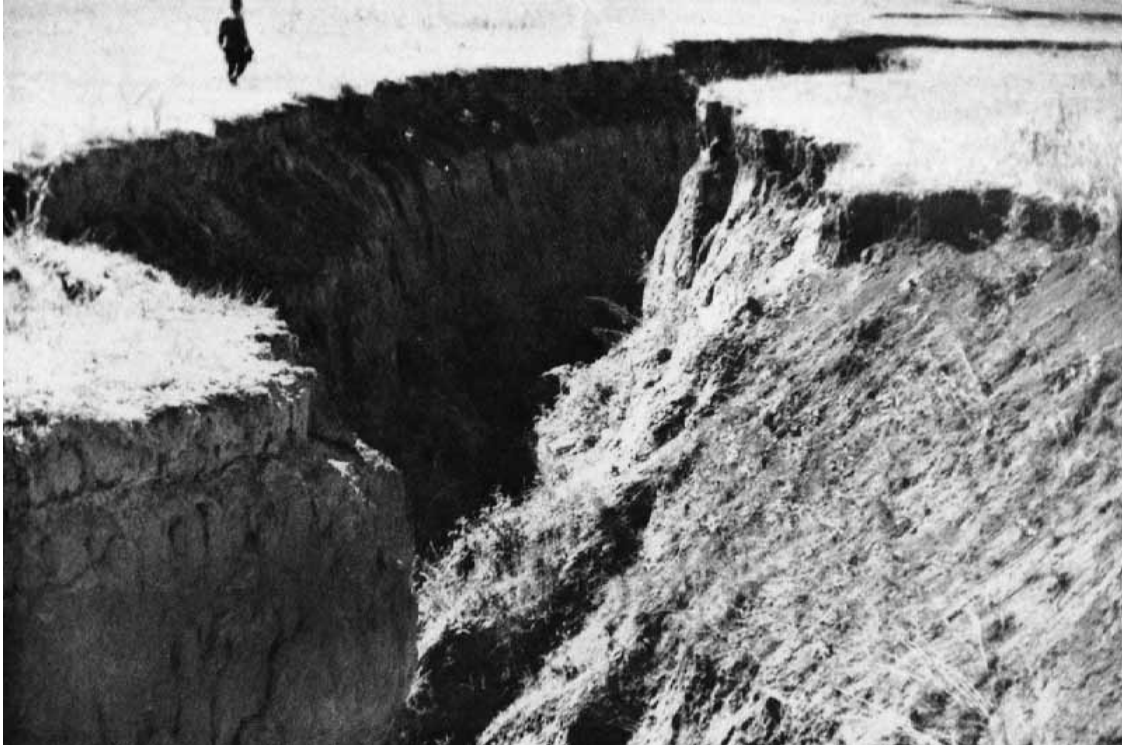
11. Gully through grassland at Bindi, Upper Tambo, 25 feet to 30 feet deep.

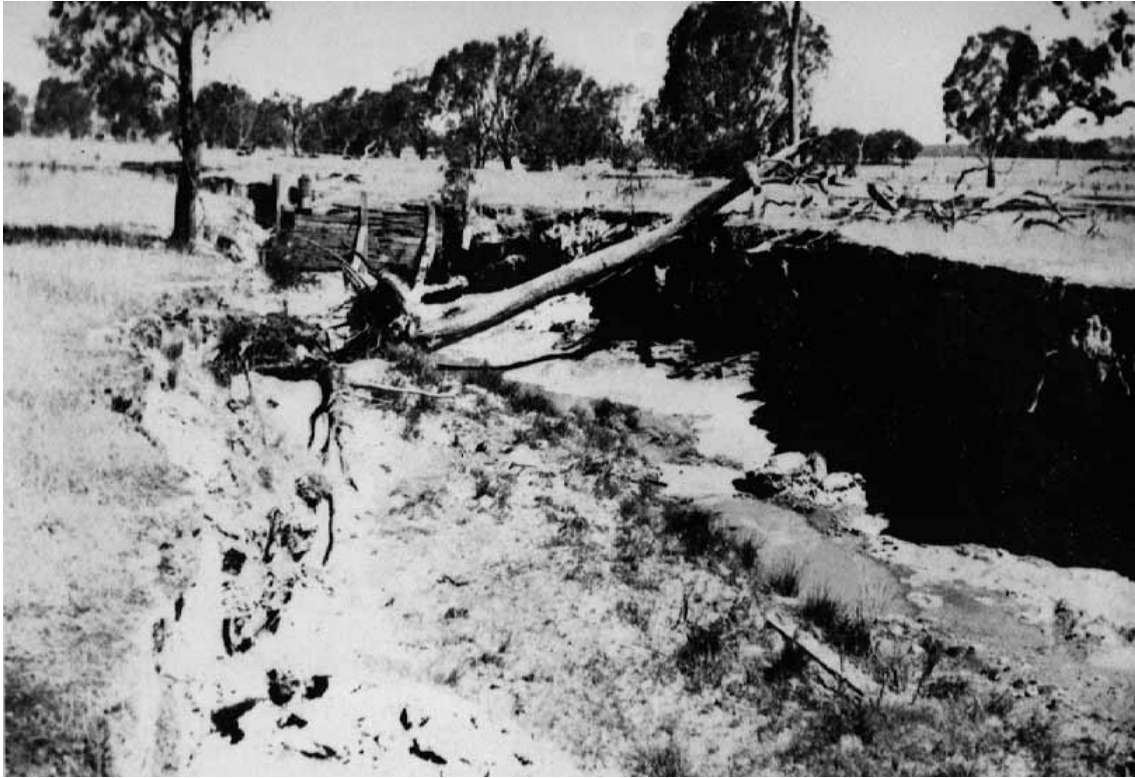
12. This gully, north-east of Benalla, has worked back for several miles through grazing properties. Structure in background was one of several installed by landholder to check it.

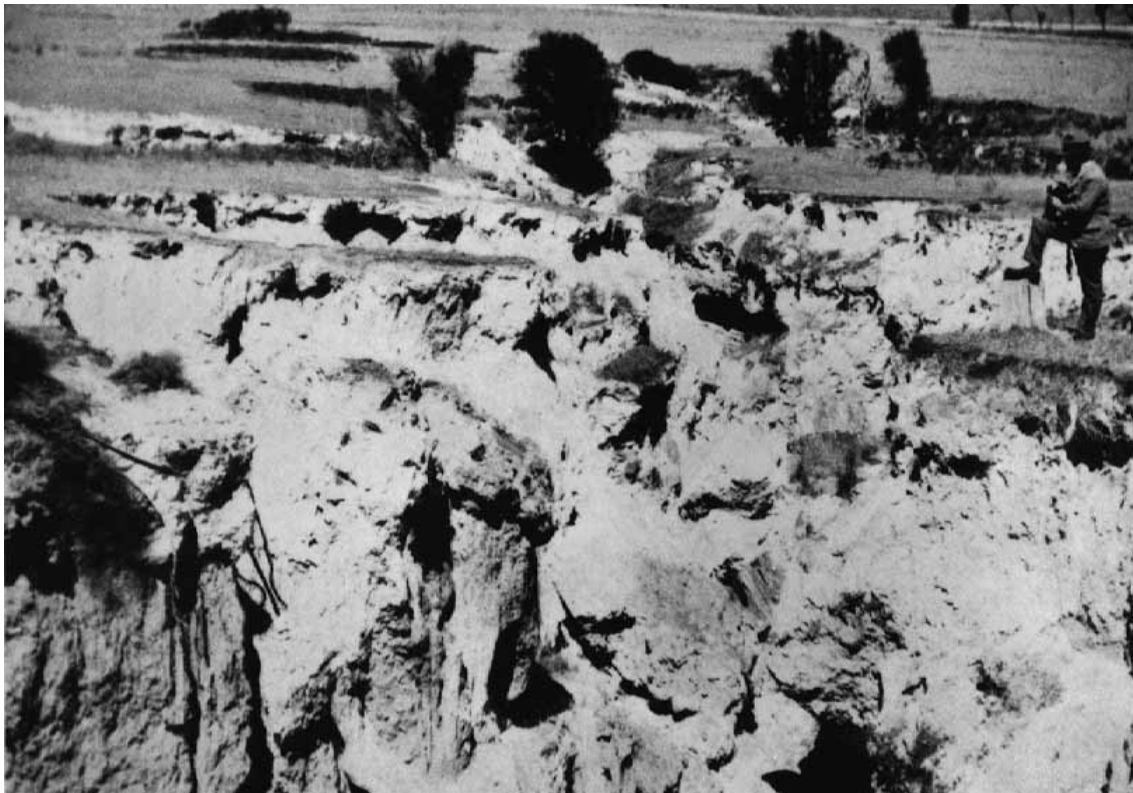
13. Scour in the flank of a hill near Wallan, Silurian bedrock.

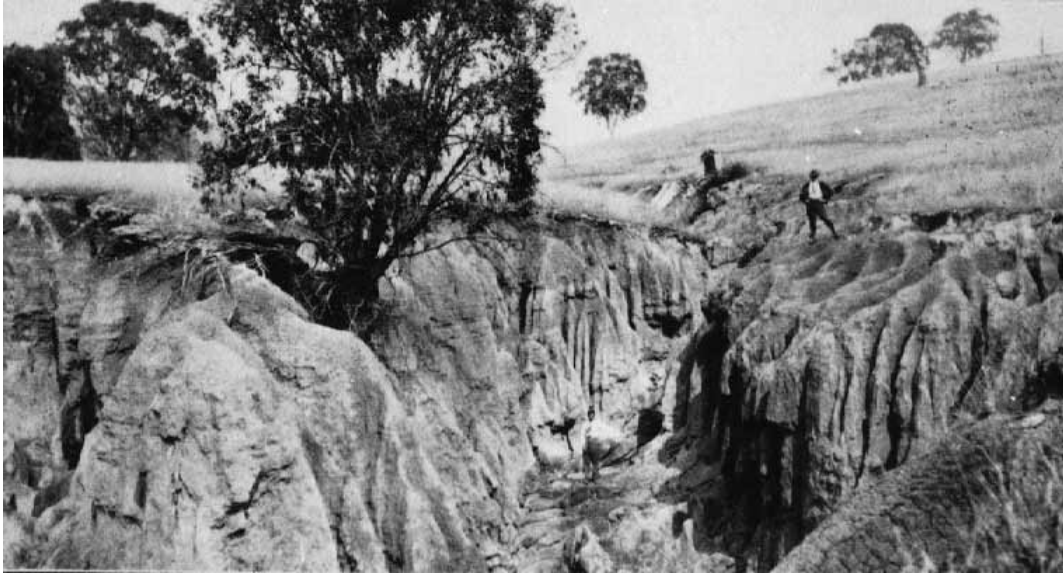
14. Huggin's Gully, a scour some three-quarters of a mile long, running up from Day's Creek near Omeo. Grazing country, with metamorphic bedrock and friable subsoil, the erosion of which undermines the topsoil. Note how the tree roots have retarded scouring at one point.

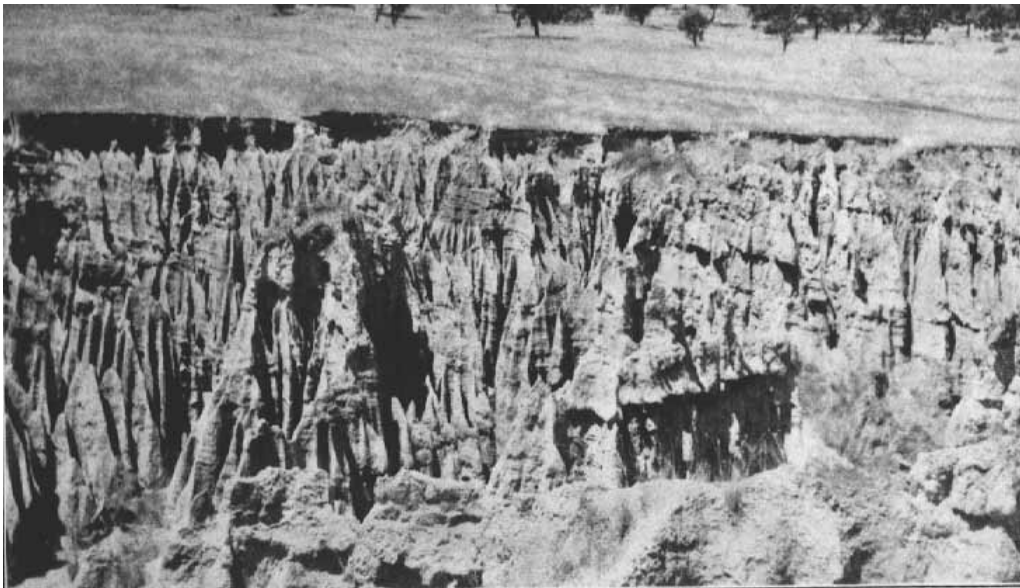
15. The "Cathedrals", a huge scour in a hillslope near Towong, in the Upper Murray district. Although the catchment is not great, stormwater has in a relatively short time scoured out many thousands of cubic yards. Being formed of the wash from a granite hills, the subsoil is friable and sugary.

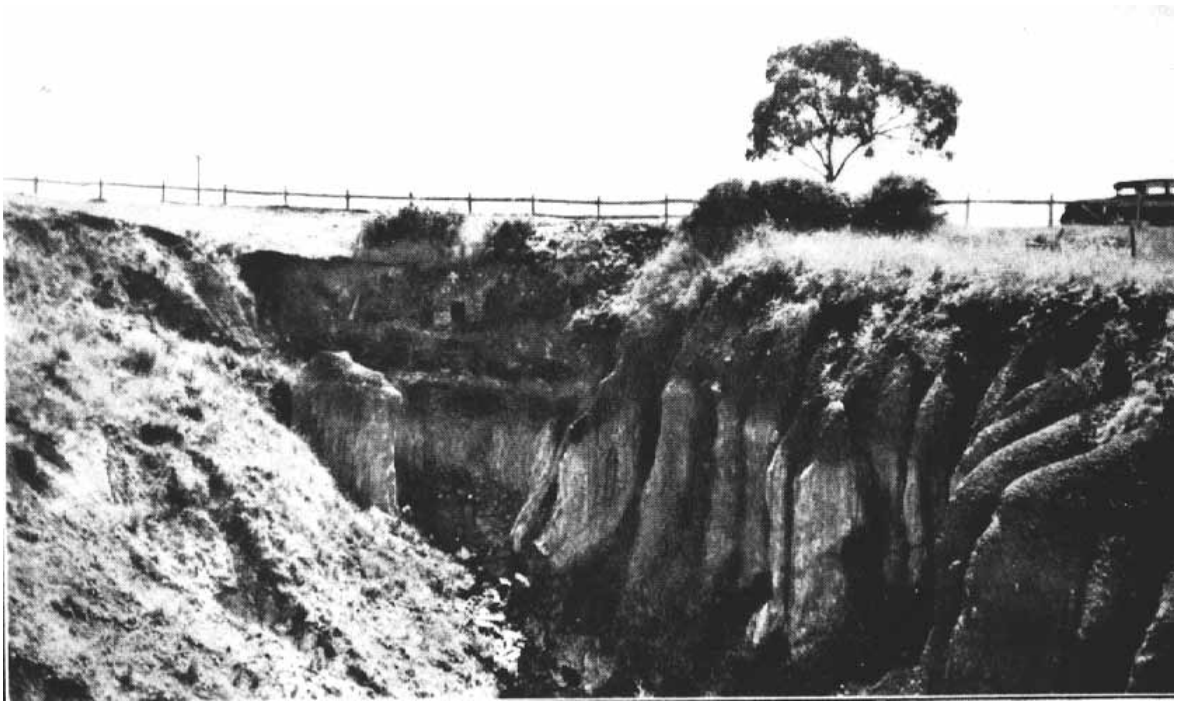
16. Scour below Bulla road, formed by small rectangular culvert through which storm water passes; may be seen in the left centre of the picture.

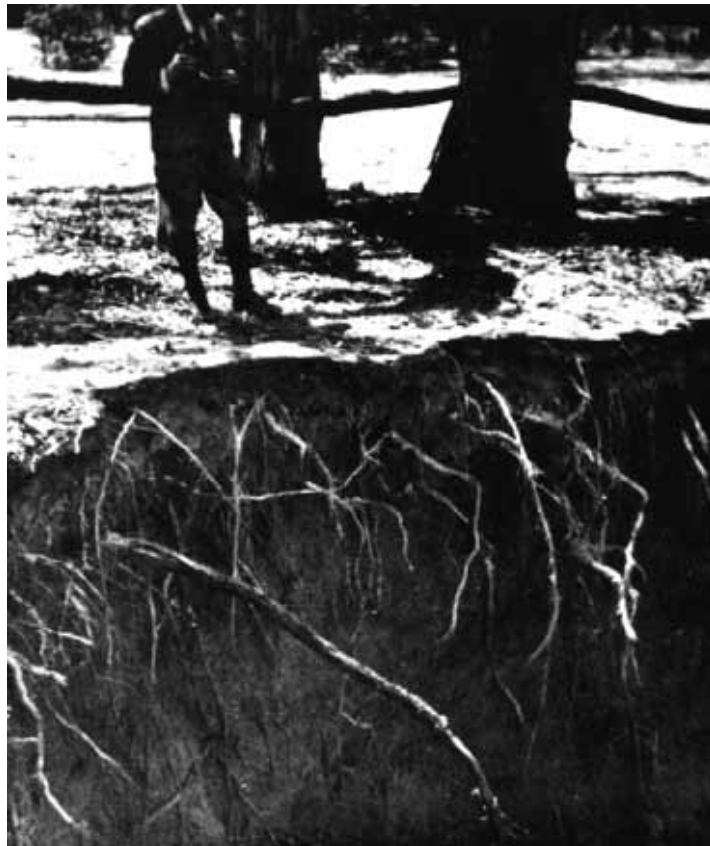
17. Head of deep scour, about half a mile long, near Toolern Vale. This is said to have started from a furrow run down a slope to lead water to a dam. It is now 15 feet deep, and has invaded a road.

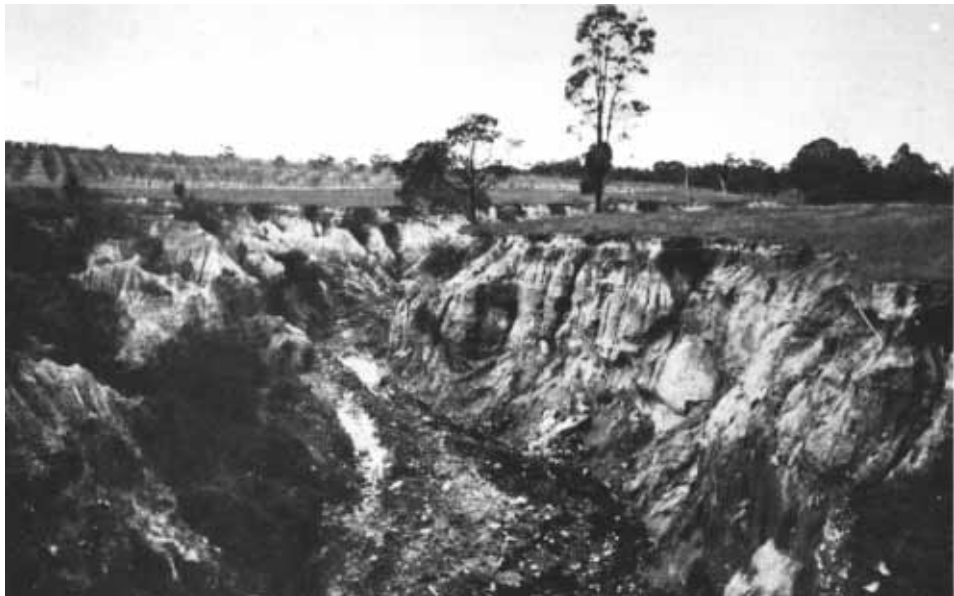
18. Large gully parallel to railway embankment near Elphinstone.

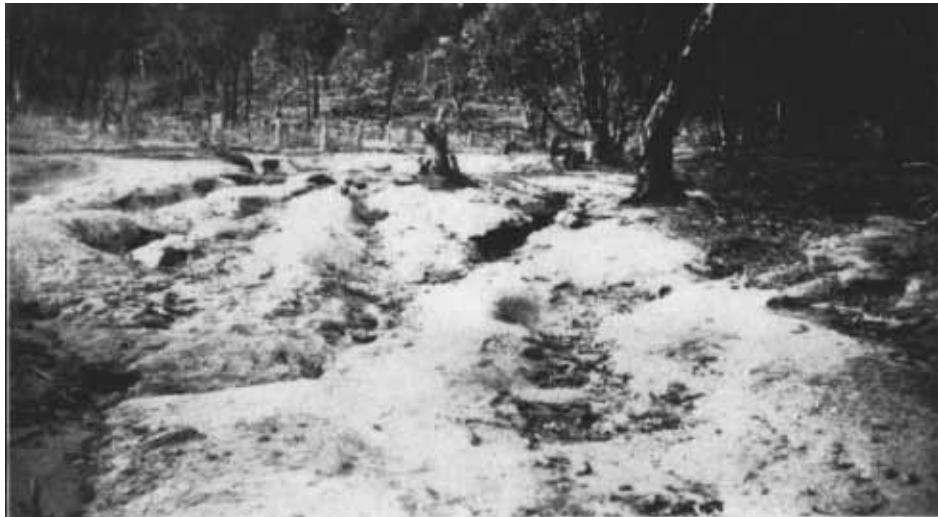
19. A road in granite country, north-east of Wangaratta. The surface has been stripped off by traffic, and gulying has commenced.

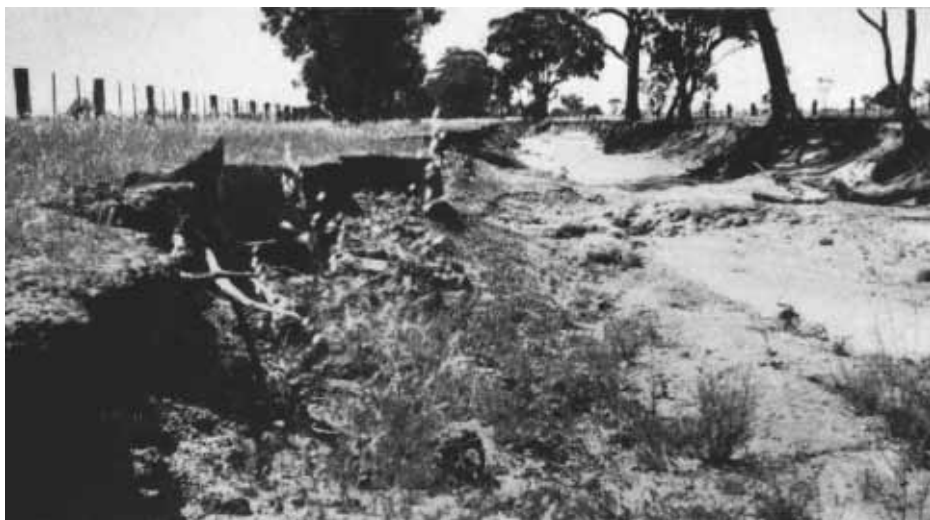
26. Spring Creek comes down from the hill west of Bendigo, and used to spread over the flatter land near Derby. A drain was cut down a road, perhaps 40 years ago, to continue the waters of the creek. This has scoured till it now occupies nearly all the road.
