CASE STUDY 3

BORDER-CHECK IRRIGATION PERFORMANCE ON A HEAVY SOIL IN THE KATAMATITE DISTRICT, NORTHERN VICTORIA

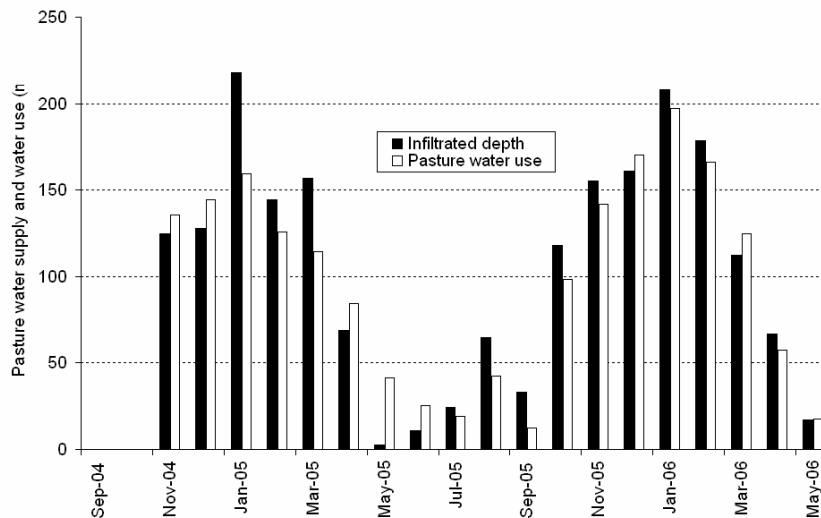
Figure 1: Comparison between monthly water supply (irrigation and rainfall less rainfall), and pasture water use for the 2004/05 and 2005/06 irrigation seasons.

A combination of good layout design and management resulted in a matching of the infiltrated depth of water (irrigation plus rainfall less run-off) and demand. There was close correspondence between monthly measures of pasture water use (ET_a) and water supplied as rainfall plus irrigation (Figure 1 below).

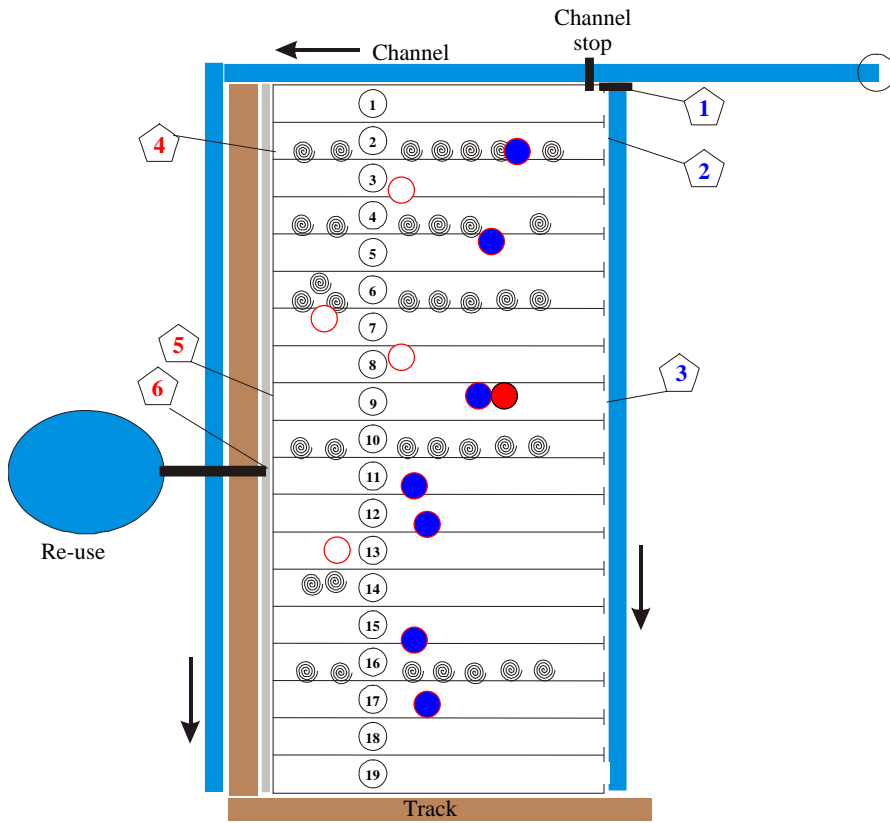
Figure 2: Field site layout

- Bowen ratio
- Soil-water and pasture monitoring
- Pasture cage only
- Tree

Measurement location sites:

- 1** Main Inflow
- 2 & 3** Inflow into bay 2 and bay 9 respectively.
- 4 & 5** Surface drainage from bay 2 and bay 9 respectively.
- 6** Main surface drainage.

The owner operates a 200 hectare dairy farm in the Murray Valley Irrigation Area of northern Victoria. A 30 hectare section of the farm was monitored for border-check irrigation performance and pasture production under a Department of Primary Industries research project (see Figure 2 below for field site layout). The soil type on the block is predominantly heavy clay. The landowner wants to know his irrigation performance and also find whether he can improve on his current system.
