6. *Soil Conservation*

R. F. Chaffe, J.E. Grimes and B.R. Bradford

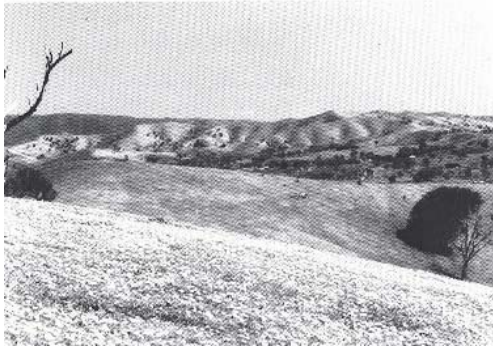
Plate 6.2 Increased fertility has caused the spread and dominance of capeweed. When capeweed dies off in late spring the hills are left bare.

The control of rabbits and the introduction of superphosphate and subterranean clover in the 1950's reduced the severity of the degradation as ground cover was restored. However, the increased fertility and higher stocking rates created new problems such as the spread and dominance of annual weeds (Plate 6.2) and increased incidence and severity of grass fires. Annual weeds provide very poor ground cover over the summer/ autumn period and grass fires have the effect of rapidly devastating large areas of ground cover in the same period.

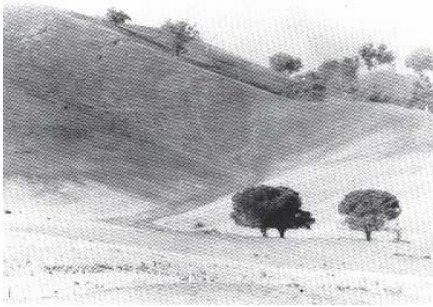
Plate 6.4 A heavy thunderstorm on an overgrazed hillside resulted in severe sheet erosion in the vicinity of Boonie Doon.

Loss of ground cover becomes disastrous when followed by high intensity thunderstorms. Such storms are frequent throughout summer, but are usually confined to smaller areas. Soil loss in such instances has been estimated at over 5 tonne/hectare. Occasionally the storms are more widespread as in 1983 when several thousand hectares were severely sheet eroded by 40 mm of rain falling in less than 30 minutes in the vicinity of Bonnie Doon (Plates 6.3 and 6.4).

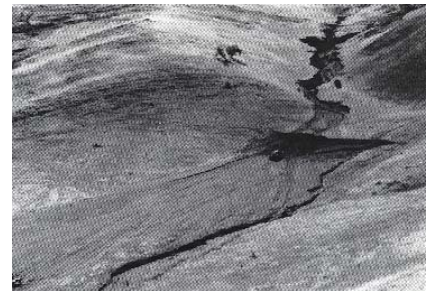
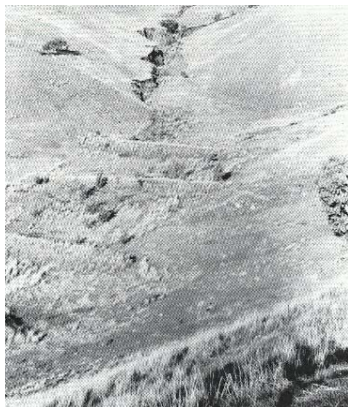
Plate 6.6, 6.7 Deep gullies often develop in drainage lines on overgrazed hillsides. However with reduced grazing, a series of diversion banks and treeplanting this gully has been stabilised.

Control of erosion on these areas has involved an integrated approach using deep rooted perennial grasses, treeplanting, earthworks and structures (Plates 6.6, 6.7 and 6.8). However the major emphasis is placed on presentative measures by providing advice for improved farm management (Plate 6.9).

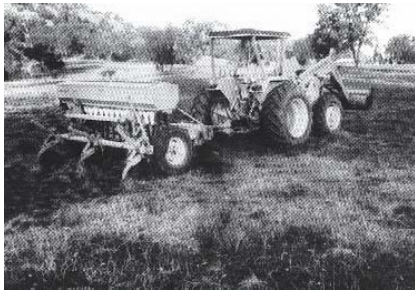
Plate 6.8 The sowing of deep rooted perennial pastures is an important means of controlling and preventing erosion. Traditionally a chisel seeder like the one above has been used but many other methods including aircraft are also successful.

Expert advice and incentives are given to encourage the introduction of deep rooted perennial grasses on the most erosion prone grazing lands. Techniques used include aerial seeding and contour seeding by chisel seeders (Plate 6.8). Such pastures increase production while providing improved ground cover and reduced runoff.

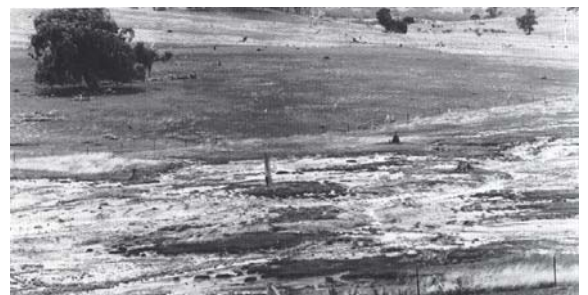
Plate 6.11 Rising saline water tables have caused severe land degradation in drainage lines in the west of the study area

The deterioration of valley grazing land by salinisation is a direct result of rising saline water tables. This is thought to have been caused by the removal of deep rooted native species from groundwater intake areas. Not only does salting cause land deterioration, but also has a marked effect on water quality in streams (Plate 6.11).
