Soil landform map unit: HGn; Hills on Gneiss, Tallangatta / Leneva / Bethanga

Component: 1

Land element: Steep slopes

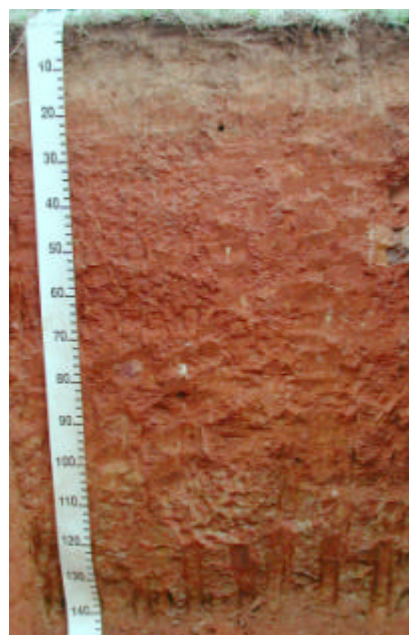
Horizon	Depth (cm)	Representative profile description Site ID: Tallangatta 102
A1	0-20	Dark brown (10YR3/3) sandy clay loam; moderate crumb structure; ped sizes 5-10 mm; weak consistence when moist; pH 6.0; clear transition to:
A2	20-25	Brown to dark brown (10YR4/3) loam fine sandy; moderate subangular blocky structure; ped sizes 8-10 mm; weak consistence when moist; common medium sized platy mica coarse fragments; slight dispersion; pH 6.0; gradual transition to:
B2	25-70	Yellowish brown (10YR5/4) clay loam fine sandy; moderate subangular blocky structure; ped sizes 10-15 mm; smooth fabric; firm consistence when moist; many medium sized platy mica coarse fragments; slight dispersion; pH 5.5; gradual boundary transition to:
C/R	70+	Weathered bedrock
