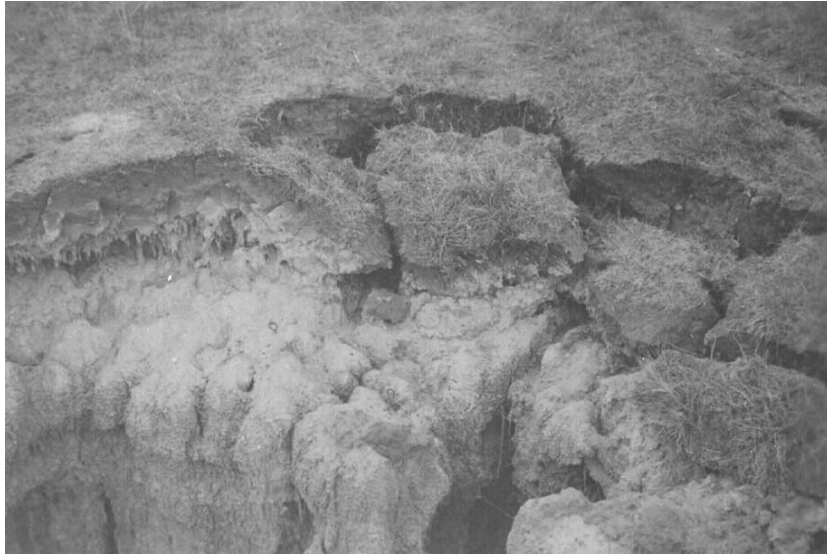
***Plate 9. Extrusion sapping in the A horizon of a solodic soil.***

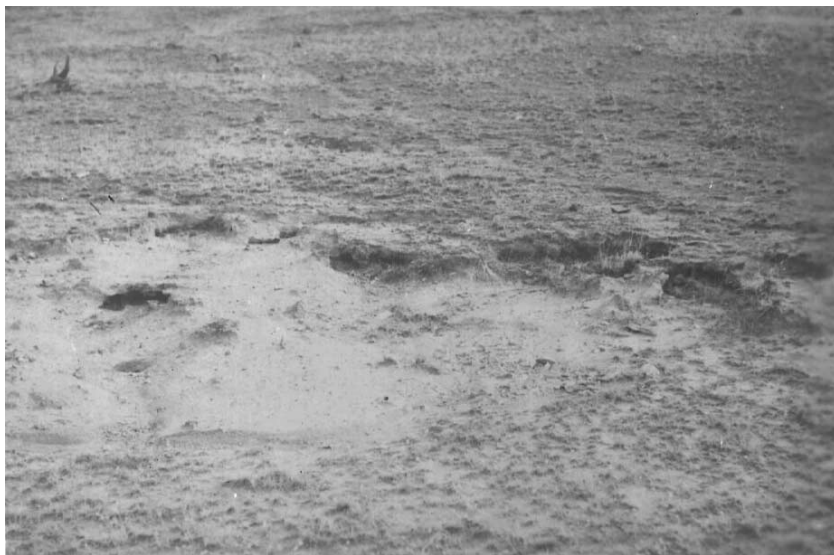
***Plate 10. A horizon sheet sapping.***

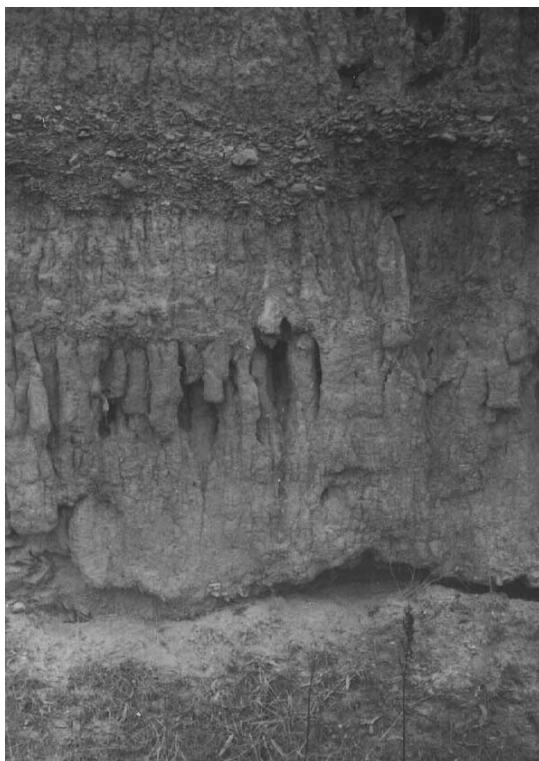
***Plate 11. Tunnel erosion long cracks in burned soil (centre) and along Root-holes (top).***

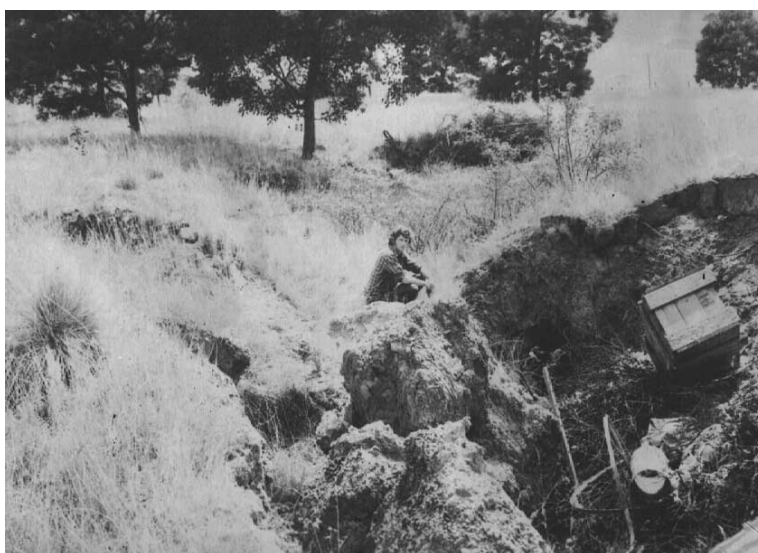
***Plate 12. A gully forming by collapse of a tunnel 6ft below the ground surface.***

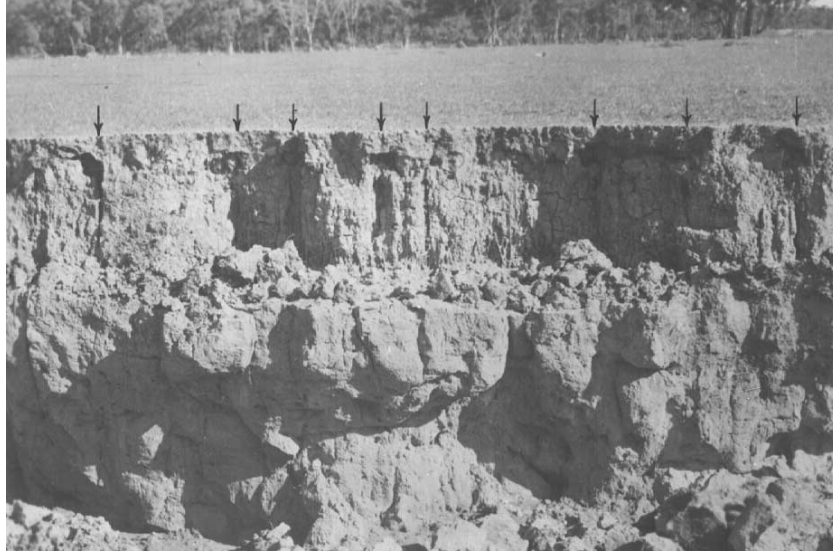
***Plate 13. Tunnels form along vertical cracks in alluvial soil.***

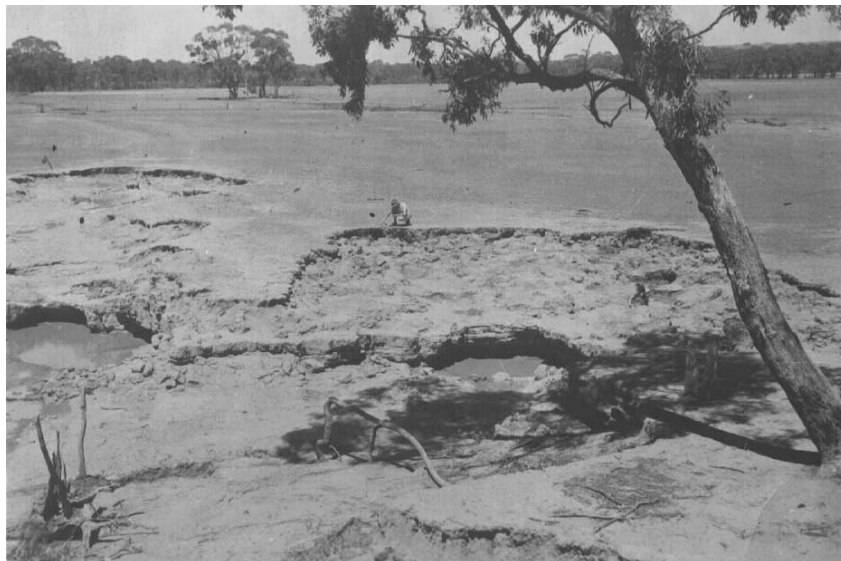
***Plate 14. Wide gullies created by tunnel-sapping in alluvial soils.***

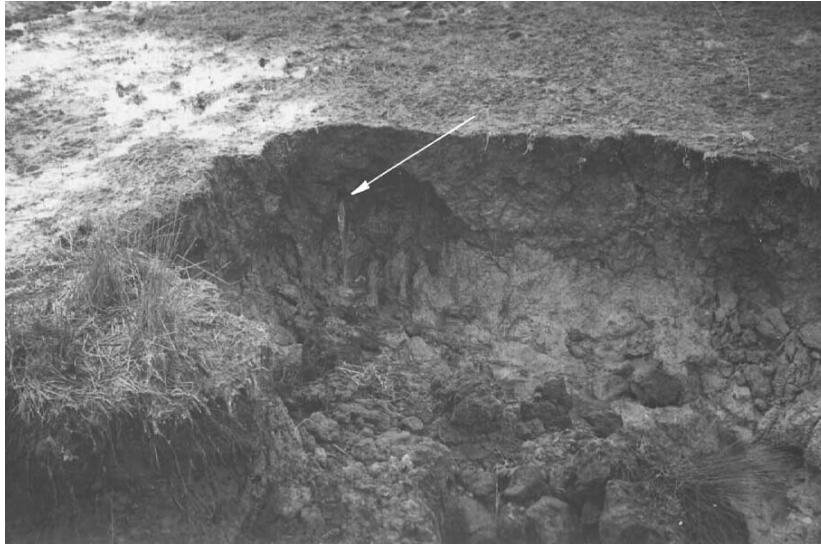
***Plate 15. Tunnels formed in valley marsh soil.***

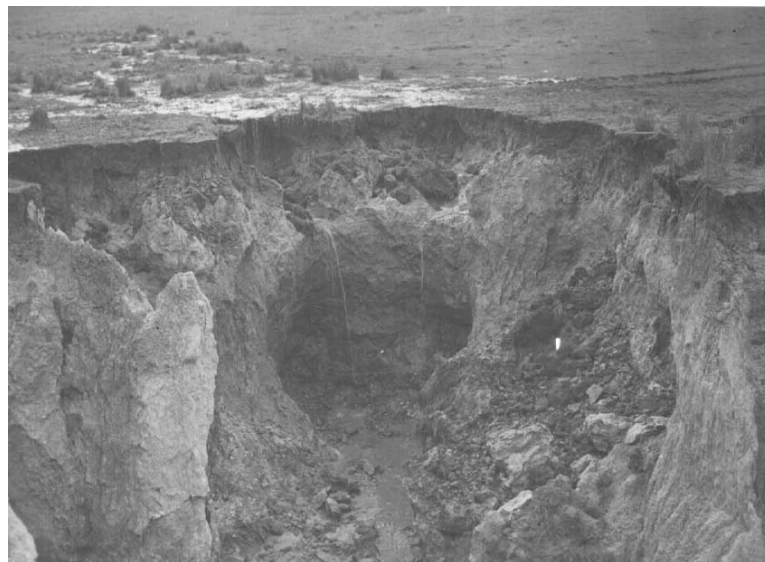
***Plate 16 (3 parts). Stages in the headward advance of a gully head where the Mechanism tunnel-sapping is operating in a valley marsh soil.***

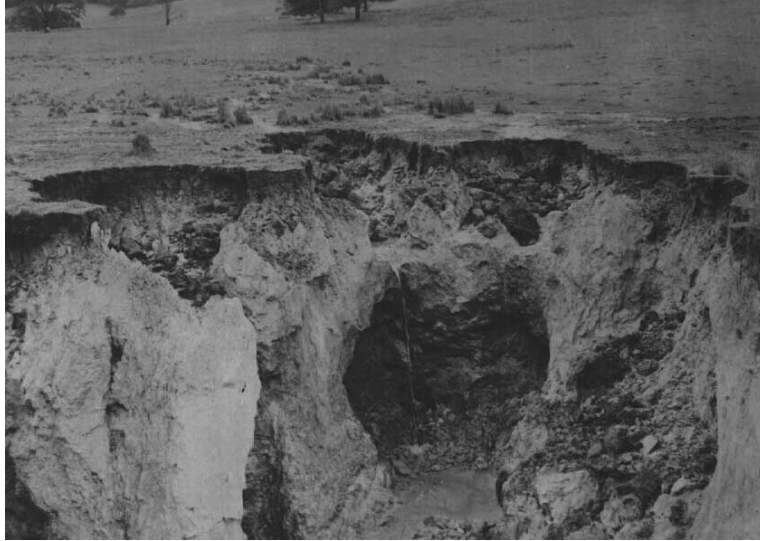
***Plate 16B. Within 6 days the head advanced by 12 ft.***

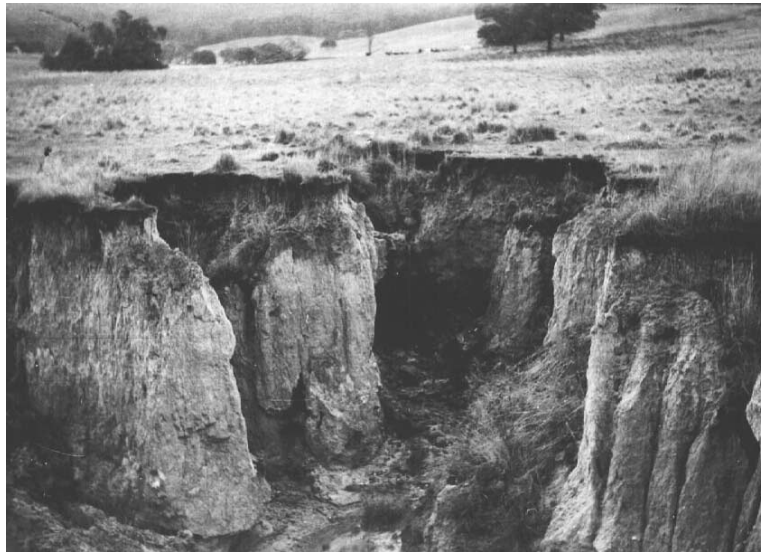
***Plate 16C. Within 3 months the subsoil was nearly all removed by spalling.***

***Note also basal cave caused by spalling and slaking.***

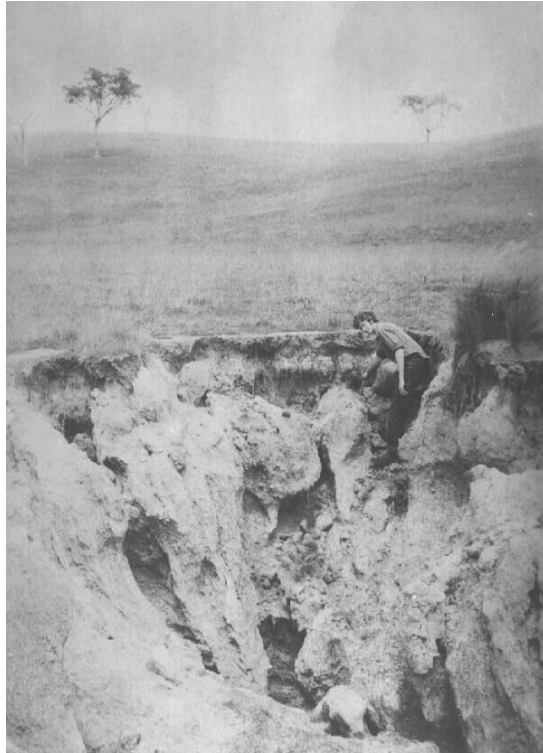
***Plate 17. When the catchment had only a poor pasture, this gully head operated by A horizon sapping. Since the catchment was improved, sapping has stopped, but the head is still progressing by means of tunnelling below the roots of phalaris.***

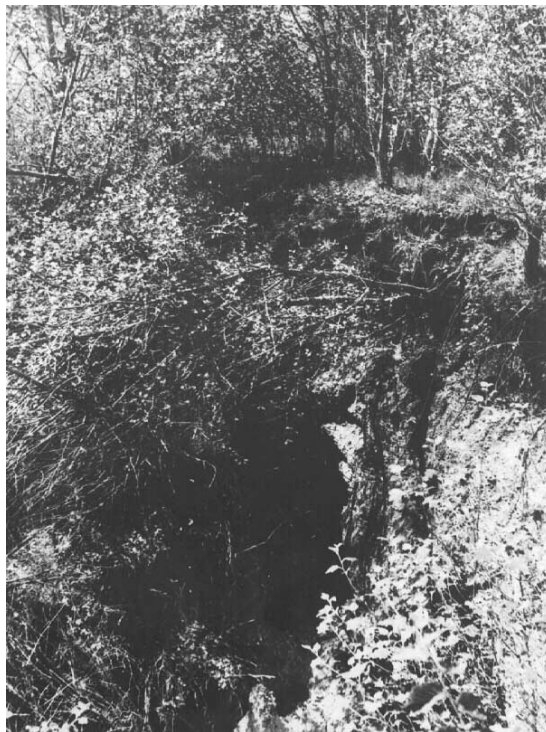
***Plate 18. Tunnelling below poplar roots at contact with tough, impermeable layer.***

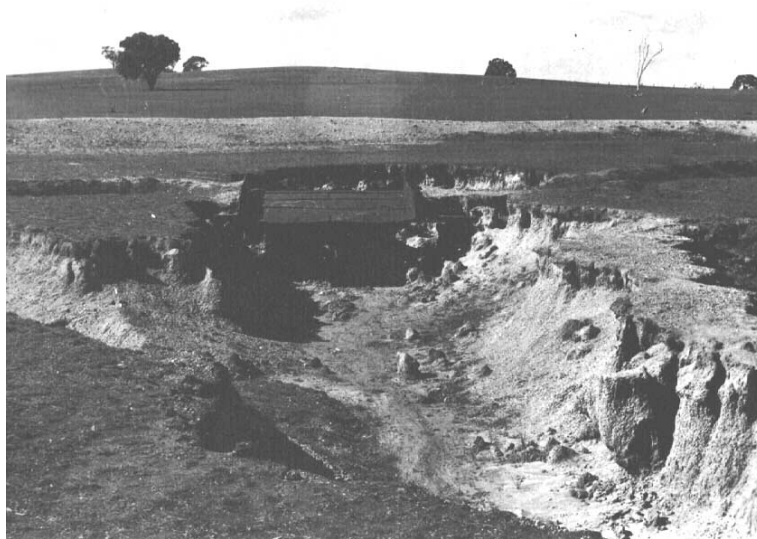
**Plate 19. This verandah structure failed because it could not cope with A horizon sapping and deep tunnelling.**

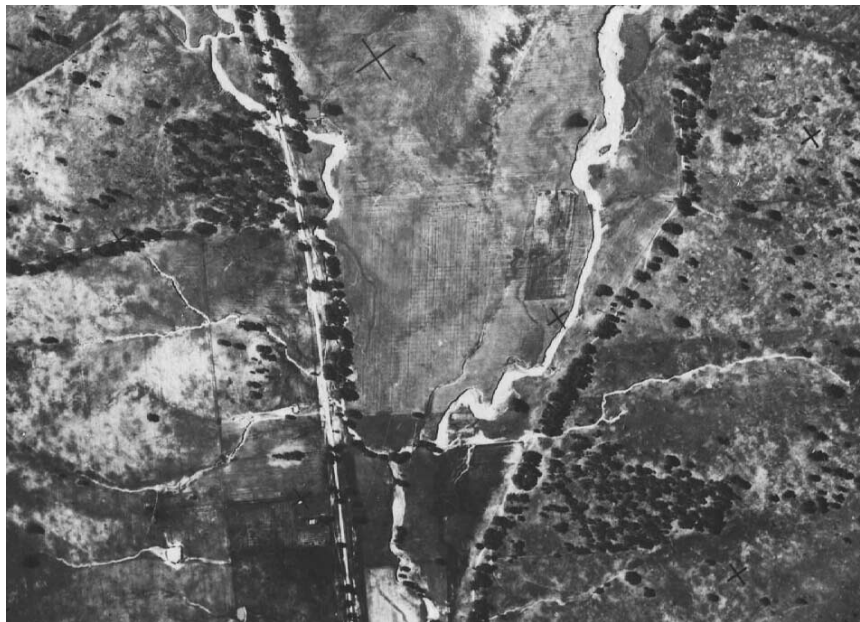
**Plate 20. Wide gullies cut in columnar alluvial soil (1"≅35 chains)**
