## ***Landslides***

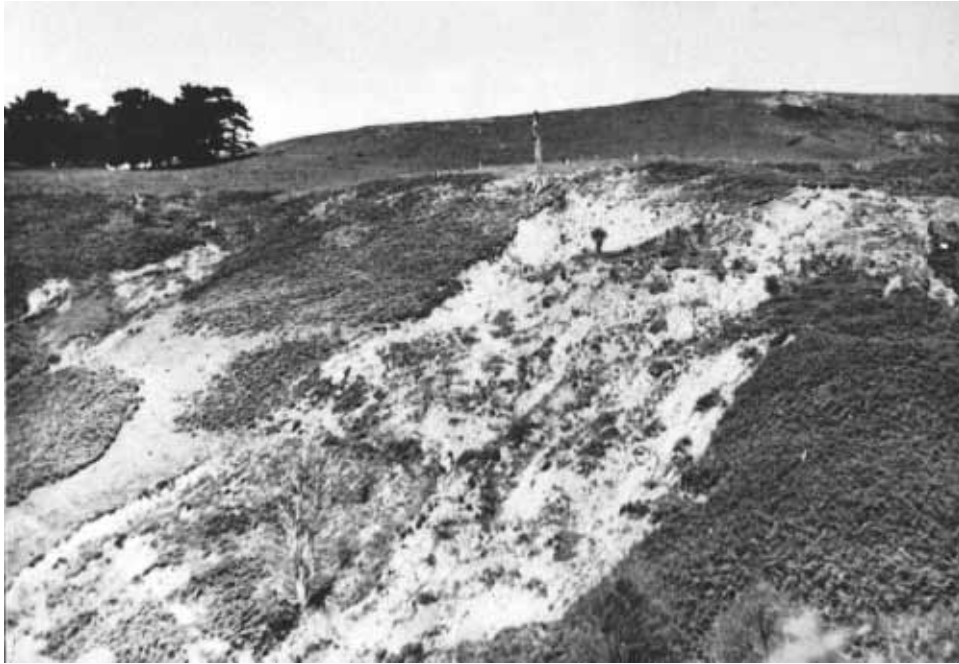
29. Landslide in loams overlying Jurassic sedimentaries near Allambee - South Gippsland

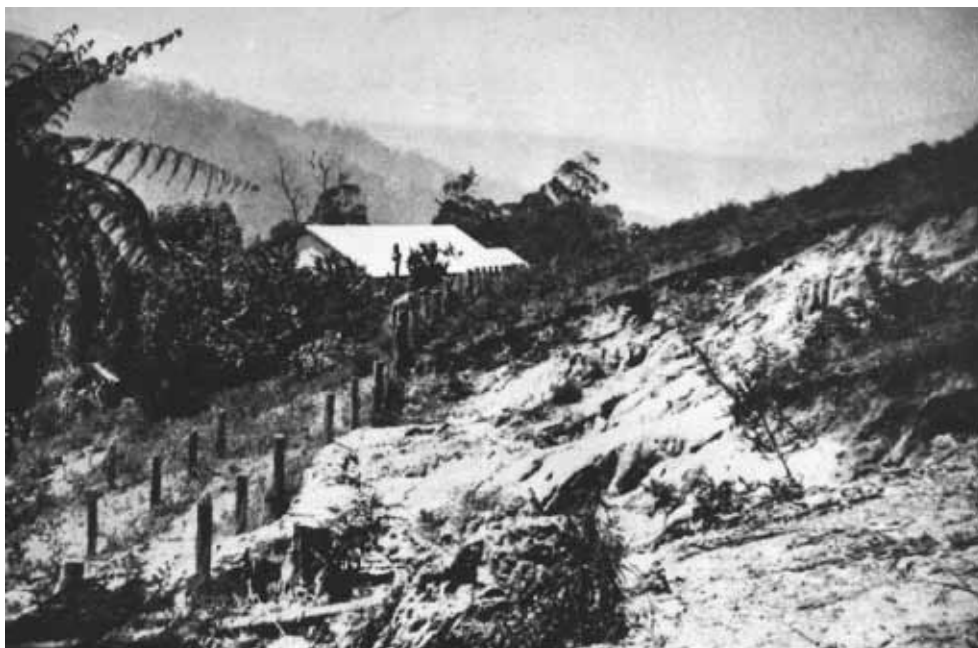
30. Landslide in the light arenaceous loams overlying the granite in the Cannibal Creek area (Bunyip Catchment). Under prevailing climatic conditions, this soil is too unstable to remain on these slopes without the protection of the forest.

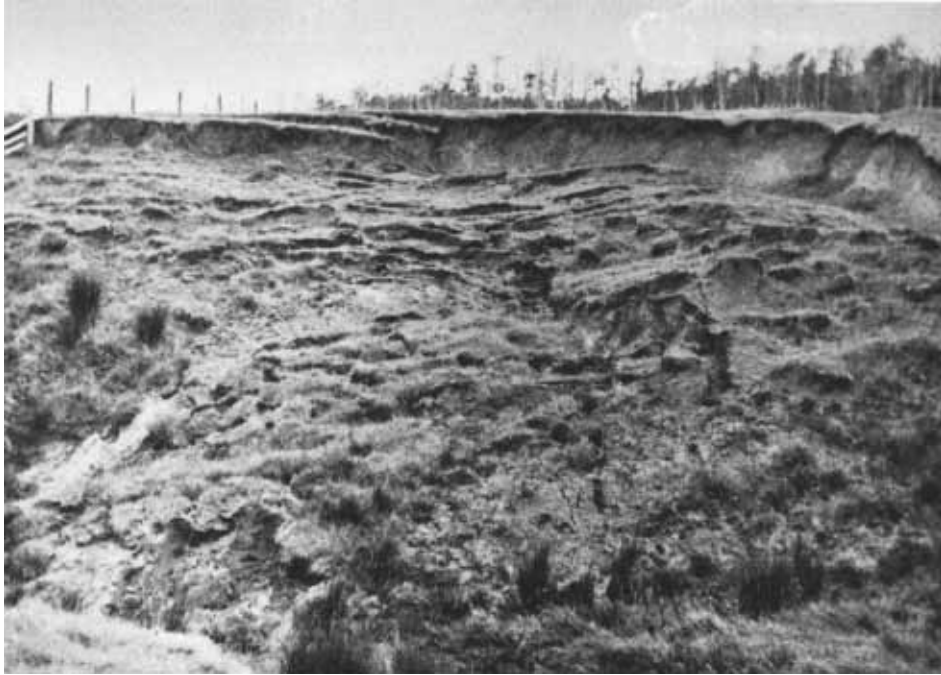
31. Landslide in balsaltic country near Mirboo North, South Gippsland. Debris has partially blocked creek, and is washing away.

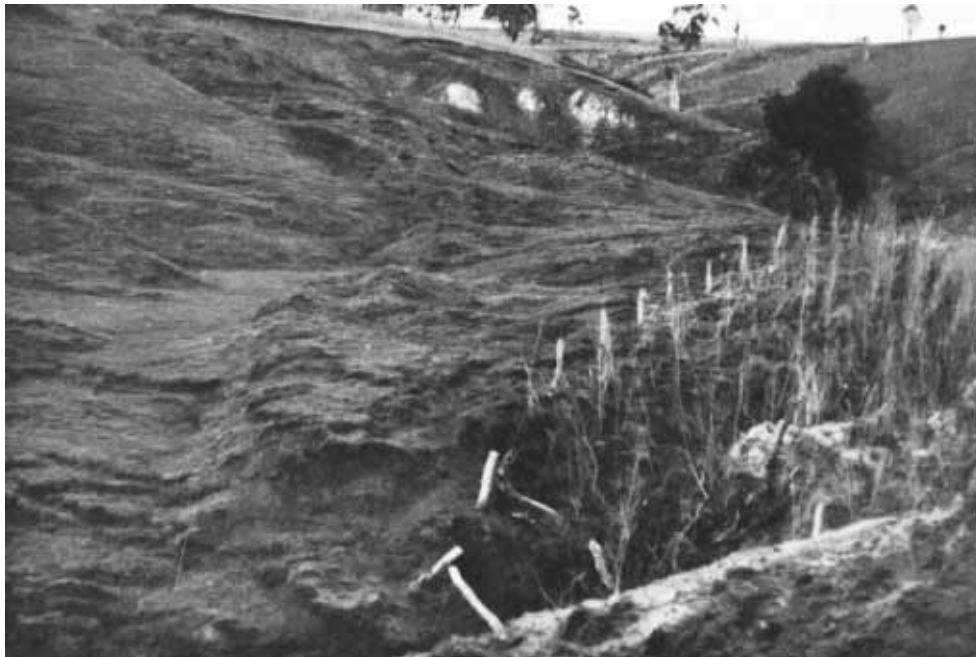
32. Landslides - Coleraine. Willows planted to bind the soil.

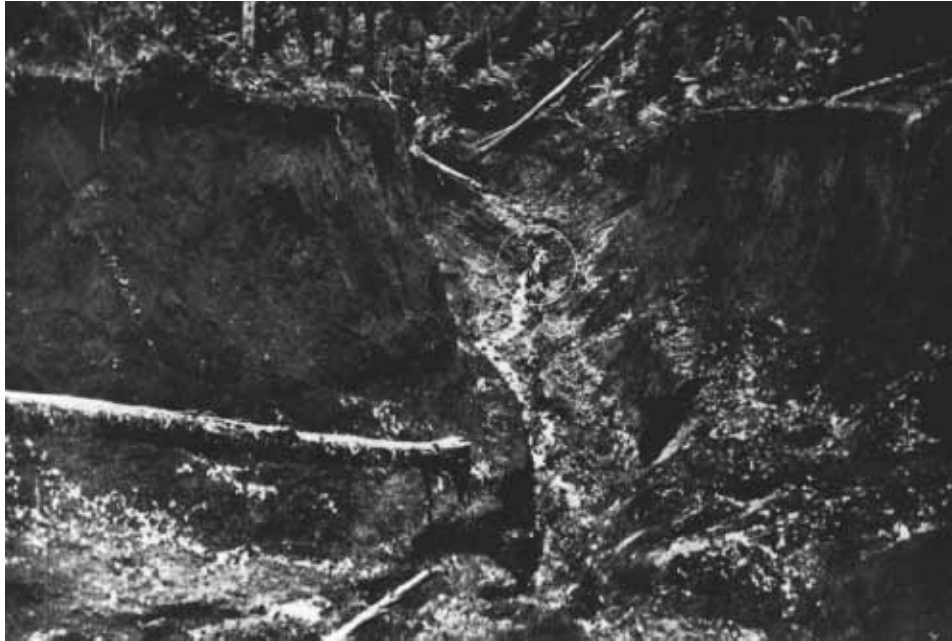
33. Landslide, Myers Creek, south of Toolangi. This forest area was cut over about 30 years ago. The slide followed a rainfall of 11.47 inches in four days and appears to have been caused by the trapping of water in loose deposits of shingle beneath a heavy mantle of soil. The extent of landslide is indicated by the size of men shown in circle.

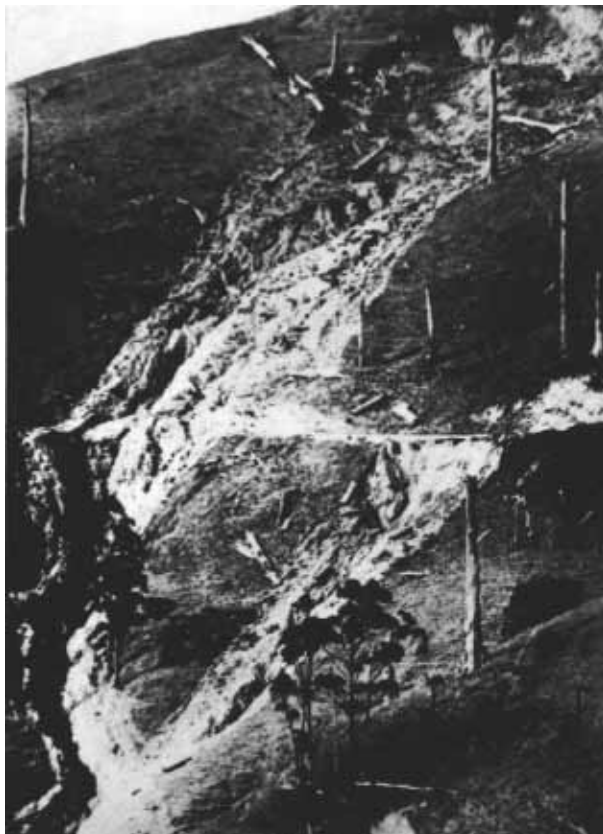
34. Extensive landslides on a deforested slope near Allambee, South Gippsland. The loams overlying Jurassic sedimentaries on steep slopes appear to be particularly susceptible to sliding when deprived of forest cover and the binding of the soil by roots.
