APPENDIX

SOIL EROSION COMMITTEE

February 1938

TYPES OF WATER EROSION

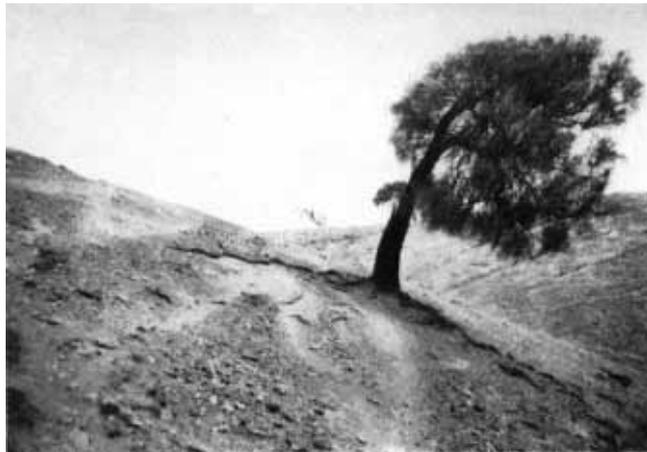
1. Sheet erosion, north-west of Bacchus Marsh. These slopes were one well-forested, but deprived of this protection sheet erosion has removed up to 2 feet of soil and exposed the underlying rocks. Soil wastage has been accelerated by over-grazing and numerous rabbits are taking toll of what little vegetation remains.

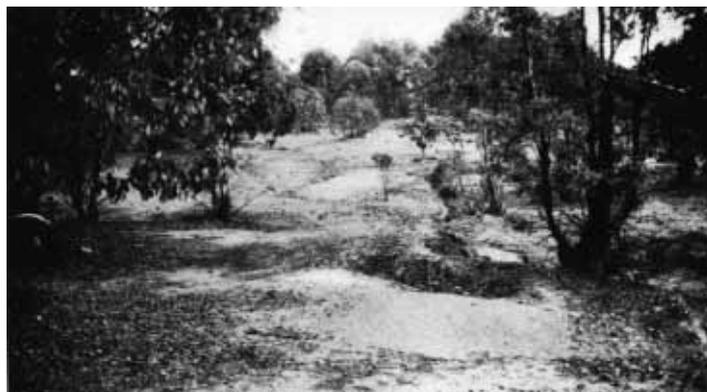
2. South-east of Castlemaine. Originally covered with timber, which was cleared for firewood for the mines. The land is now practically stripped of soil between the stunted saplings.

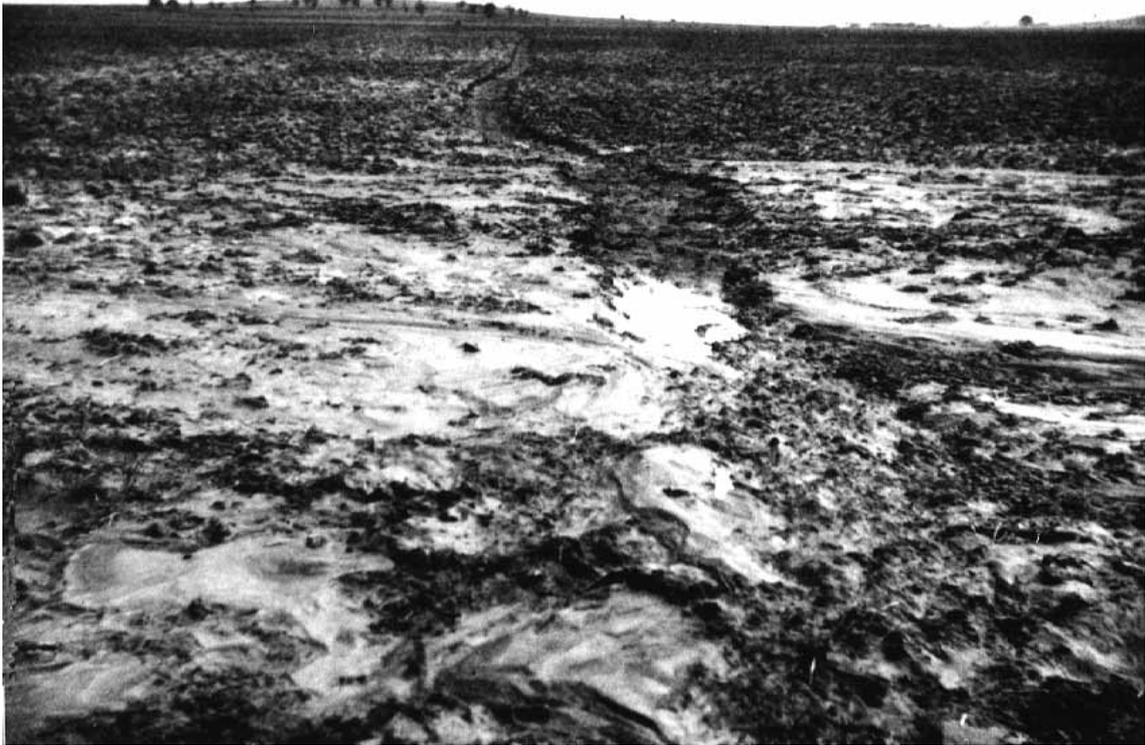
3. Sheet erosion, basalt country at Diggers Rest. Silt in foreground has been washed from cultivated paddock of clay loam.

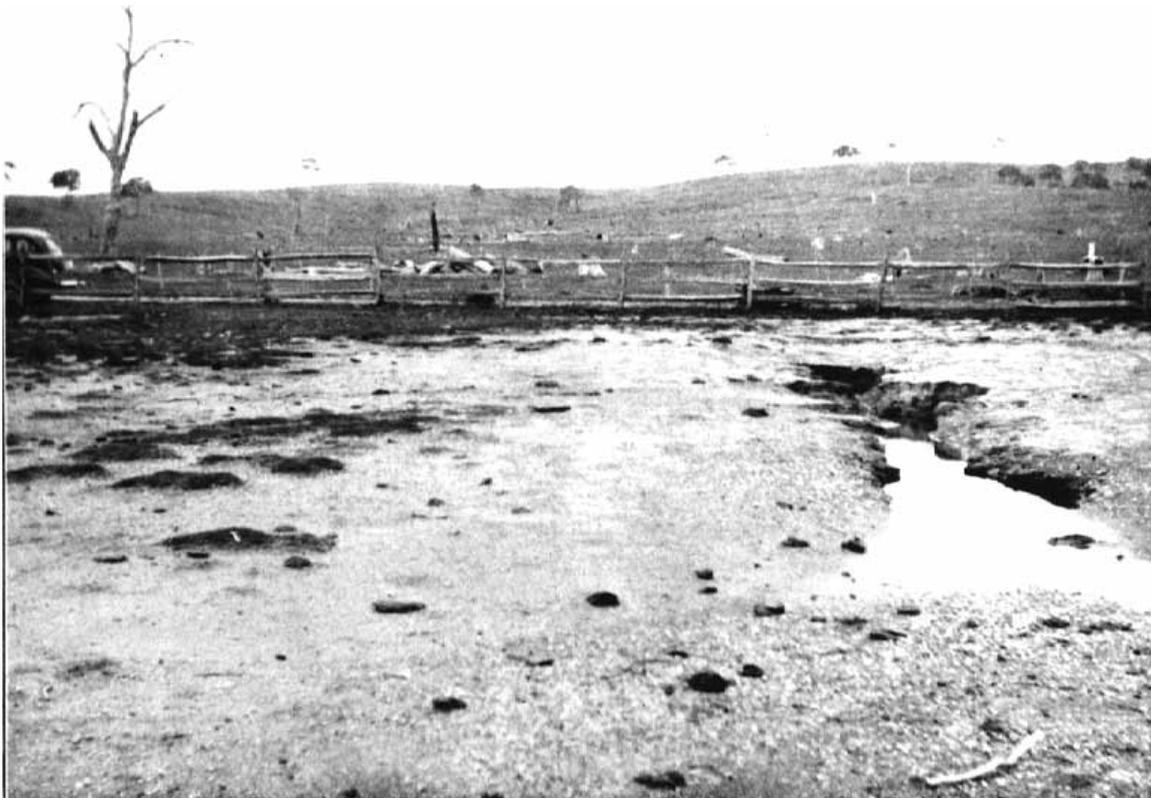
4. Sheet erosion developing into gullying, south of Avoca. Paddock in foreground was apparently cultivated with the slope. Stormwater from the cleared hills beyond has flowed across it, stripping off most of the topsoil. Odd furrows have scoured out, forming the beginnings of gullies, as on the right of the picture.

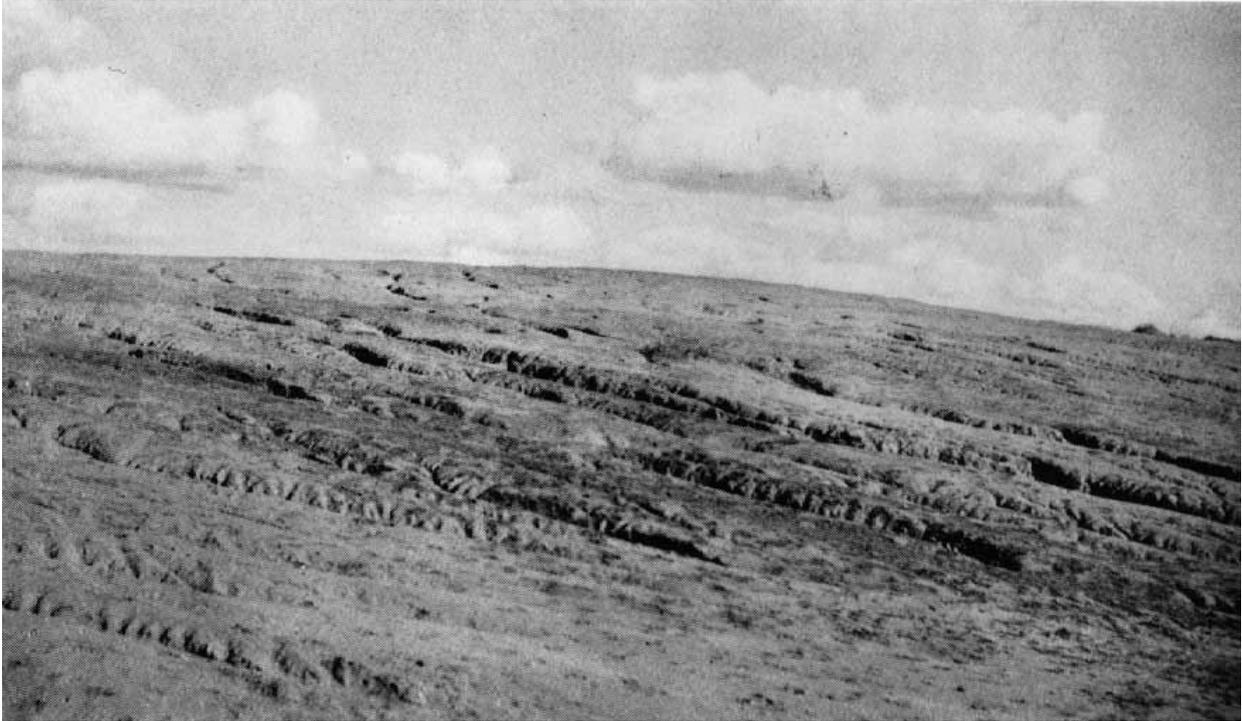
5. Grazing land west of Ouyen. Formation - fine reddish-brown silty loam. Rainfall 10 inches to 15 inches. After the drought of 192 had depleted this area of vegetative cover, heavy rains caused serious sheet erosion. With concentration of the run-off "rill" erosion is developing.

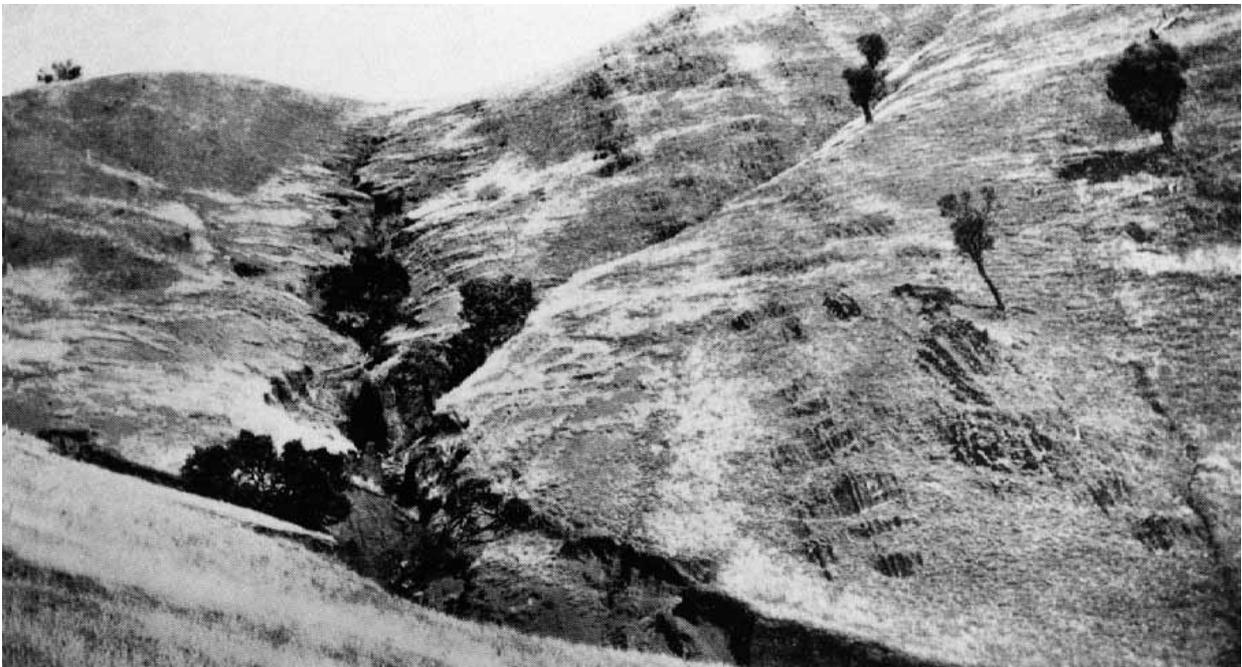
6. Sheet and gully erosion west of Mindample. The surface soil has been washed from the slopes, exposing the underlying Silurian rocks. In the depressions gully erosion is rapidly tearing out the deep loams.

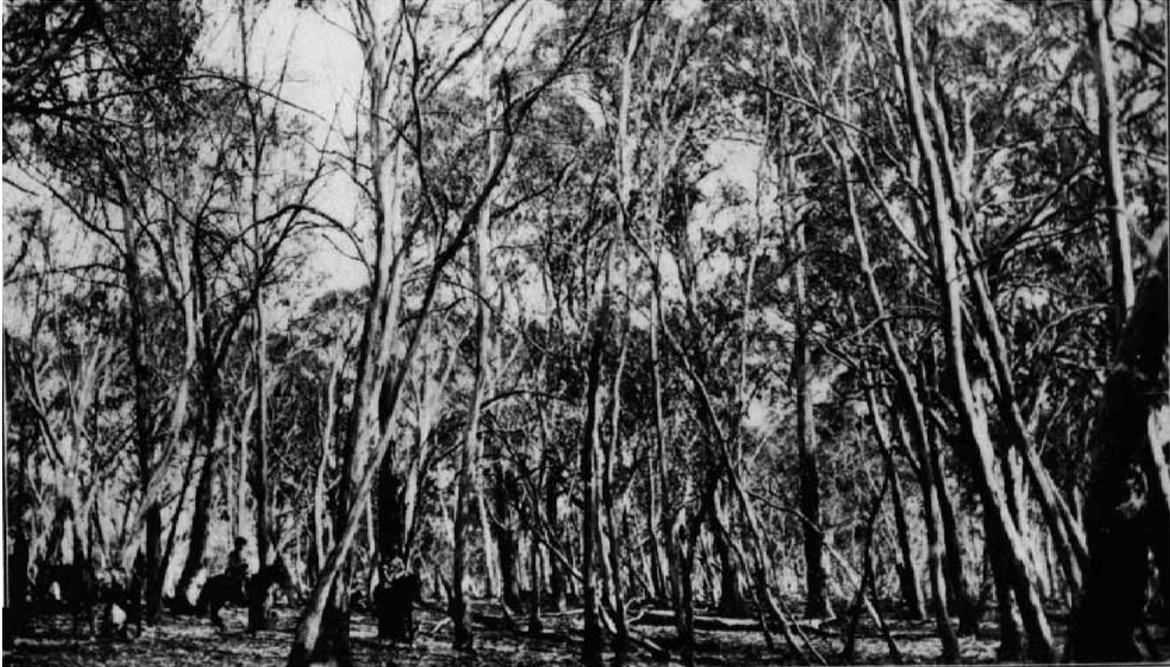
7. Undulatory country on the Limestone Creek (Hume Reservoir Catchment). Constant firing has seriously damaged this stand of *eucalyptus coriacea*. The thin canopy affords little shelter to the bare surface from which litter, grass, and much of the surface soil have disappeared.

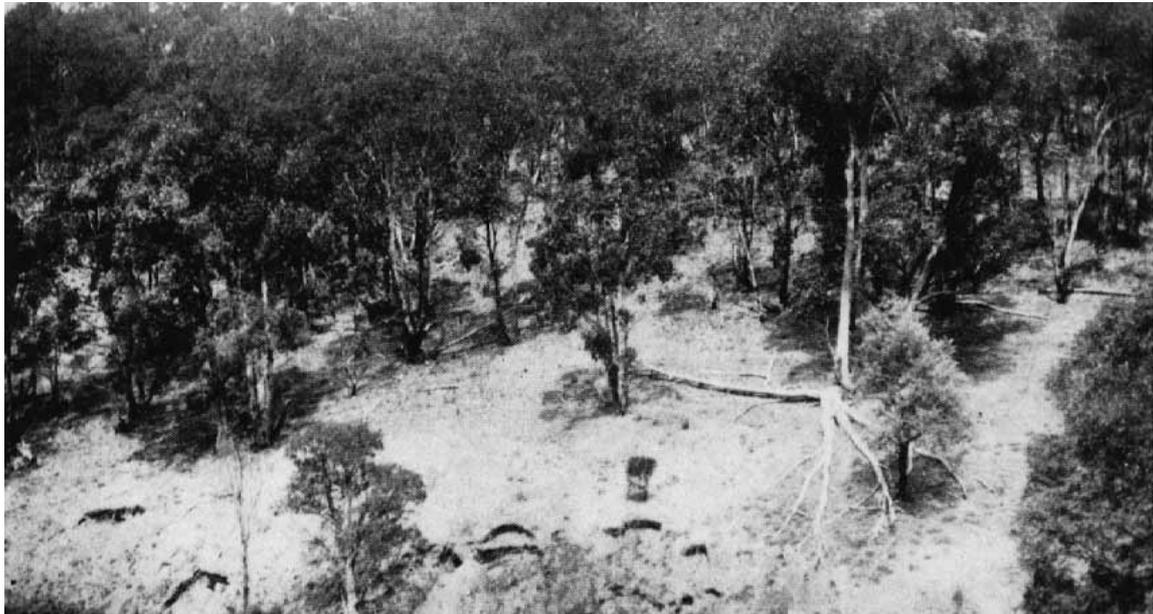
8. The southern slope of Tussocky Creek - a small tributary of Wilson's Creek (Omeo). The poor protection afforded by the open stunted forest is inadequate to prevent the washing away of forest litter and surface soil when such a slope is grazed. The soil is stiff clayey loam overlying ordovician sedimentaries.
