SALINITY CHANGE IN THE WEST WIMMERA

September 2002

AGRICULTURE VICTORIA - BENDIGO
CENTRE FOR LAND PROTECTION RESEARCH

Technical Report No. 92

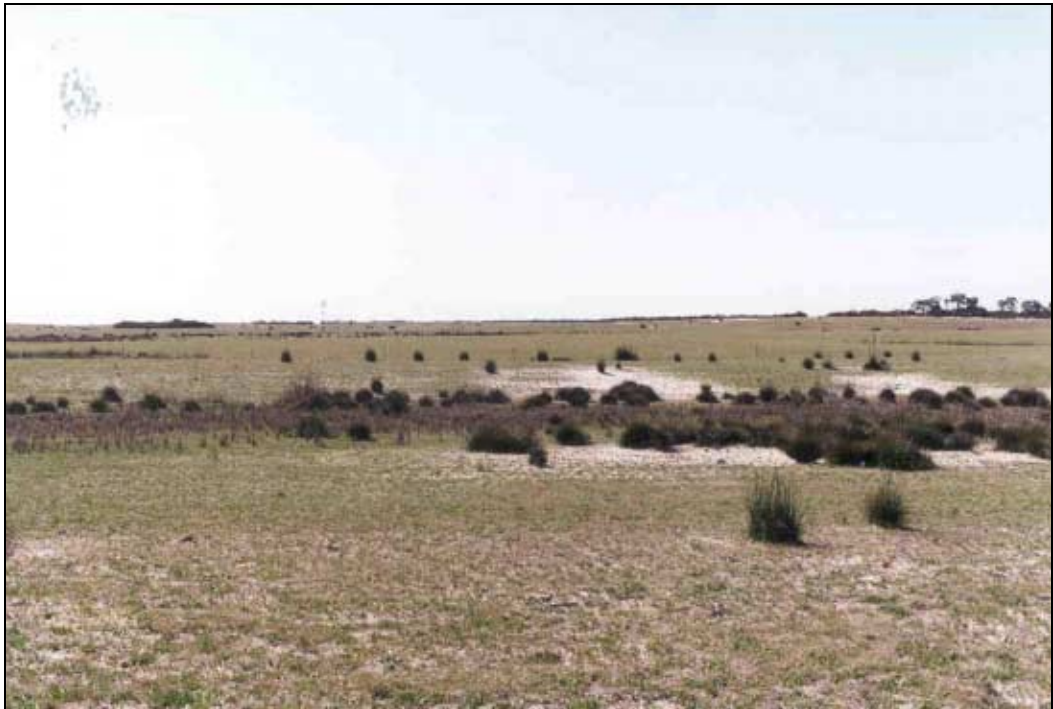
Plate 1 Break-of-slope salinity in the Telopea Downs study area featuring low severity salinity plant indicator species

Salinity in the Telopea Downs area appears to occur due to local groundwater processes (break-of-slope and groundwater perching), and is mostly classed as low severity (Bozon & Matters 1995). Saline sites occur at the break-of-slope and are not very well established (see Plates 1 & 2). Only one site within the Telopea Downs study area is considered to be of moderate severity (see Plate 3)

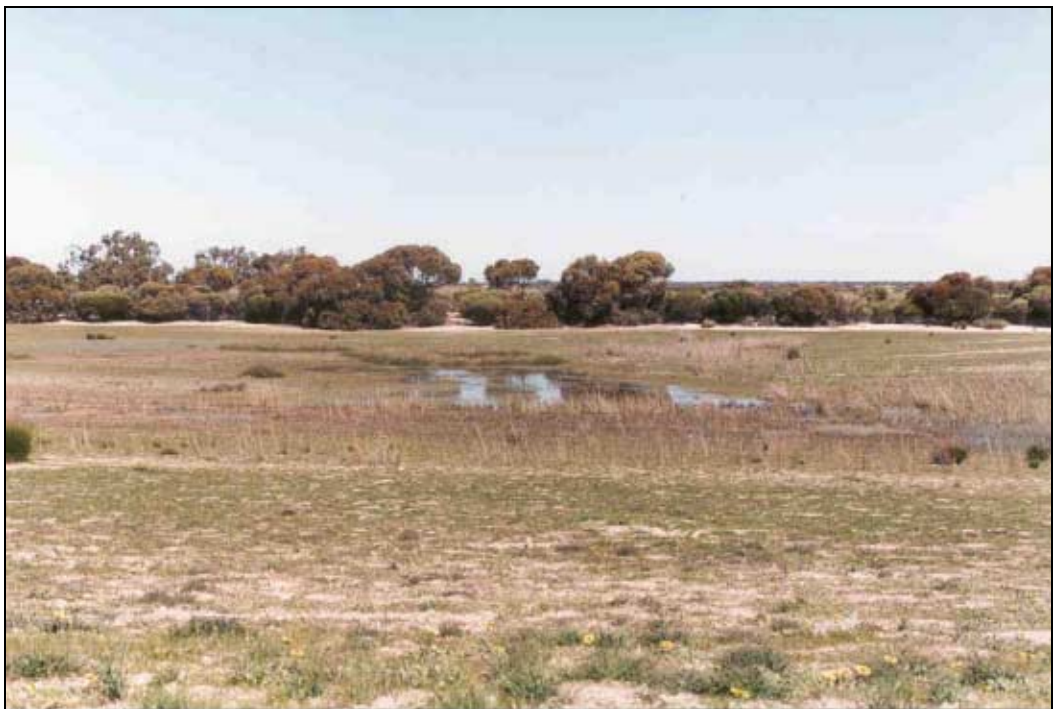
Plate 2 Waterlogging at the break-of-slope within the Telopea Downs study area

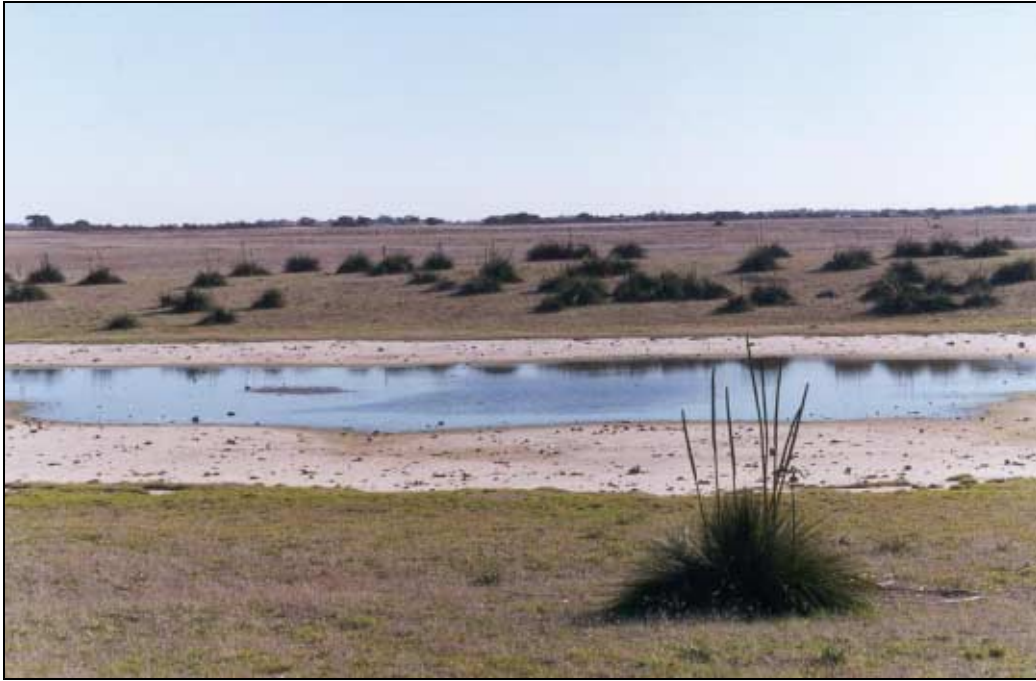
Plate 3 Saline site due north-east of the Teloepa Downs Hall, displaying moderate severity salinity (Class 3)

The site close to the Telopea Downs Hall is the only mapped site that has evidence of moderate salinity. Assuming the occurrence of tree stumps at this site is in situ, tree growth would suggest that this site has not always been saline. It is likely that this site is underlain by an iron hardpan, possibly close to the surface, that is inhibiting deeper drainage. Development of this hardpan layer is likely due to water accumulation in these low-lying areas. This may be of concern for other areas where break-of-slope salinity is occurring, as it could lead to more serious degradation of these sites.

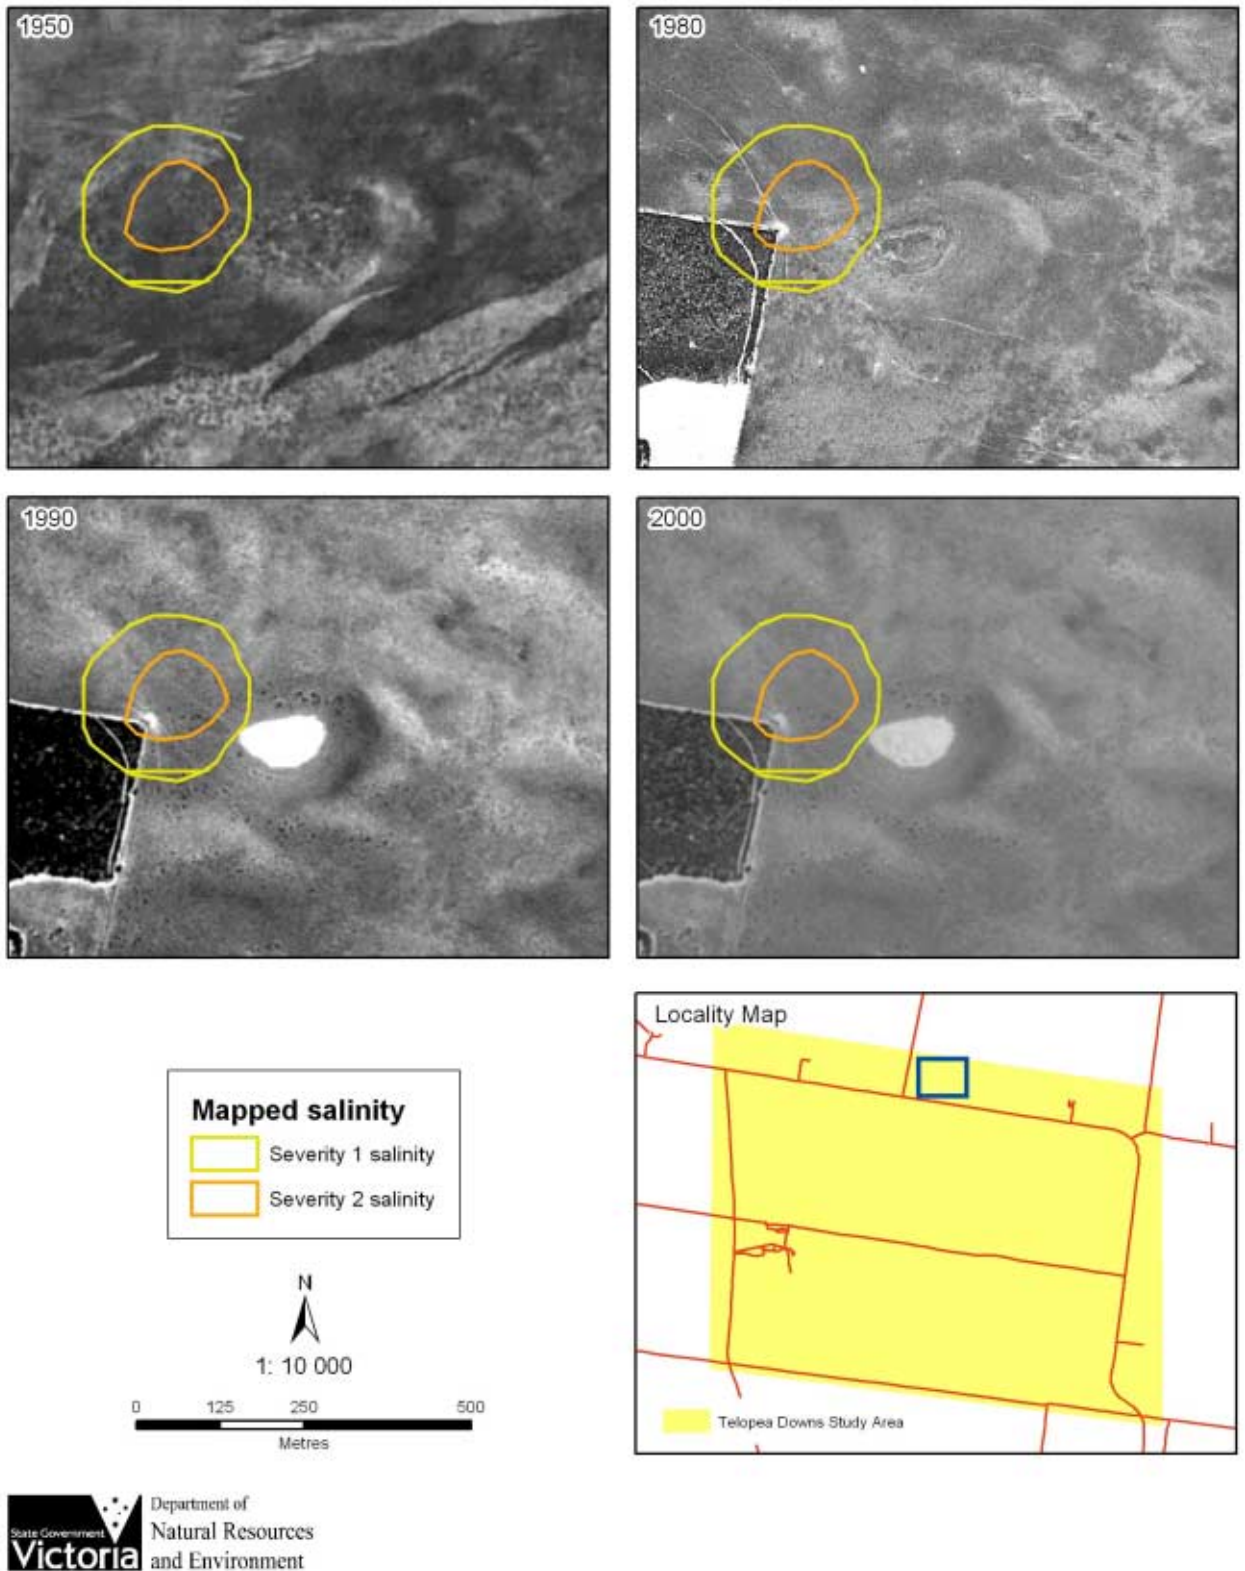
Figure 4 Airphoto series for saline site located north-east of the Telopea Downs Hall (Note: mapped salinity layer is skewed, or offset, to the west of actual salinity site)

The moderate salinity and surrounding halo of low salinity can be clearly defined on all images with the exception of the 1940s airphoto, as the poorer resolution makes the image appear unfocused at this magnification. The extent of the waterlogged halo has appeared to remain constant throughout the 50-year period, although the severity may have increased significantly between 1949 and 1981.

The 1940s airphoto shows evidence of a circular feature most likely representing the present depression. Within this boundary the image appears blotchy which may suggest the presence of tree/vegetation cover. It is inferred that tree cover also exists around this depression, except where the photo appears very pale which is more likely to represent unvegetated sand dunes.

The 1980s photo depicts the cleared form of the study area, however, evidence of salinity is unclear. The 1990 and 2000 airphotos suggest the depression is inundated. The existing moderate and low severity salinity is likely to be also reflected in the 1990-2000 aerial photographs.

Site investigations (during mid to late 2001) revealed that the depression holds water and is surrounded by a perimeter of bare land. Within the depression there is a large number of tree stumps (refer to Plate 4). They appear in situ which complements the evidence in the 1940s airphoto that trees were present within the depression, suggesting the site has not always been saline.

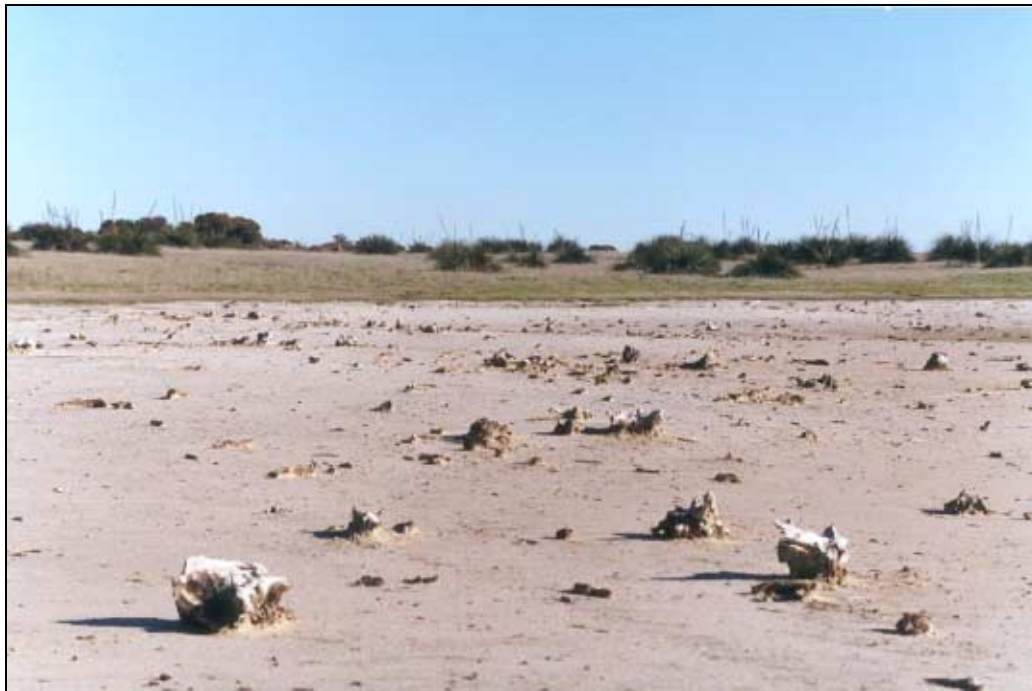
Plate 4 Numerous tree stumps are scattered within the boundary of the current salinity (at the study site north-east of the Telopea Downs Hall), which may suggest that salinity has not always been present

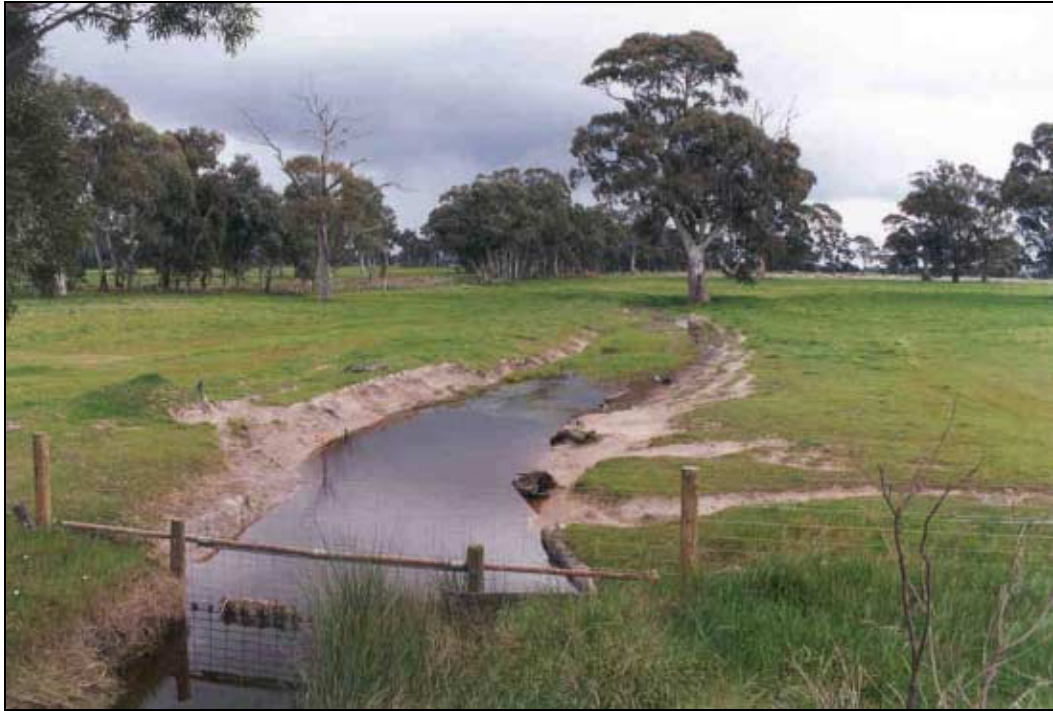
Plate 5 Saline site along the Mosquito Creek drainage line, Powers Creek Road

The salinity observed at Finches Road (see Plate 5) is apparent in the 1970s photographs, and occurs as white strips of bare land adjacent to the northern branch of the Mosquito Creek drainage line. It can be clearly defined and is interpreted to be of moderate – high severity (Class 2-3). During the 1980s, airphoto interpretation suggests the spread of salinity to be minor but with a marked change in the severity. During the early 1980s a revegetation program was implemented to combat the salinity at this site. By the 1990s there was a marked increase in tree/scrub cover surrounding the drainage line. The evidence of salinity appears to have reduced significantly, its extent rarely deviating from the creek. It is evident that the revegetation scheme has been more successful outside the perimeter of defined salinity of previous decades, with growth occurring within this boundary being patchy and stunted (i.e. salt-affected). Similar responses are evident in the most recent airphoto (2000) where vegetation growth is more prominent further away from the creek and the occurrence of salting also appears to have reduced.

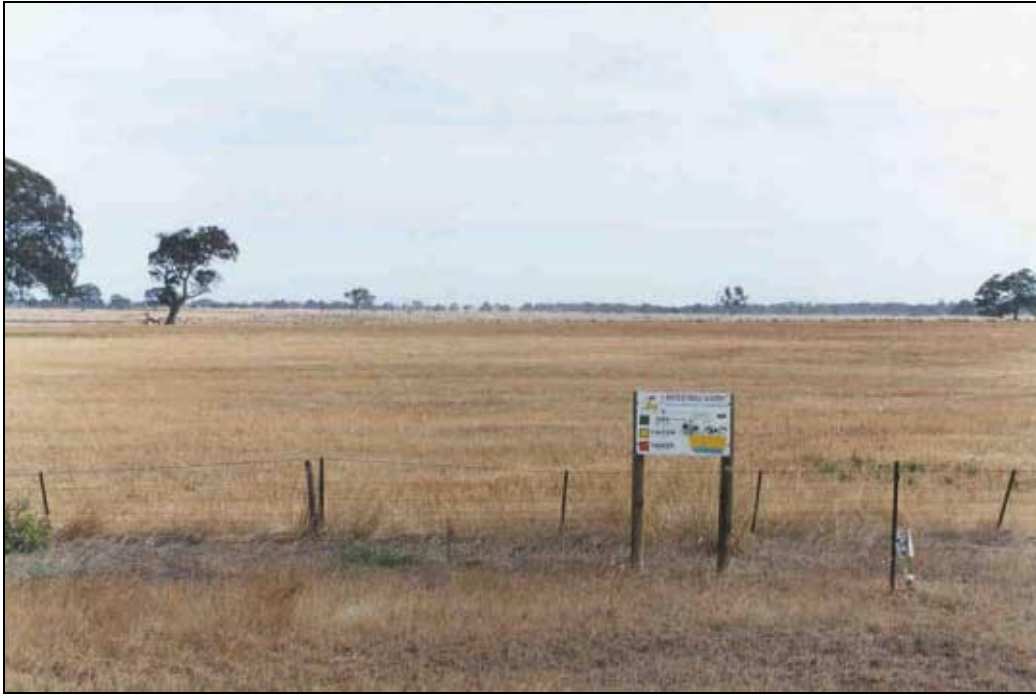
Plate 6 Location of the Wimmera Highway saline site

The photo of the site (see Plate 6) was taken during late summer (February 2002) and does not show any significant visible indicators of salinity. Closer inspection did show that sea barley grass (a low severity salinity indicator species) is quite prolific throughout this area of the crop (see Plate 7). In 1996 a 'Watertable Watch' bore was constructed when large areas of bare land were evident throughout the crop (see Plate 8). Field site investigations throughout mid – late 2001 revealed that the impact of salinity is not as severe as it has been in the past.

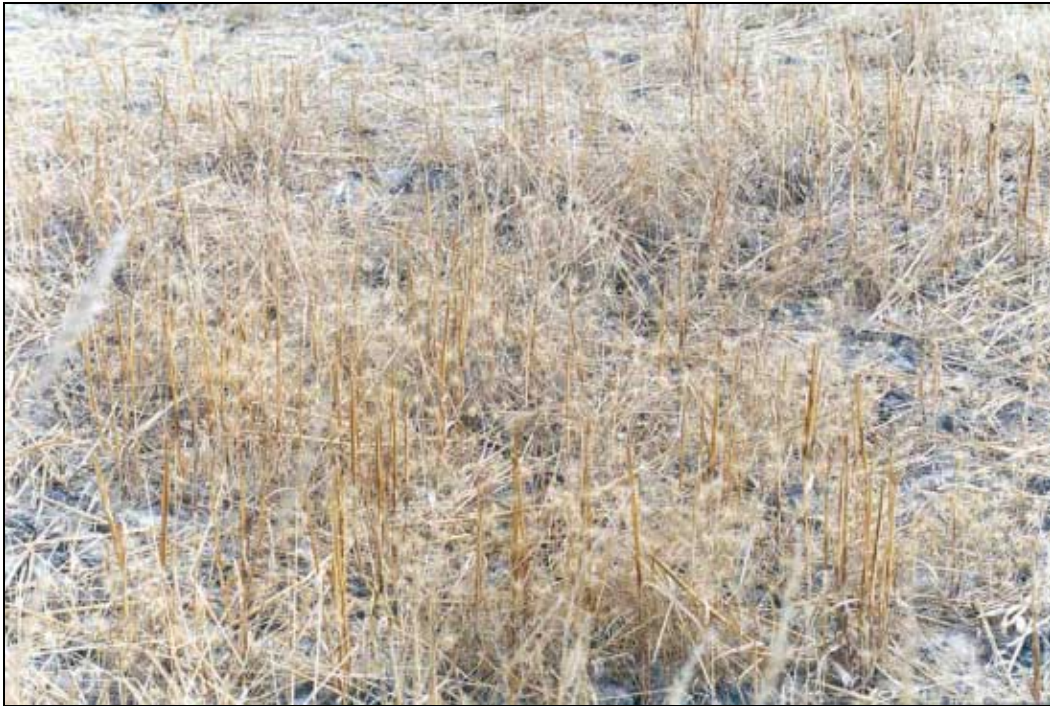
Plate 7 Sea barley grass is significant within the crop at the Wimmera Highway site

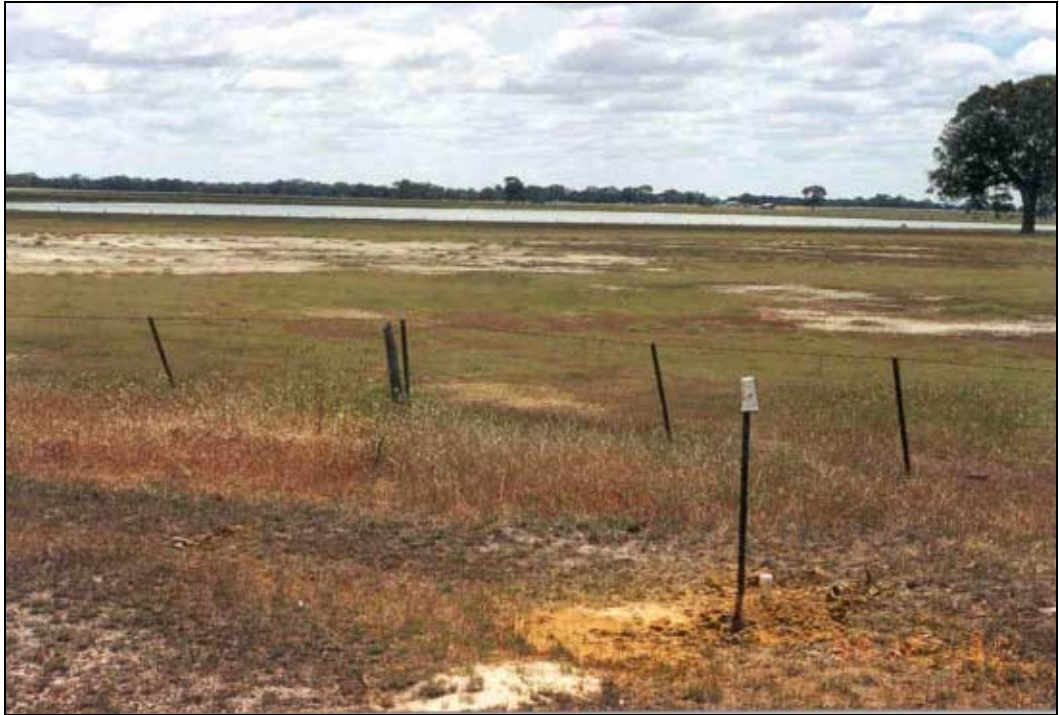
Plate 8 The Wimmera Highway site in 1996 when a 'Watertable Watch' bore was installed; note bare patches and occurrence of higher severity salt indicator species (dark patches)

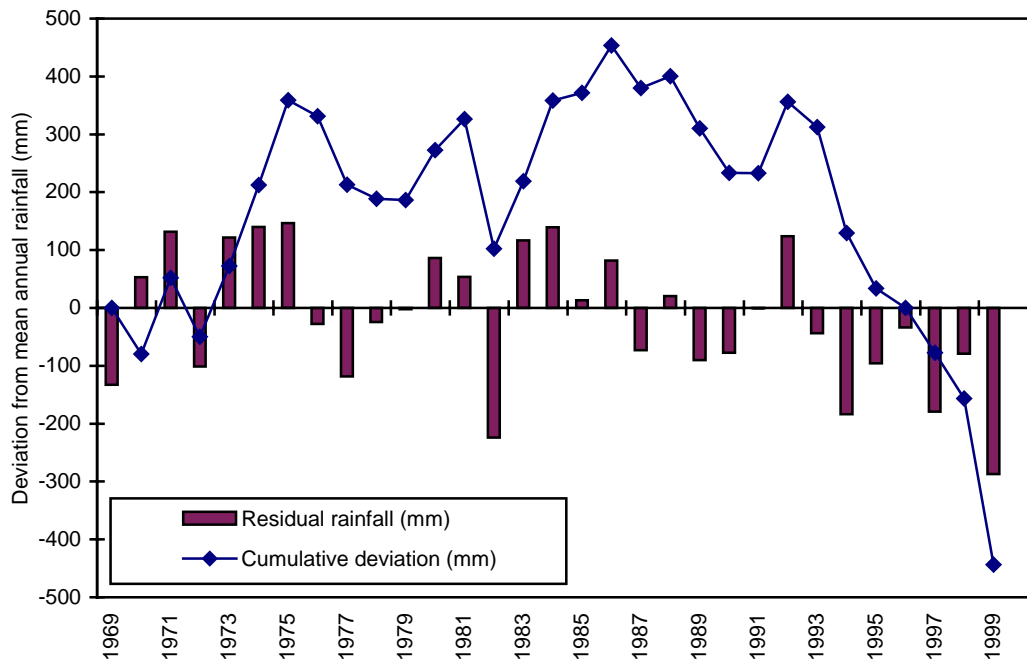
Rainfall at Edenhope has been monitored since 1969 (see Figure 7). The bar graph represents the deviation of rainfall (residual rainfall) from the long-term average rainfall (approximately 610 mm/yr) recorded at the monitoring station (no. 079011). The line graph shows the cumulative additions of deviations from the average rainfall, allowing a greater insight into the trends occurring due to these climatic variations.

Between 1969 and 1975 an increasing trend of annual rainfall occurred, with the majority of years having above average rainfall. Following this wetter period, rainfall trends reduced until 1982 (which received 390 mm of rainfall) causing a significant drop in the cumulative graph. Above average rainfall prevailed again until 1986, followed by mainly below average rainfall preceding an above average rainfall year in 1992. From 1993 to 2000, all annual rainfall recorded for the Edenhope area has fallen below the average for the monitoring station, resulting in a sharp decline in the cumulative rainfall to -440 mm.

Figure 7 Yearly residual and cumulative rainfall at Edenhope (rainfall station no. 079011), source: Bureau of Meteorology and MetAccess 1998)

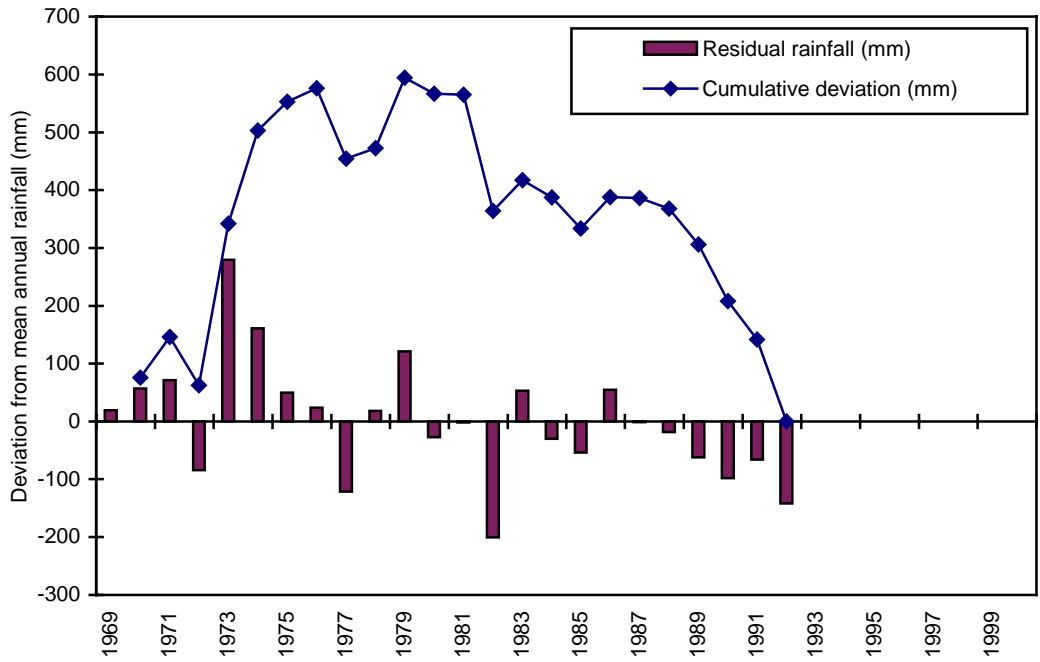
Rainfall monitoring at Teloepa Downs (station no. 077093) (Figure 8) began in 1969, but lapsed in 1992 and has not been monitored since. In order to assess more recent trends, rainfall data from the Kaniva monitoring station (no. 078078) was also analysed.

Rainfall trends recorded in the Teloepa Downs region began with an increasing cumulative deviation from 1969-76 followed by more stable conditions. 1982 received lower than average rainfall. Between 1983 and 1987, a period of stable climate existed, after which cumulative rainfall fell due to subsequent years of below average rainfall. Kaniva rainfall trends (see Figure 9) show a falling trend has been sustained.

Figure 8 Yearly residual and cumulative rainfall for the Telopea Downs rainfall station (no. 077093), source: MetAccess 1998)
