7.43 *Yeodene Land System*

8. SOIL CONSERVATION

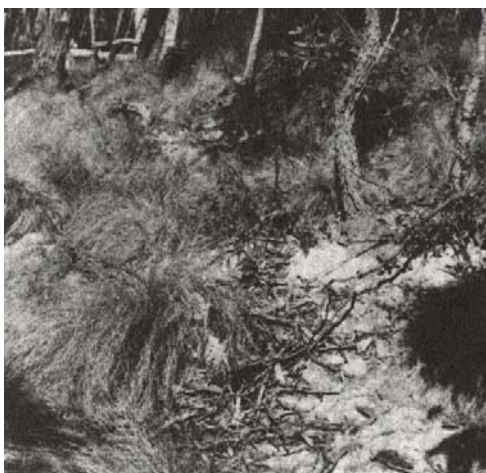
Exposure of tree roots and elevation of grass tussocks on small pedestals indicates that sheet erosion losses have been quite extensive on these steep northerly facing slopes abutting Moggs Creek.

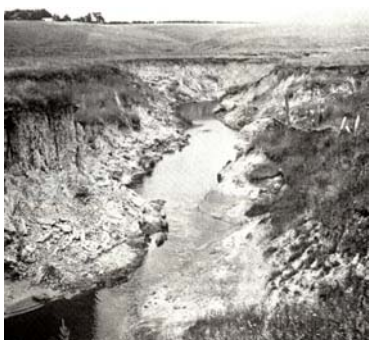
Wormbete Creek, a tributary of the Barwon River, causes particular problems through actively eroding gullies. Headward extension of this gully has caused loss of productive land, damaged fences, decreased trafficability and access and reduced aesthetic appeal.

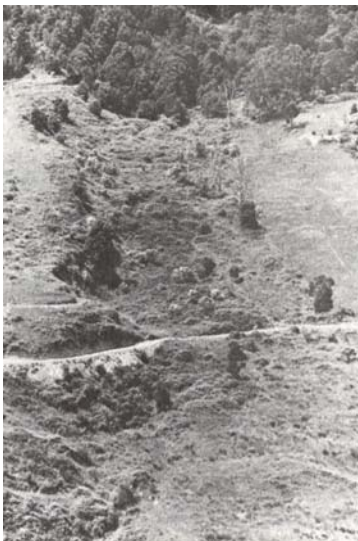
Earth flows are a common feature of the steep hills: This one near Upper Gellibrand threatens the road that crosses it.

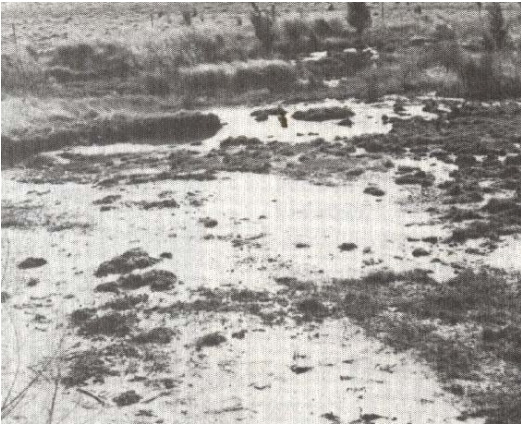
Rising salt concentrations in the topsoil both stunt and kills the pasture in lower parts of the landscape. Stock often camp on these areas, trampling the vegetation, and this may lead to sheet and gully erosion.

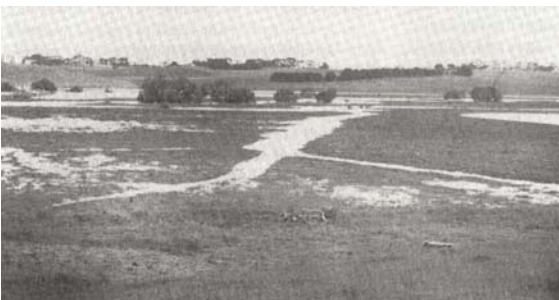
Land use in the upper parts of the Barwon River catchment effects land downstream. Unwise use can result in increased flooding, sedimentation and prolonged waterlogging.

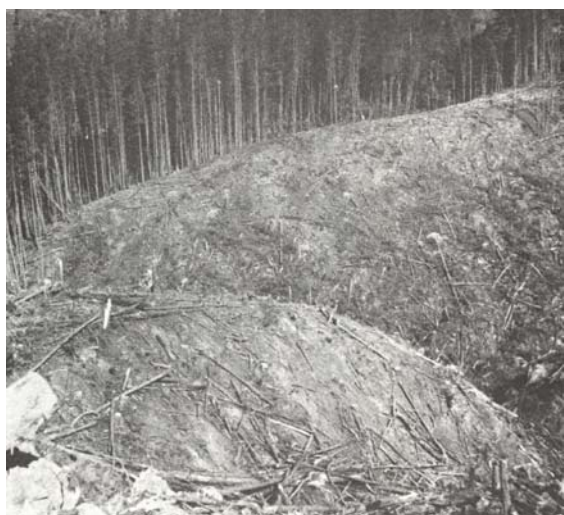
Steep slopes in and around drainage lines are more stable under hardwood than softwood forestry, because of longer growth period and more selective logging practices.

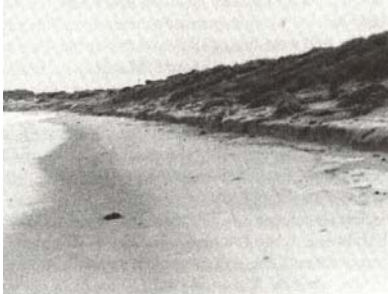
Coastal dunes are in a constant state of seasonal flux. This photo was taken in early spring, after heavy winter seas had removed much of the sand from the beach and formed a small cliff.

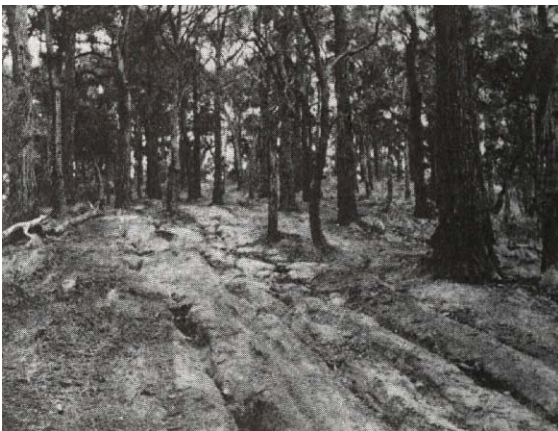
Trail bikes can cause major problems in sensitive areas. Here, vegetation has been destroyed and rapid surface run-off has removed topsoil and cut rills into the subsoil.

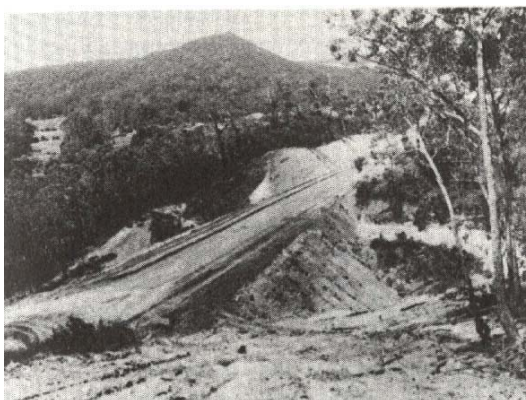
Large road batters and other bare surfaces can deteriorate rapidly. This road re-alignment near Mount Mackenzie is a source of copious sediment in the Gellibrand water supply catchment.

Rilling and slumping are problems on the over-steep slopes of road batters. Some of the larger road batters in the Mount Mackenzie land system are particularly susceptible to rilling. Rockslides and slumps along the Great Ocean Road are a hazard to motorists, and expensive clean-up operations are undertaken each wet period. Many of the road batters in the Heytesbury settlement area exhibit severe slumping.

Correct design of road batters minimizes these problems. In exposed rock or other compacted material, near-vertical-cut batters can be successfully made, but generally a slope of 200% is recommended for stable soils while some soils will still be a source of sediment at slopes less than 50%. A catch drain constructed near the top of the batter will divert water. In large batters, further catch drains should be installed at intervals down the slope. Subsoil drainage may need to be provided
