7.6 Buckrabanyule land system

BUCKRABANYULE LAND SYSTEM Area 113 sq. km

Land deterioration hazards - Buckrabanyule land system

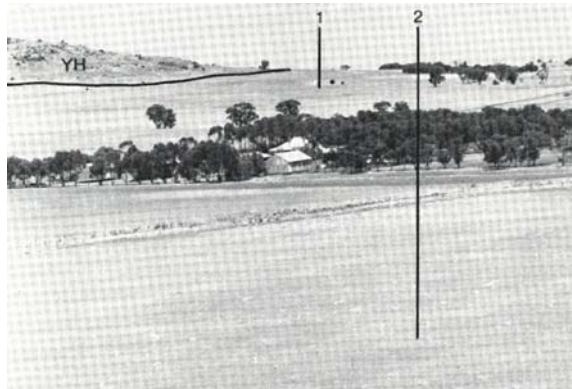
This area, used predominantly for cropping, slopes gently away from steep granitic hills. Gully erosion (right) is common on the upper slopes.

This area, used predominantly for cropping, slopes gently away from steep granitic hills.

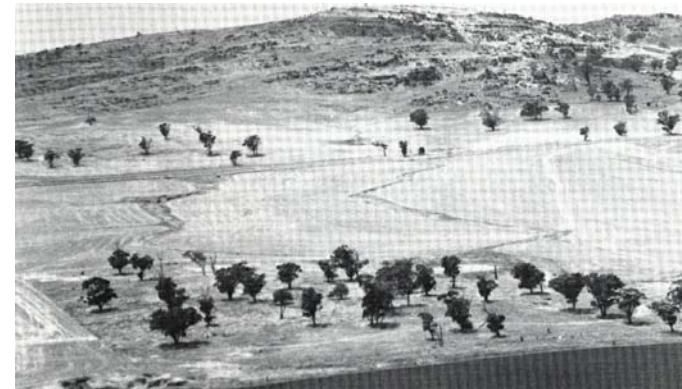
Gully erosion (right) is common on the upper slopes.

The upper slopes are particularly prone to gully and sheet erosion. Gullies are prominent in the drainage lines, aggravated by run-off from the adjacent rocky hills, which have been excessively cleared and grazed. Gully dimensions are increasing steadily, promoted by the high slaking tendency of the soils.

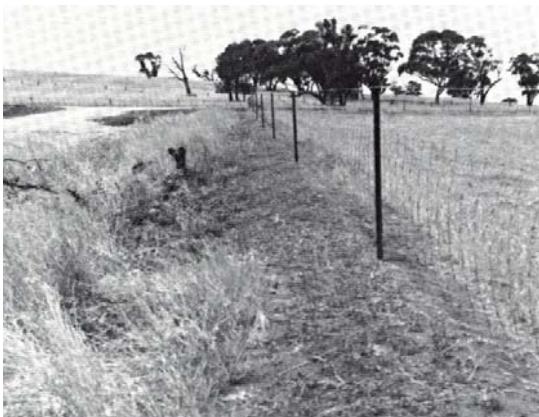
Increased run-off from adjacent hills does cause severe gully erosion on the upper slopes in soils that have a high slaking tendency.
