7.27 Yeungroon land system

YEUNGROON LAND SYSTEM Area 173 sq. km

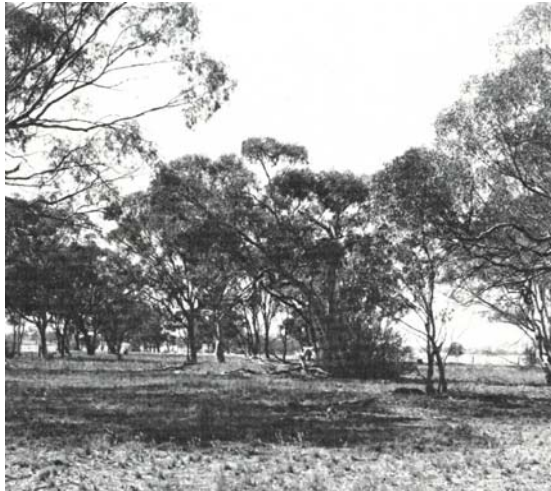
*A small reserve of grey box (*Eucalyptus microcarpa*) and yellow gum (*E. leucoxyton*) represents the original vegetation on this gently sloping alluvial apron.*

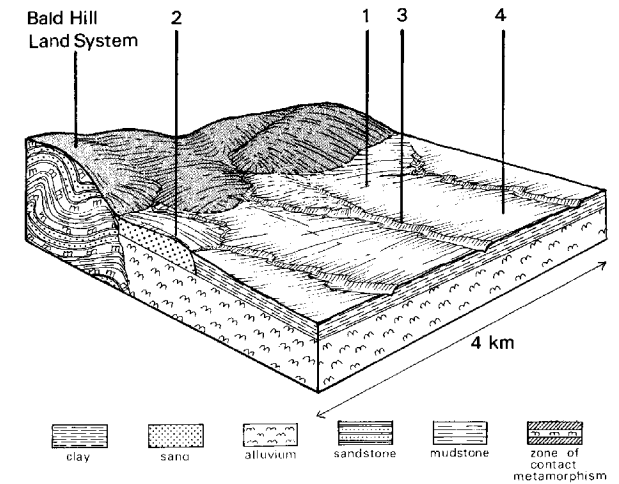
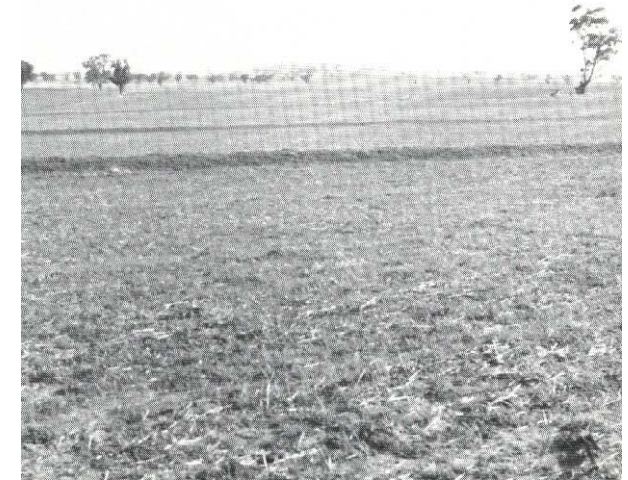
Contour banks prevent the build-up of overland water flow down the gentle slopes, thereby reducing sheet erosion.

Gullies have developed in most of the drainage lines, where the soils are particularly dispersible and prone to slaking. Sheet erosion is also widespread. Small areas of soil salting at lower sites indicate that the accession of waters and salts to groundwaters and the leaching of nutrients have increased. Salting and nutrient decline are subtle forms of deterioration, but they emphasise the need for careful management of a sensitive, relatively productive area.

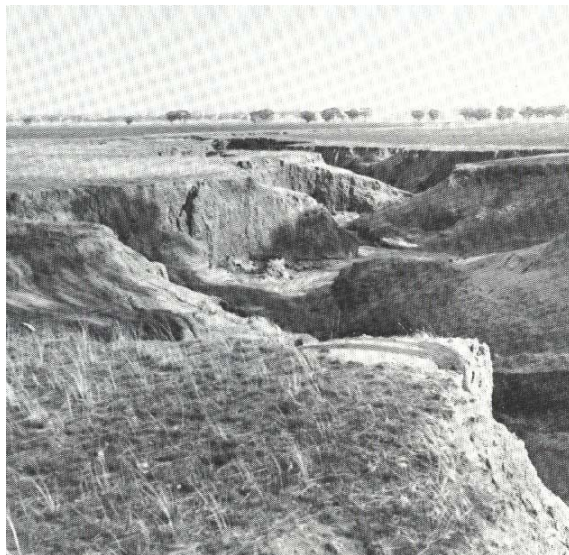
Deep gullies are the result of increased run-off from adjacent cleared hills.

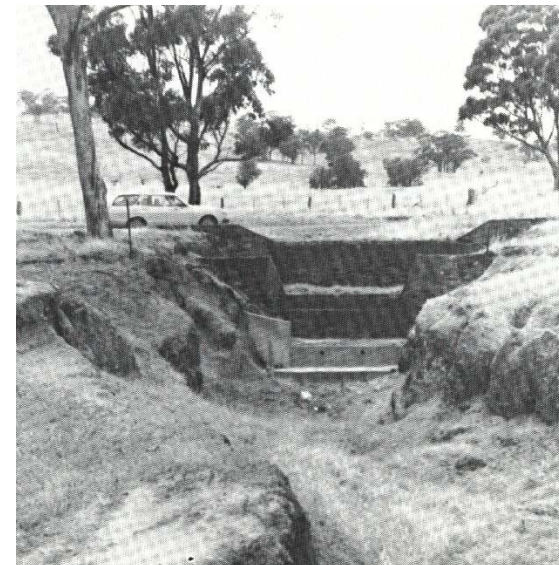
Gully-head structures are necessary - to protect roads and other services.
