Methods of Control

A few typical examples of methods of erosion control already adopted in Victoria are shown hereunder and in the following pages.

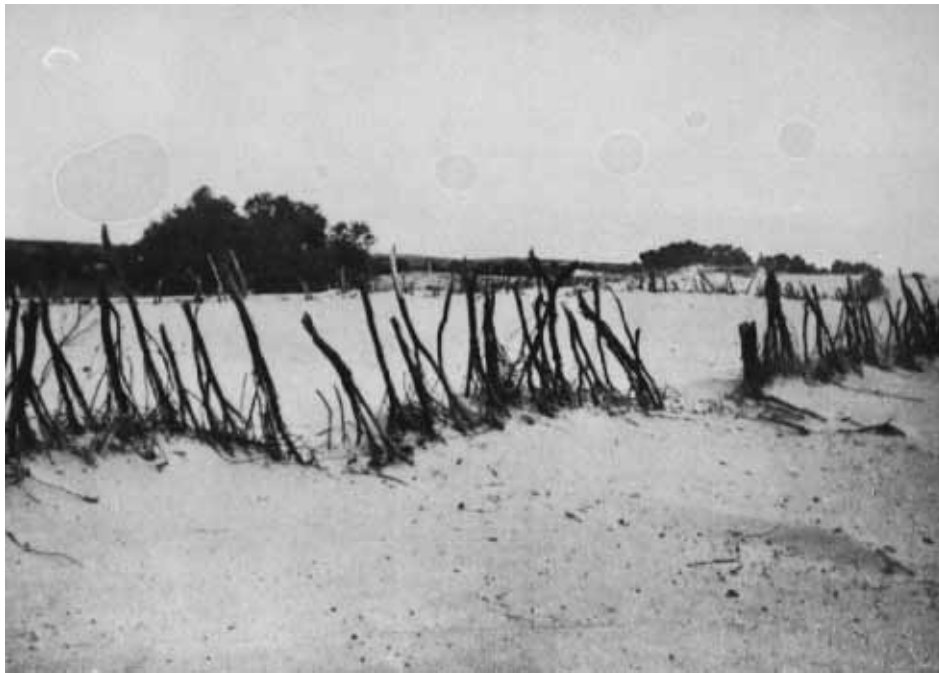
61. North of Hopetoun. Brush fence to check sand drift which was blocking channel.

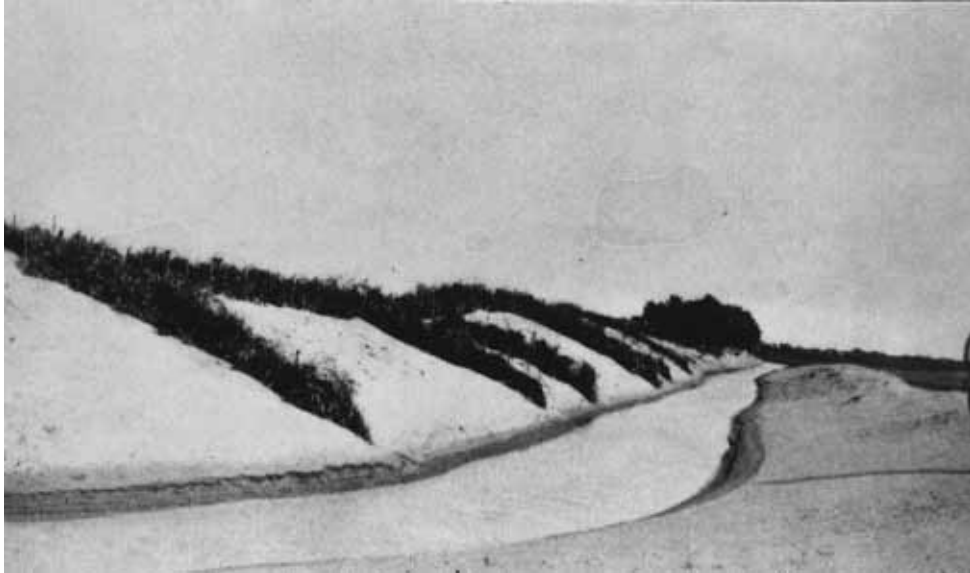
62. Brush wind check at side of channel. Block 28, Mittyack

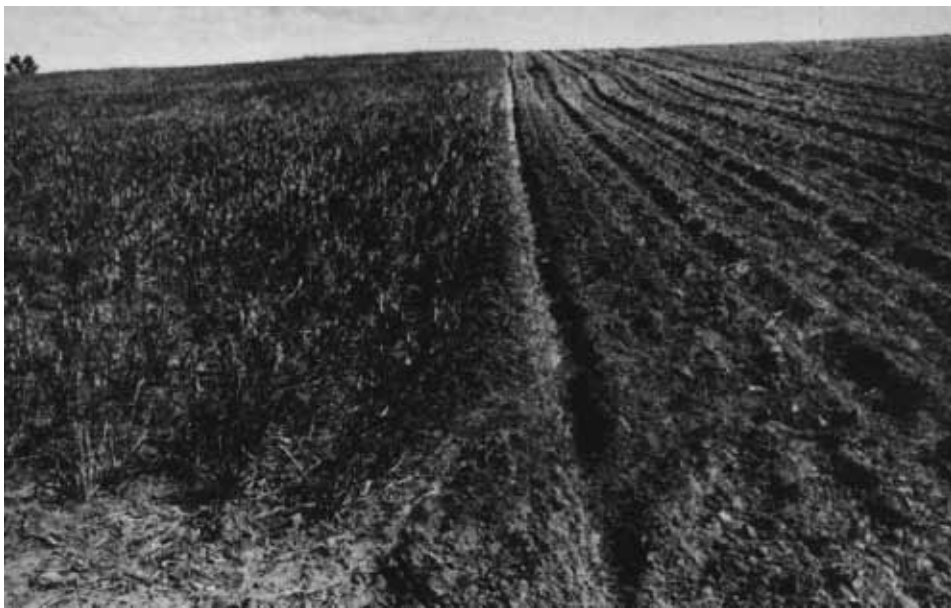
63. Mallee Research Station, Walpeup. Part of drift control equipments - on left - oats acting as cover crop - to be grazed. On right - furrowed fallow.

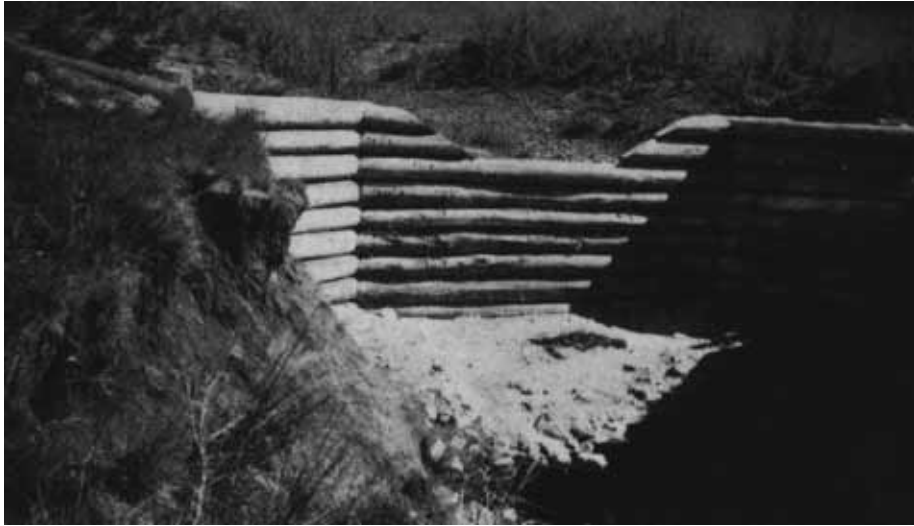
64. Log dam across scour near Bindi Station. This is now filled to the top

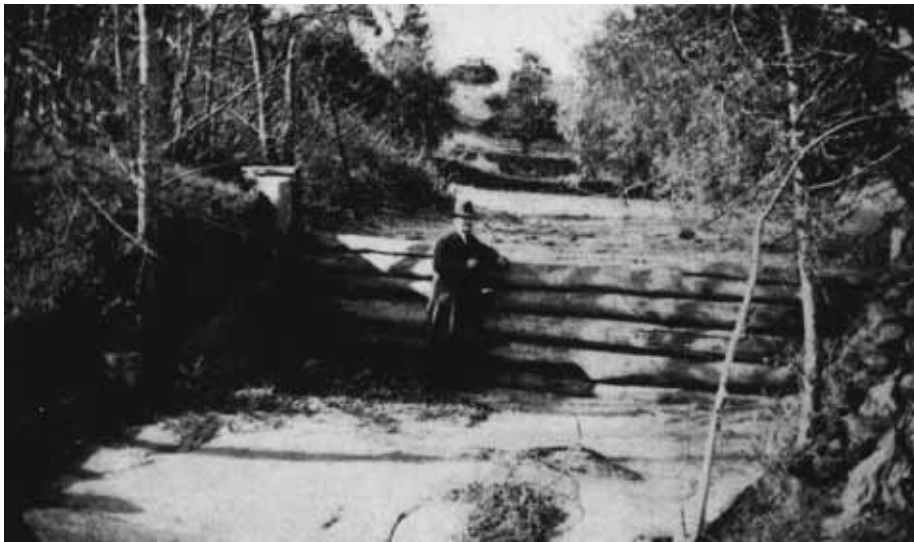
65. Check dam to stop scour alongside Gisborne road, Bacchus Marsh Shire

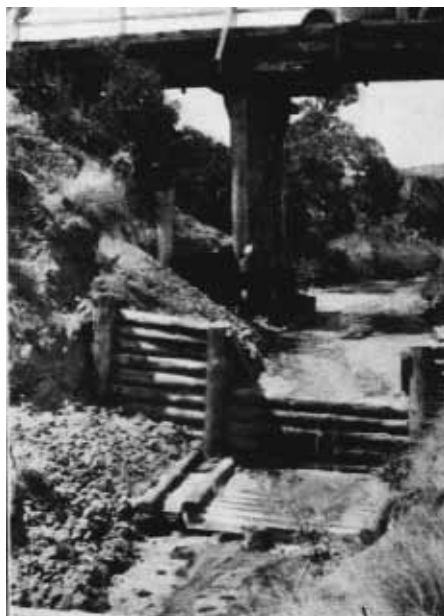
66. Small log dam constructed by Omeo Shire to protect road bridge over scouring gully.

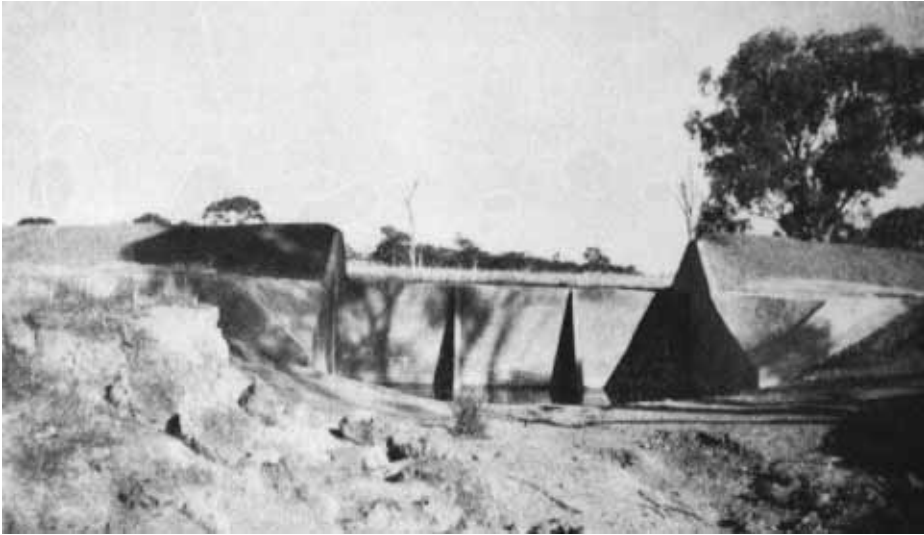
67. Concrete drop on the Sheep Pen Creek, at Caniambo. This is to check the extension of a branching scour, by concentrating all flow at a protected drop.

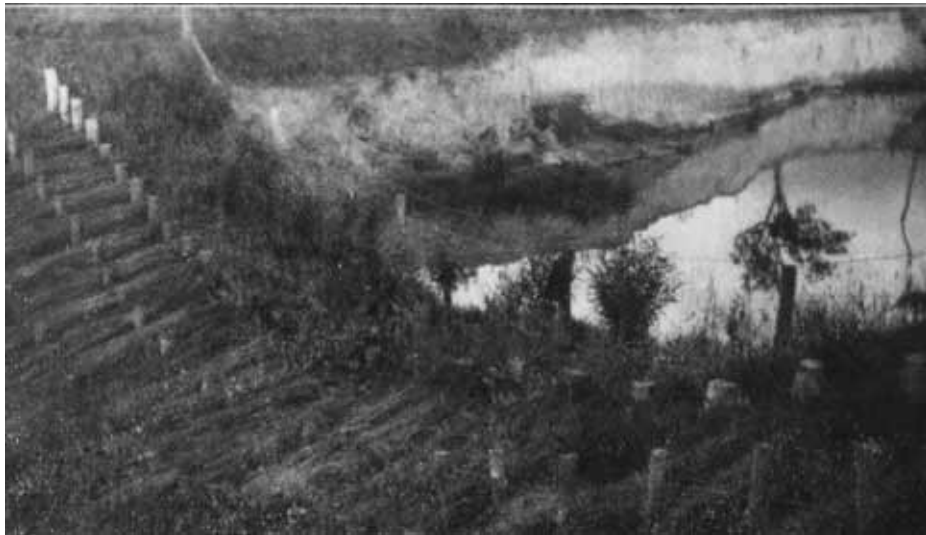
68. Brush dam to catch silt derived from eroding banks, Skull Creek, near Bairnsdale.

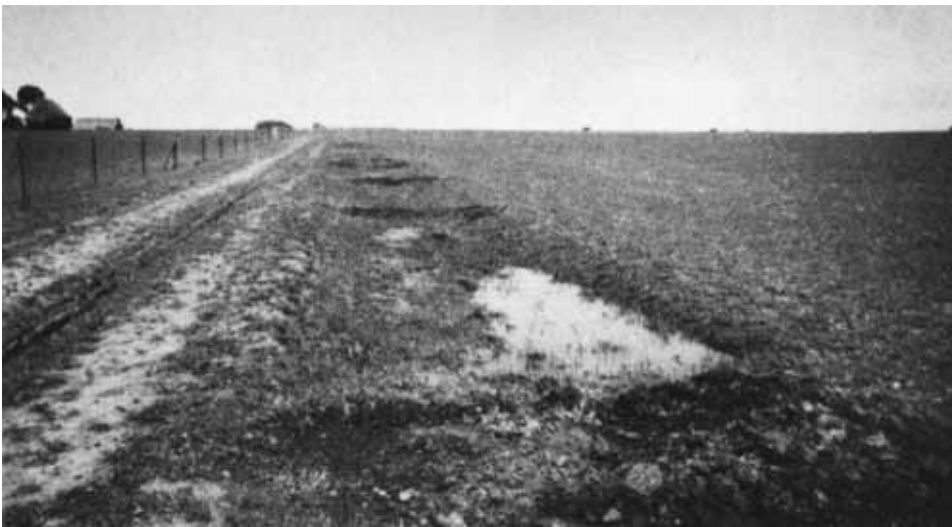
69. Small check dams of grass and manure constructed by land holder to check scour alongside road formation.

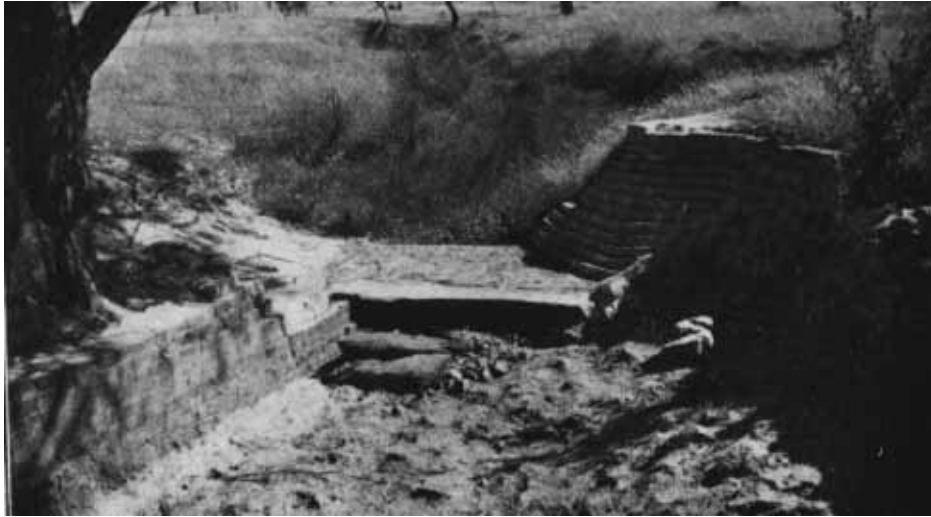
70. Near Benalla. Brick and concrete drop constructed by land holder in scouring gully. This has been effective in preventing extension of scour.

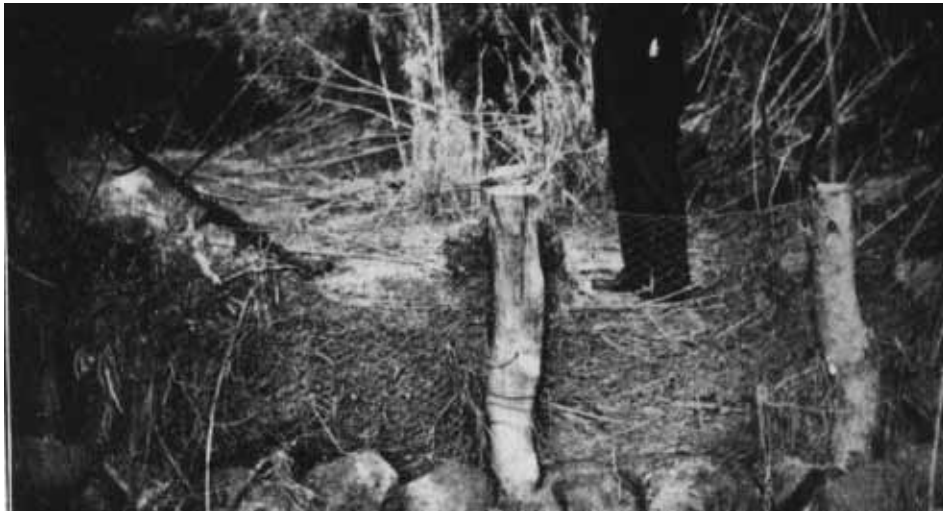
71. Showing how even ordinary wire netting will catch silt. Note how leaves, &c., have lodges against the netting, forming a silt trap.

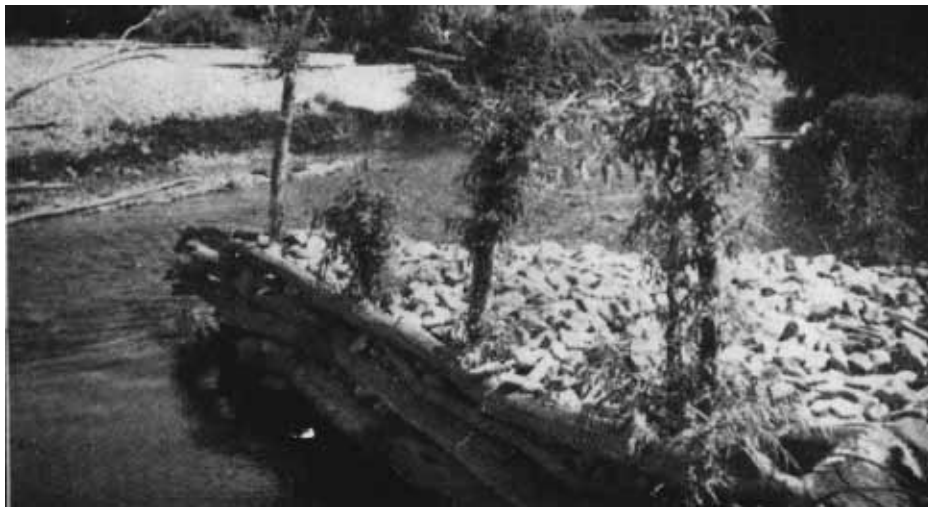
72. Up stream view of groyne installed by land holders on the Upper Tambo River.

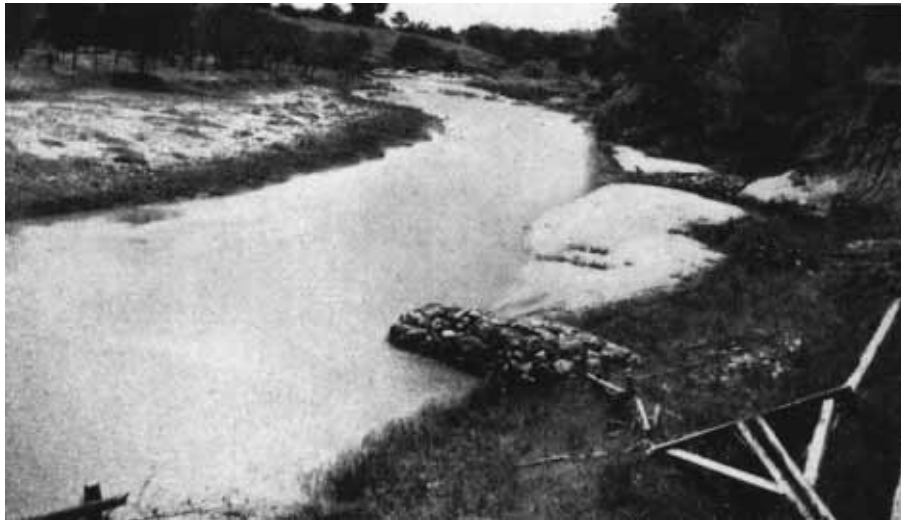
73. Small stone-wire mesh groynes in Yackandandah Creek to protect eroding bank. Note sand already deposited in twelve months.

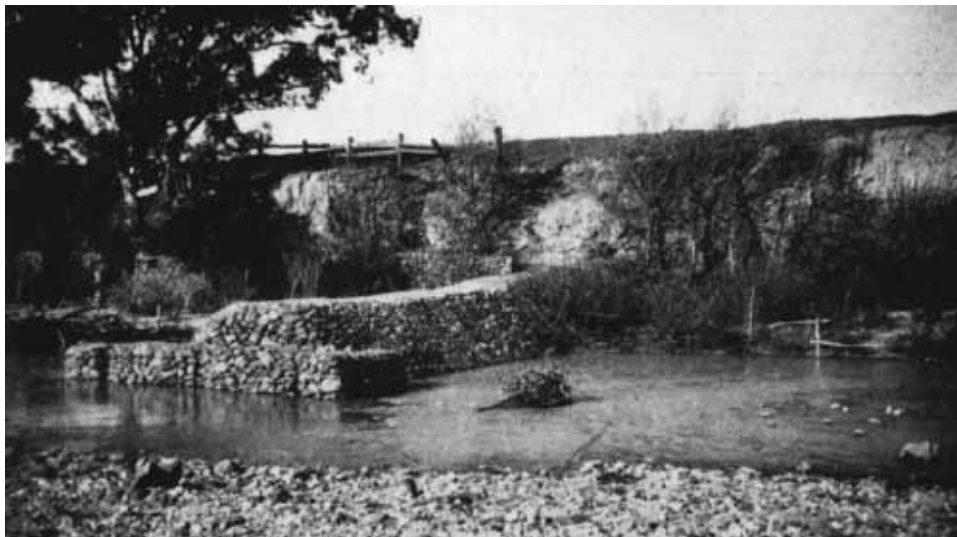
74. Lerderberg River, Bacchus Marsh. Protection of eroding bank. Shingle and wire type groyne, showing siltation to original end of groyne in two years, and recent extension. Note willow stakes in silt bench.

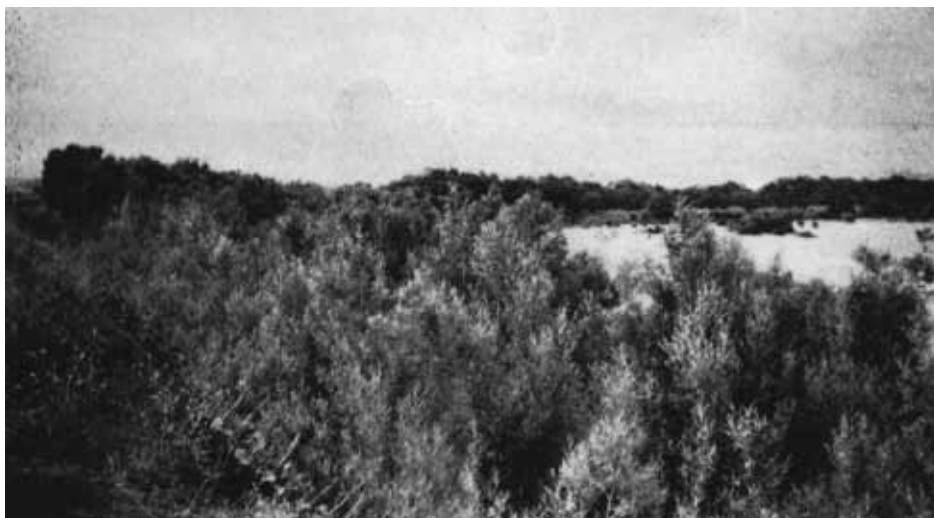
75. Willows about eight years old growing thickly on cribwork and sloped banks, Avon River, Boisdale. Shingle banks in river bed at back.
