Siltation and secondary effects of erosion

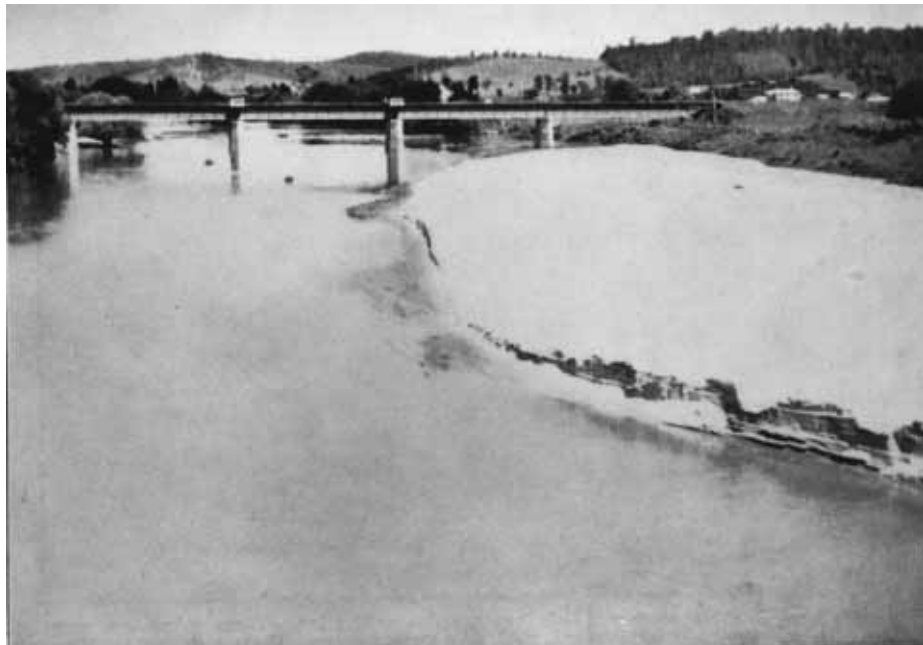
43. Siltation. Huge deposits in Tambo River, at Bruthen. A low level bridge has been completely covered over by this silt which is scoured from the hillsides by sheet erosion, gullies, &c., further up the stream.

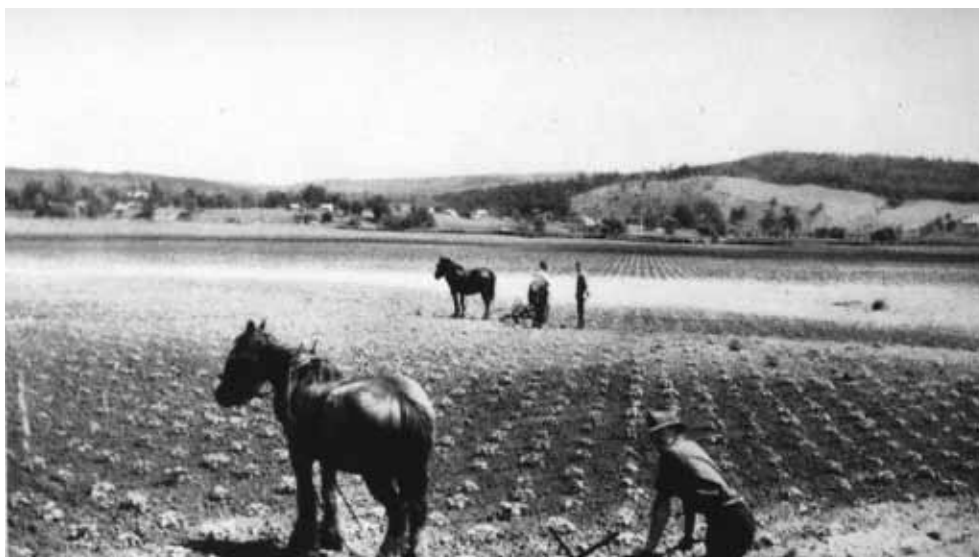
44. Siltation. Valuable Tambo flats at Bruthen being destroyed by deposit of raw sand. Sunflower crop, soil not now good enough for maize.'

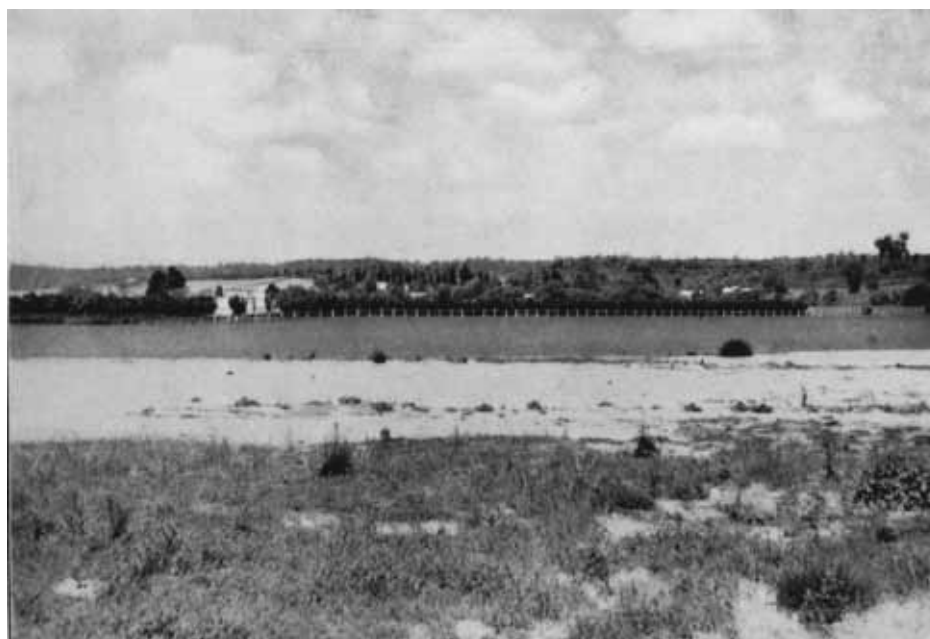
45. Siltation. Raw sand brought down by Tambo creeping over Bruthen flats and severely lessening their productiveness.

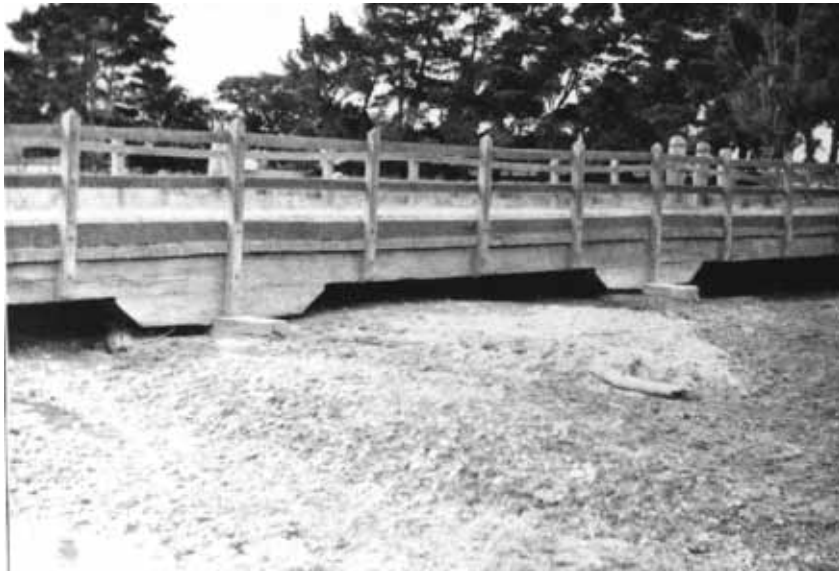
46. Bridge over Eaglehawk Creek on main Traralgon - Maffra road, near Glengarry. This has been so choked with debris from the scour shown in No. 26 that nearly all its capacity is gone, and the water in floodtime flow deep over the roadway, damaging it and holding up traffic.

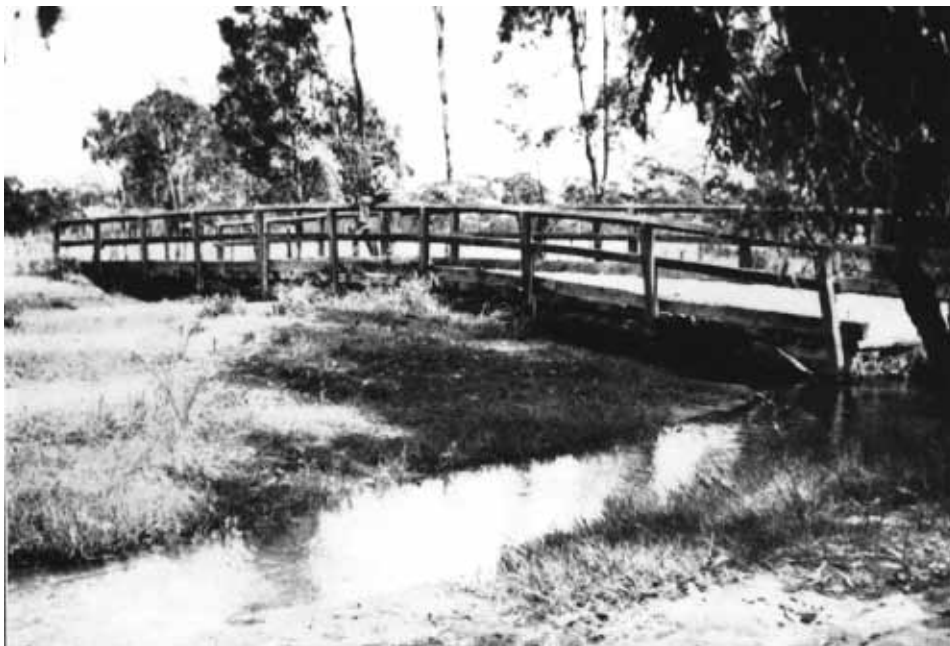
47. Bridge over Creighton's Creek, a mile or two below the Hume Highway. The creek is here so choked with sand from the Strathbogie ranges that in even small floods the water flows over the land, damaging roads and property.

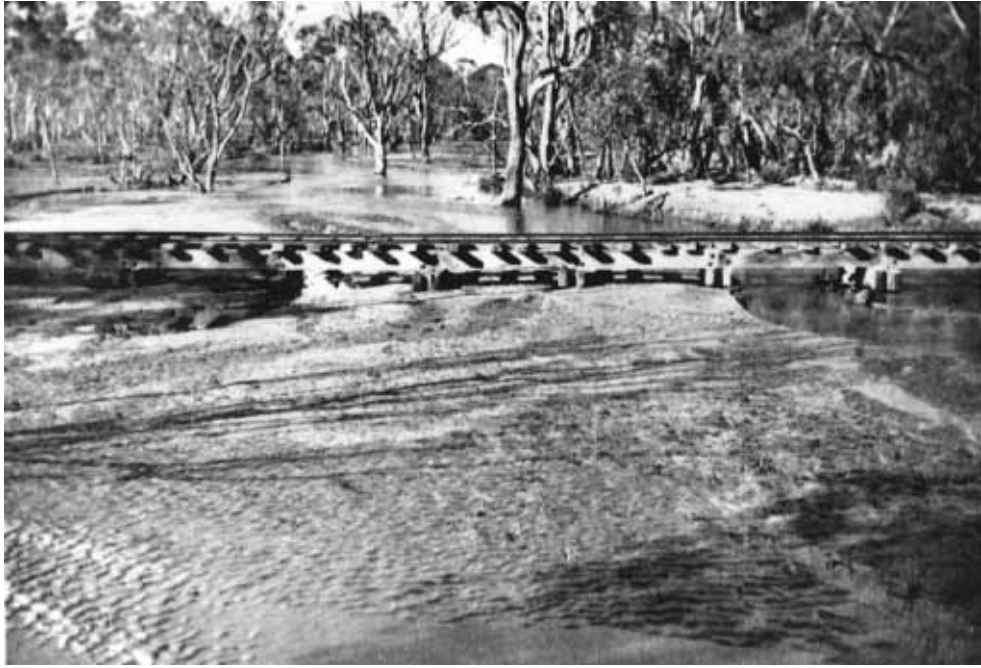
48. Siltation. Mokepilly Creek in Grampians, showing a bridge on the Stawell-Hall's Gap tramway, where 10 to 12 feet of silt have been deposited.

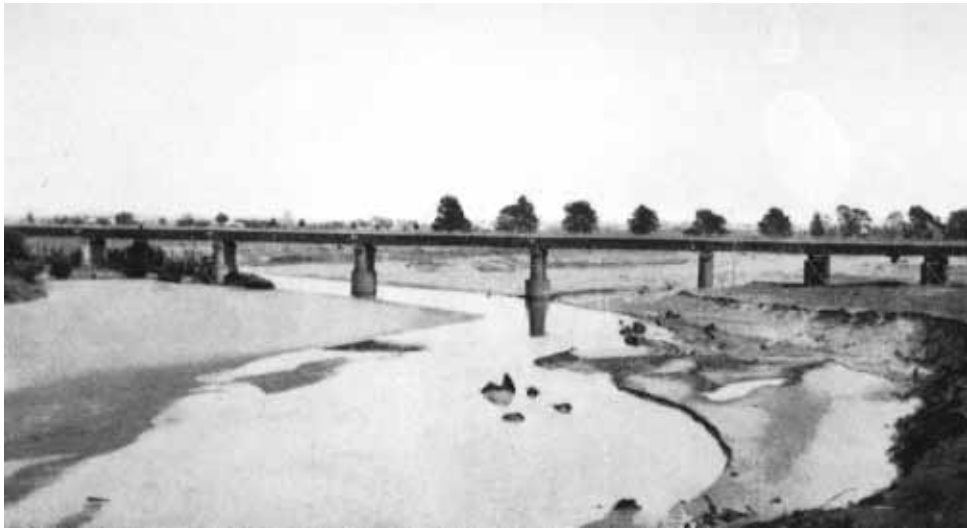
49. Railway bridge over Avon at Stratford. This has been lengthened by about 600 feet since 1886, and further extension will be necessary if further scour occurs.

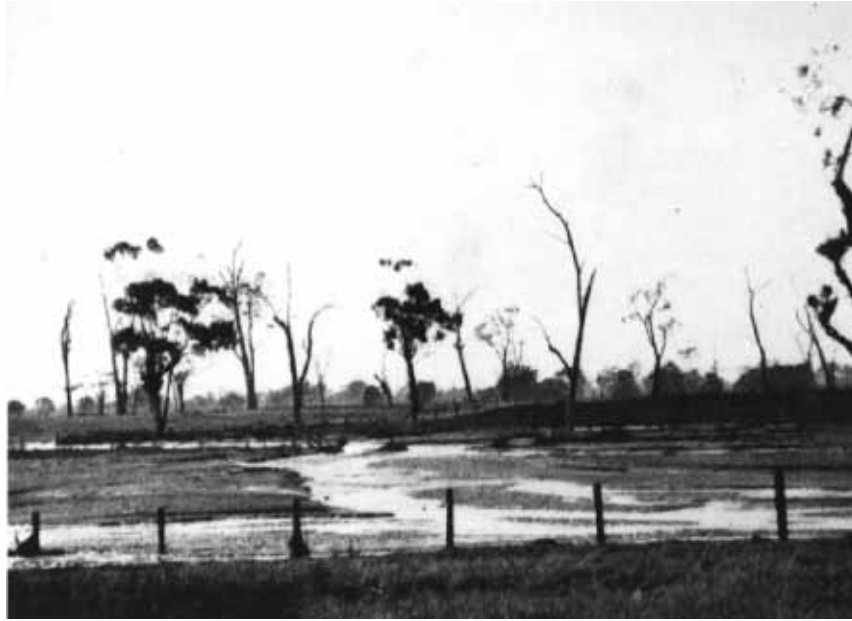
50. Below the main road bridge over Eaglehawk Creek at Glengarry (see Nos. 26 and 46). Barren subsoil has covered many acres of this holding.

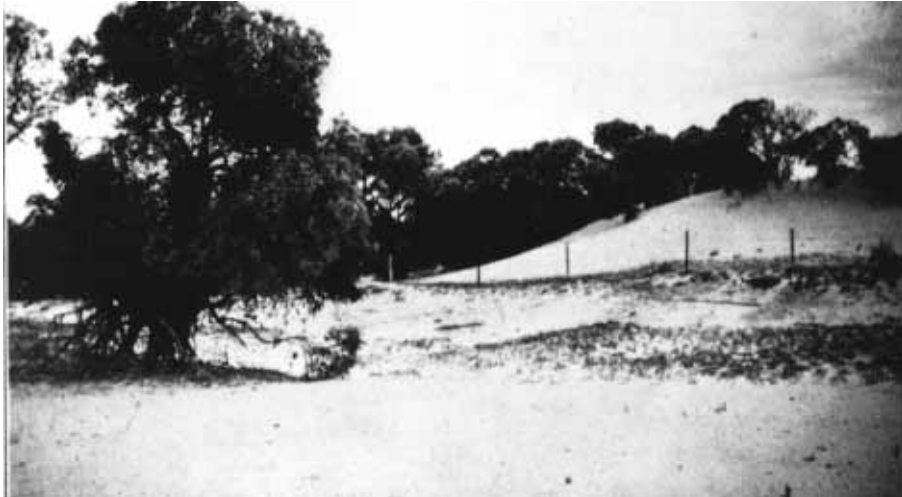
51. South of Rainbow, sand which has drifted from paddock in foreground has rendered road impassable.

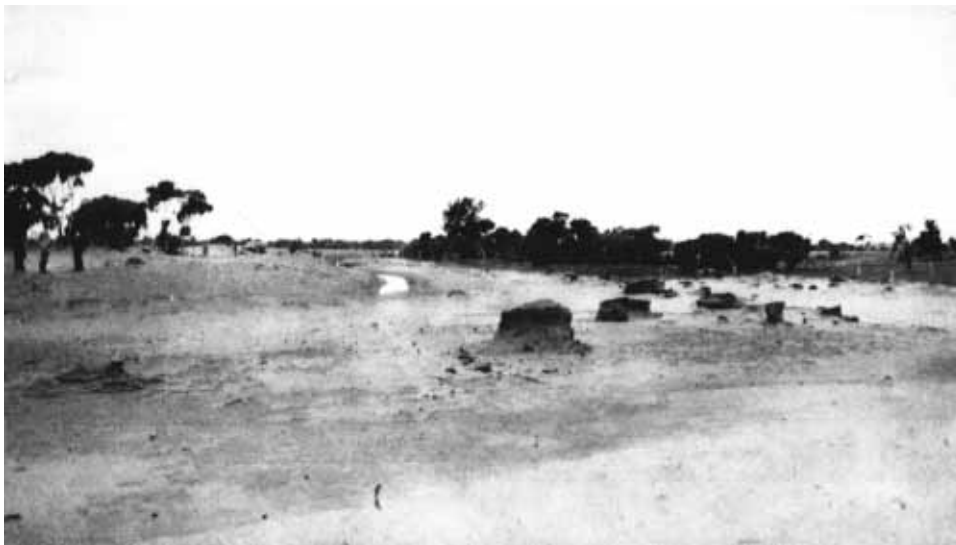
52. Parish of Bitchigal, in the Mallee. Wind erosion here has been so severe that one channel has had to be abandoned and a new one constructed.

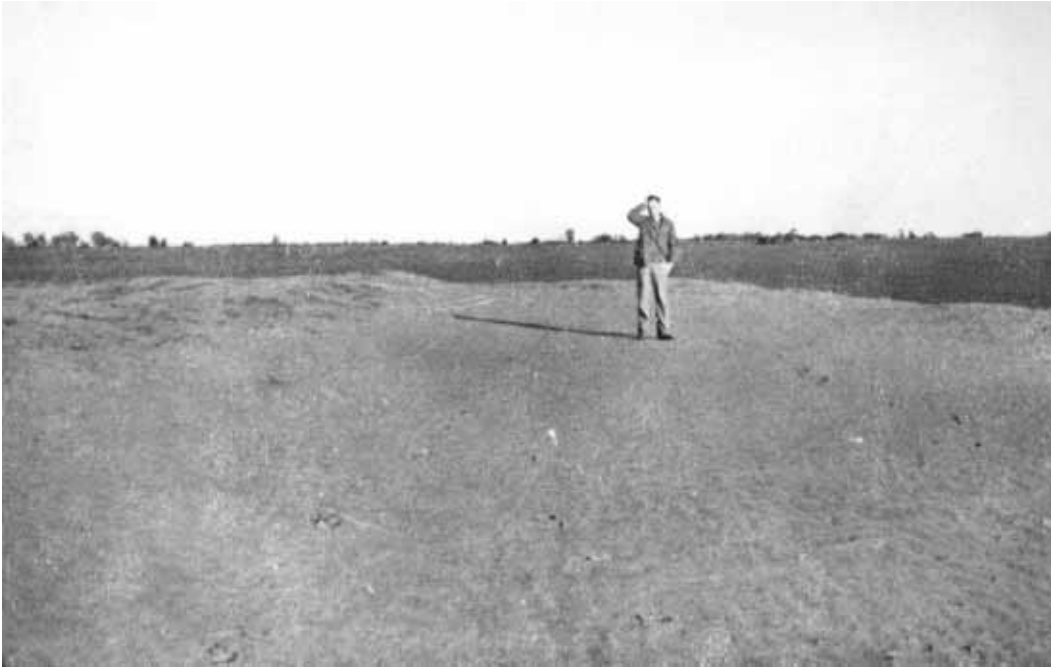
53. Main channel near Welpeup filled to the banks with drift sand from adjacent fallow.

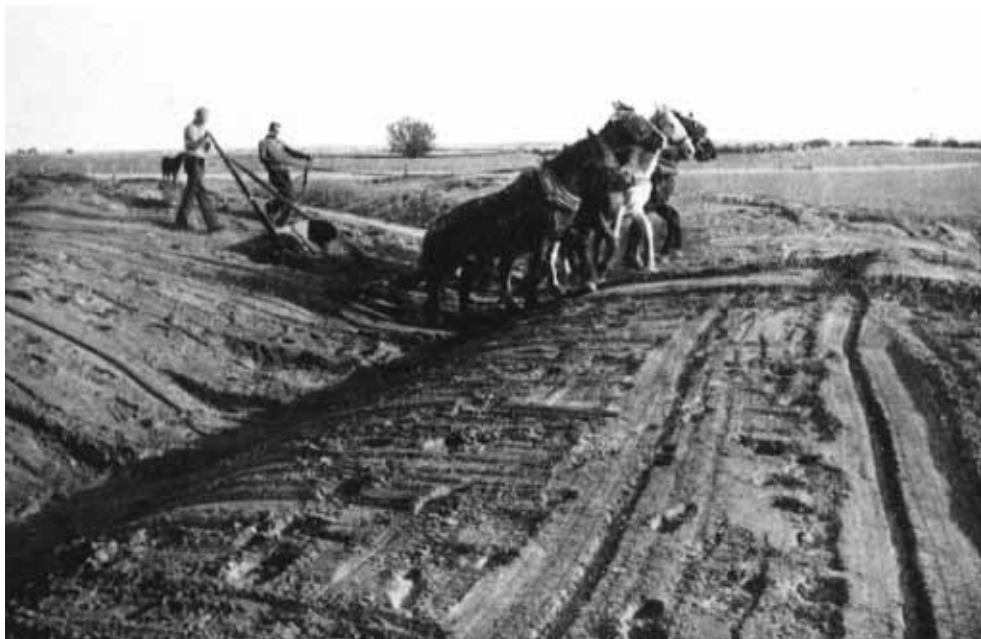
54. Scooping out channel shown in previous picture. Near Walpeup

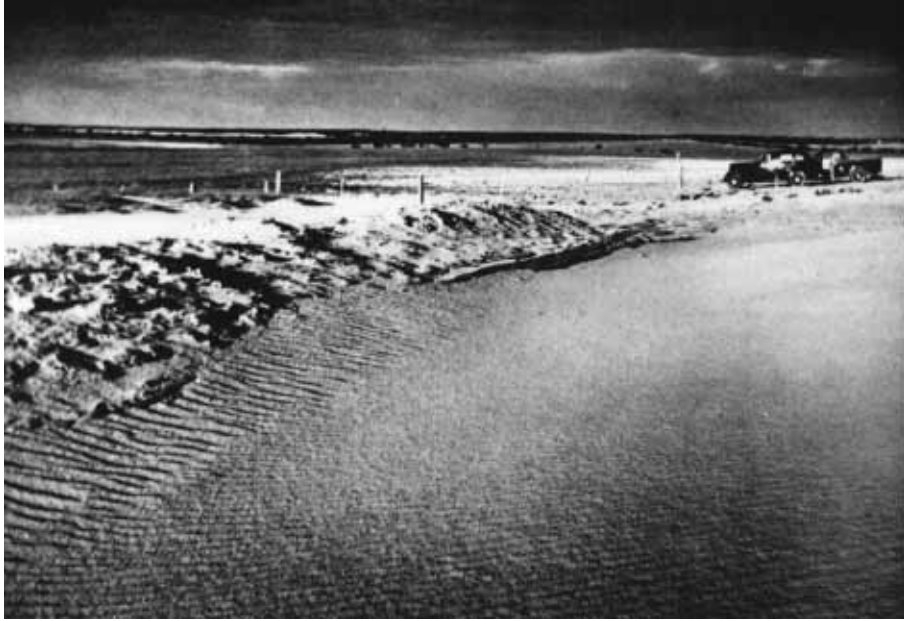
55. Parish of Kattyong - channel nearly filled with sand drift, only a few weeks after it had been cleaned out for use.

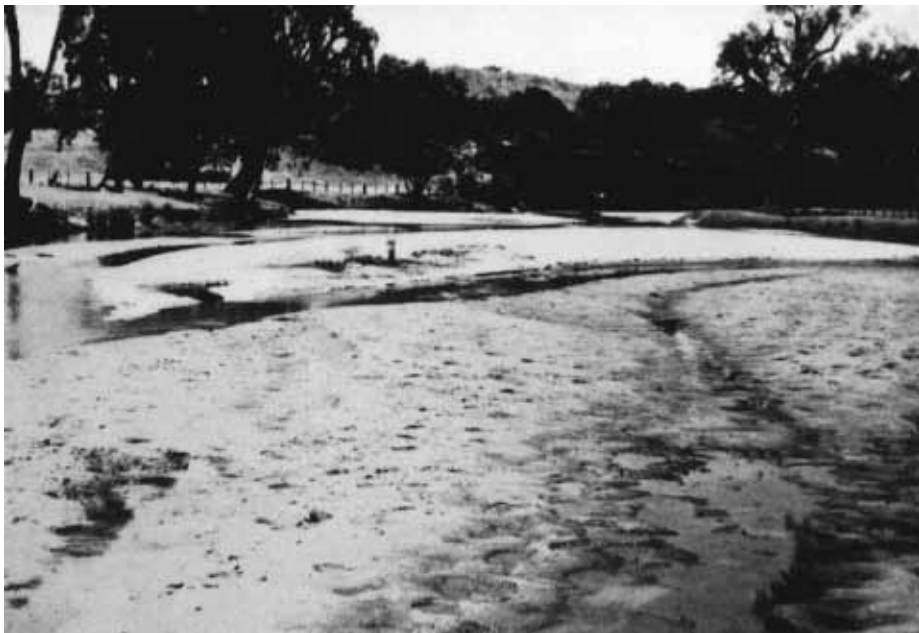
56. Hughes' Creek, near Avenel, showing huge beds of sand brought down from scours in the granitic Strathbogie Ranges. The waterholes along the creek have all been filled and are now useless. Not scouring cliff in background.

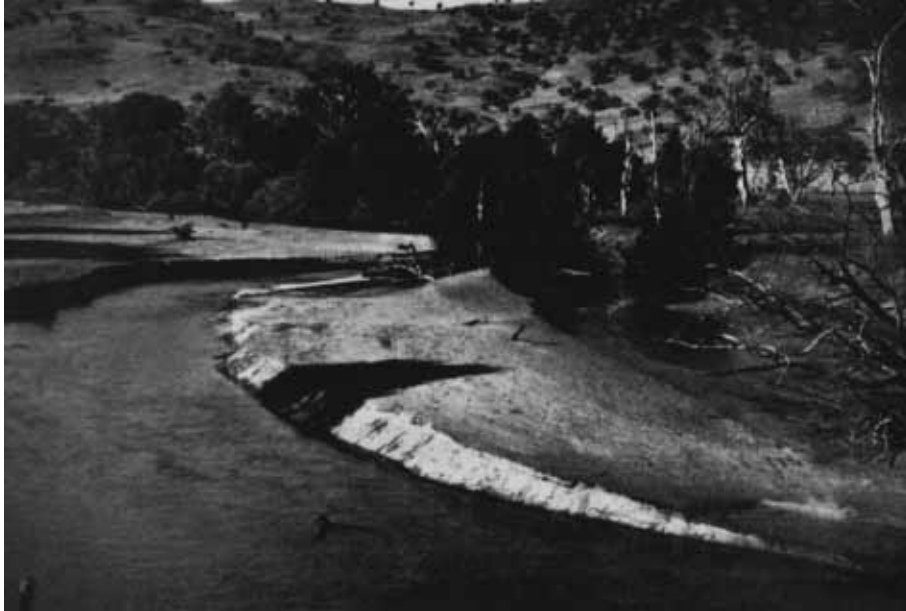
57. The Mitta River, near Tallangatta. When the Hume Reservoir is full, the stored water backs up the river, causing the sandbanks to form. When the level of the water in the reservoir falls, the stream speeds up again and washes the sand further into the reservoir. Note the clean edge of the sandbank where part has been washed away, contrasted with the greyer surface still covered with silt. In this way the Hume storage is steadily being filled.

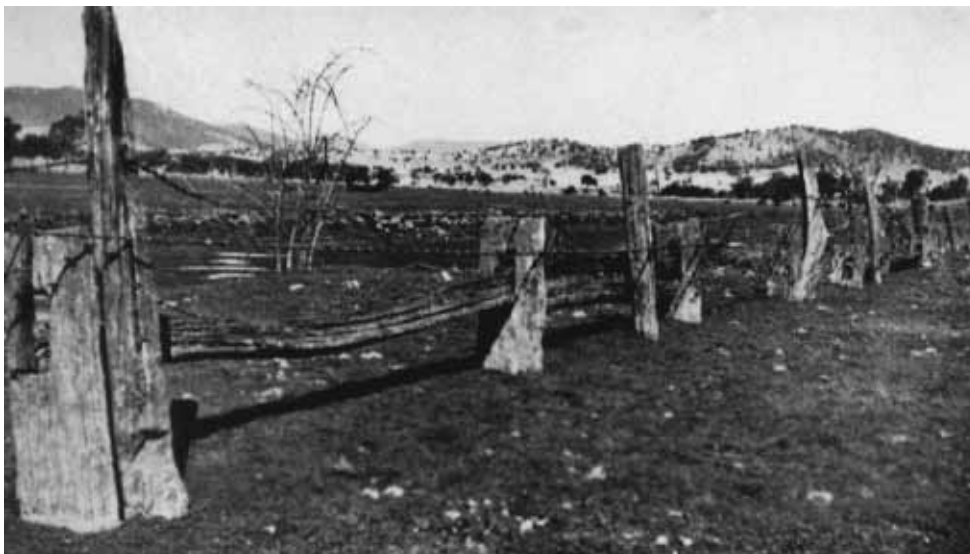
58. Flats on Sandy Creek where it enters the Hume Reservoir, near Tallangatta. This area is covered by the waters of the reservoir when it is full, and heavy siltation is taking place, extending each year further into the reservoir basin.

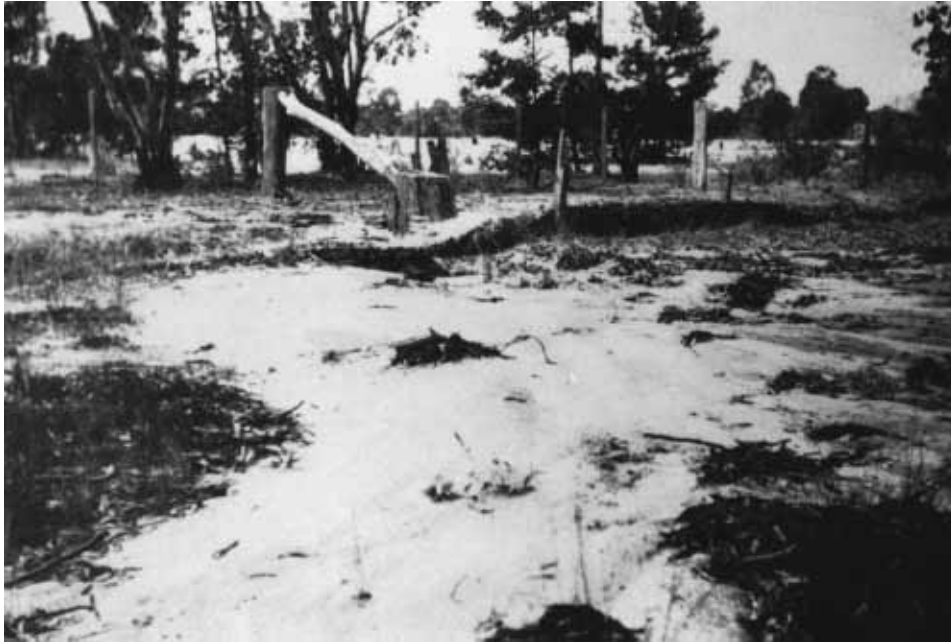
59. Siltation alongside Hume Highway, near Euroa, resulting from sheet erosion and small gulying on undulating land between the Highway and the Strathbogie Ranges. The old fence has been wrecked and a new one erected.

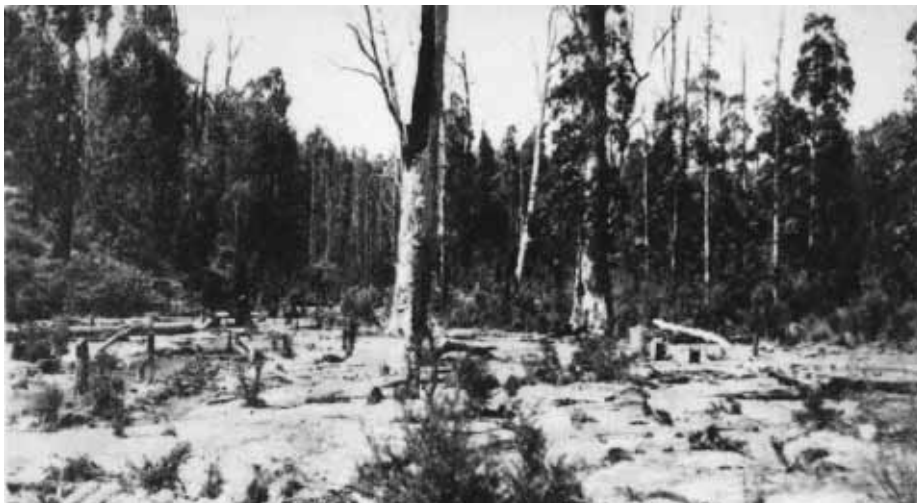
60. Bullock Creek. A tributary of the Bunyip River. Extensive forest fires, during February 1932, left mountain slopes open to the torrential rain of November and December 1931. The rapidity of the unretarded run-off carried vast quantities of surface soil to choke stream beds at lower levels and eventually drainage channels in the Koo-wee-rup area where serious losses have already occurred through flooding.
