1. INTRODUCTION

1.1 Background to the Study

The study area is a portion of the Strzelecki Ranges bounded approximately by Yarragon, Trafalgar, Moe, Narracan and Mirboo North as shown in Figure 1.1.

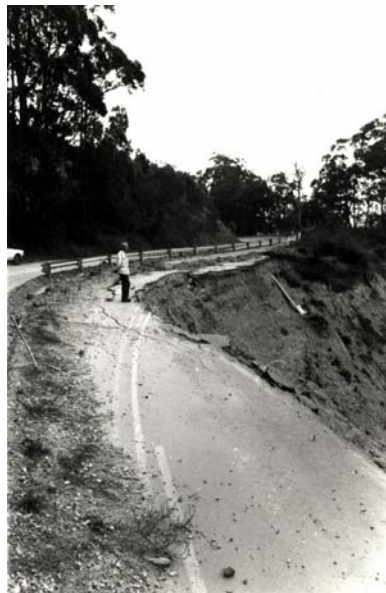
Figure 1.2 – Landslide in fill section of the main Trafalgar to Thorpdale road reduces width to one lane. April 1978.

Mr Thege stated that during 1975, approximately 22 landslides were active, and after the heavy winter rains in 1977 further landslides developed, some of them quite massive. Following the 1975 landslides, the cost of remedial work was estimated to be at least \$286,000. The cost of the 1977 landslides is anticipated to be in the order of \$200,000 with \$110,000 being required to rectify a landslide on the main Trafalgar to Thorpdale road (Figure 1.2). Periodic expenditure of this magnitude on remedial work cannot be expected to eliminate the problem of roadside landslides in the Shire. Continuing improvement on some landslides required recurrent work, and will remain an ongoing cost to the Shire until long-term solutions are found and implemented.

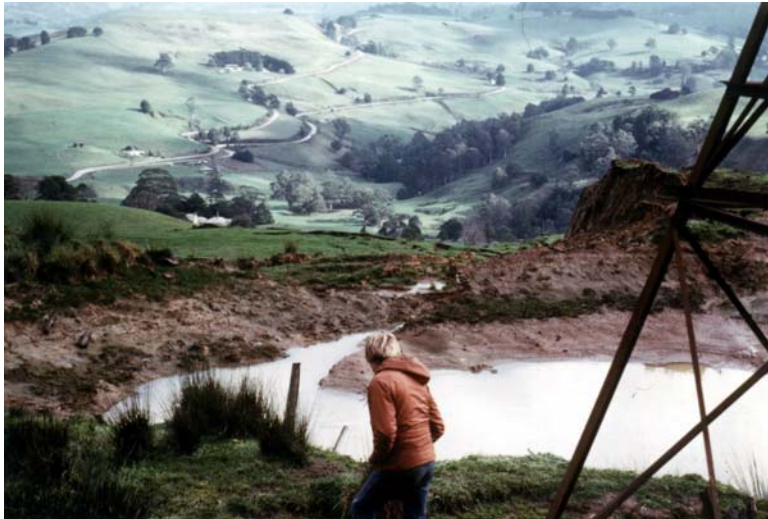
Figure 1.3 – Farm dam breached by landslide at Dingley Dell. July 1978.

The economic significance of landslides is not confined to the chronic damage caused to roads in the area. Landslides also degrade the quality of farmland pastures, damage crops, destroy dams (Figure 1.3). add to the sediment load of streams and occasionally damage buildings, fences and powerlines. No cases of human death or injury due to landsliding in the area are known to the writer, but electric fences are needed to stop stock from becoming stuck in fresh earthflows and in slump fissures.
