### 3. LANDSLIDE TYPES AND OCCURRENCE

#### 3.1 Classification of Landslides

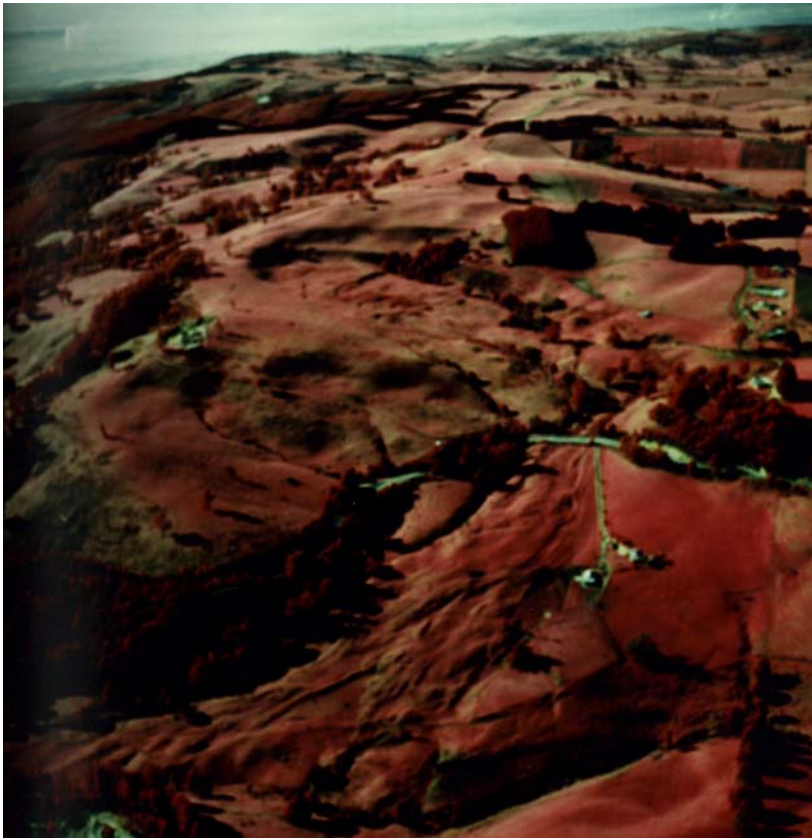
*Figure 3.3 – Oblique aerial infrared photograph of landslide No. 10 on the Trafalgar-Thorpdale Road, near Ryans Road.*

Moist zones in the recent slump-earth flow are shown in green shadings. Features of the fossil and dormant landslides to the left and in the background are more subdued. Unfortunately, the photograph is slightly out of focus.

The most common landslides are complex ones of the slump – earth flow type as shown in Figure 3.2, 3.6, 3.7 and 3.8. These landslides disturb many hectares of land and cause serious damage to the Shire roads each winter. The roads are narrowed by slumping, covered by earth flows and displaced laterally by creeping landslide material. Figure 3.8 is a photograph of a typical large slump-earth flow which crosses the main Trafalgar to Thorpdale Road (Landslide No. 10).

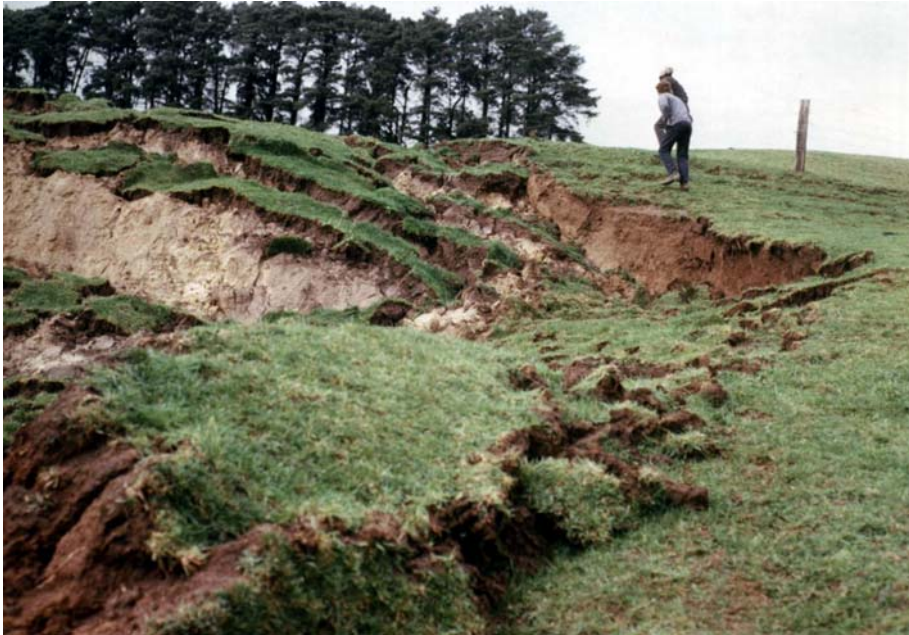
*Figure 3.6 – Slump zone of active slump-earth flow, Dingley Dell. July 1978.*

The slump-earth flows combine several types of movements. In the slump zone, where material is removed from the slope, the movement is dominantly rotational, but translational shear displacement can also occur. A typical slump zone is shown in Figure 3.6. The slumped material proceeds to break into smaller components and flow downslope as a wet viscous mass of earth as shown in Figure 3.7. The rate of flow is a function of the viscosity of the slope. Flow rates for fresh earth flows at the time of failure have been reported by local people to be in the order of 1 metre per minute, but accurate measurements have not been made. Following the initial period of relatively rapid flow, slow creep in the order of 1 metre per year or less can continue for many years,

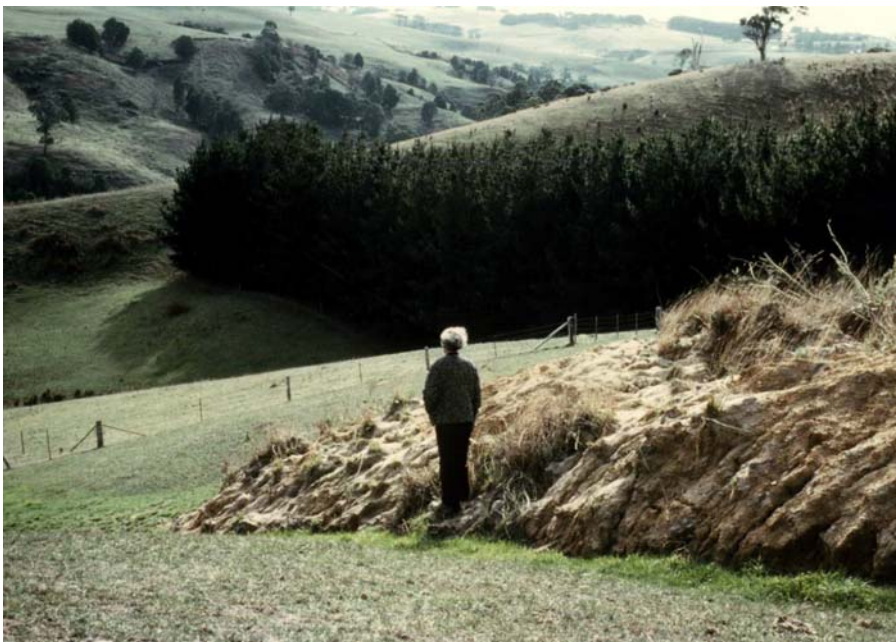
*Figure 3.7 – Toe of earth flow zone of recent landslide, Dingley Dell. July 1978.*

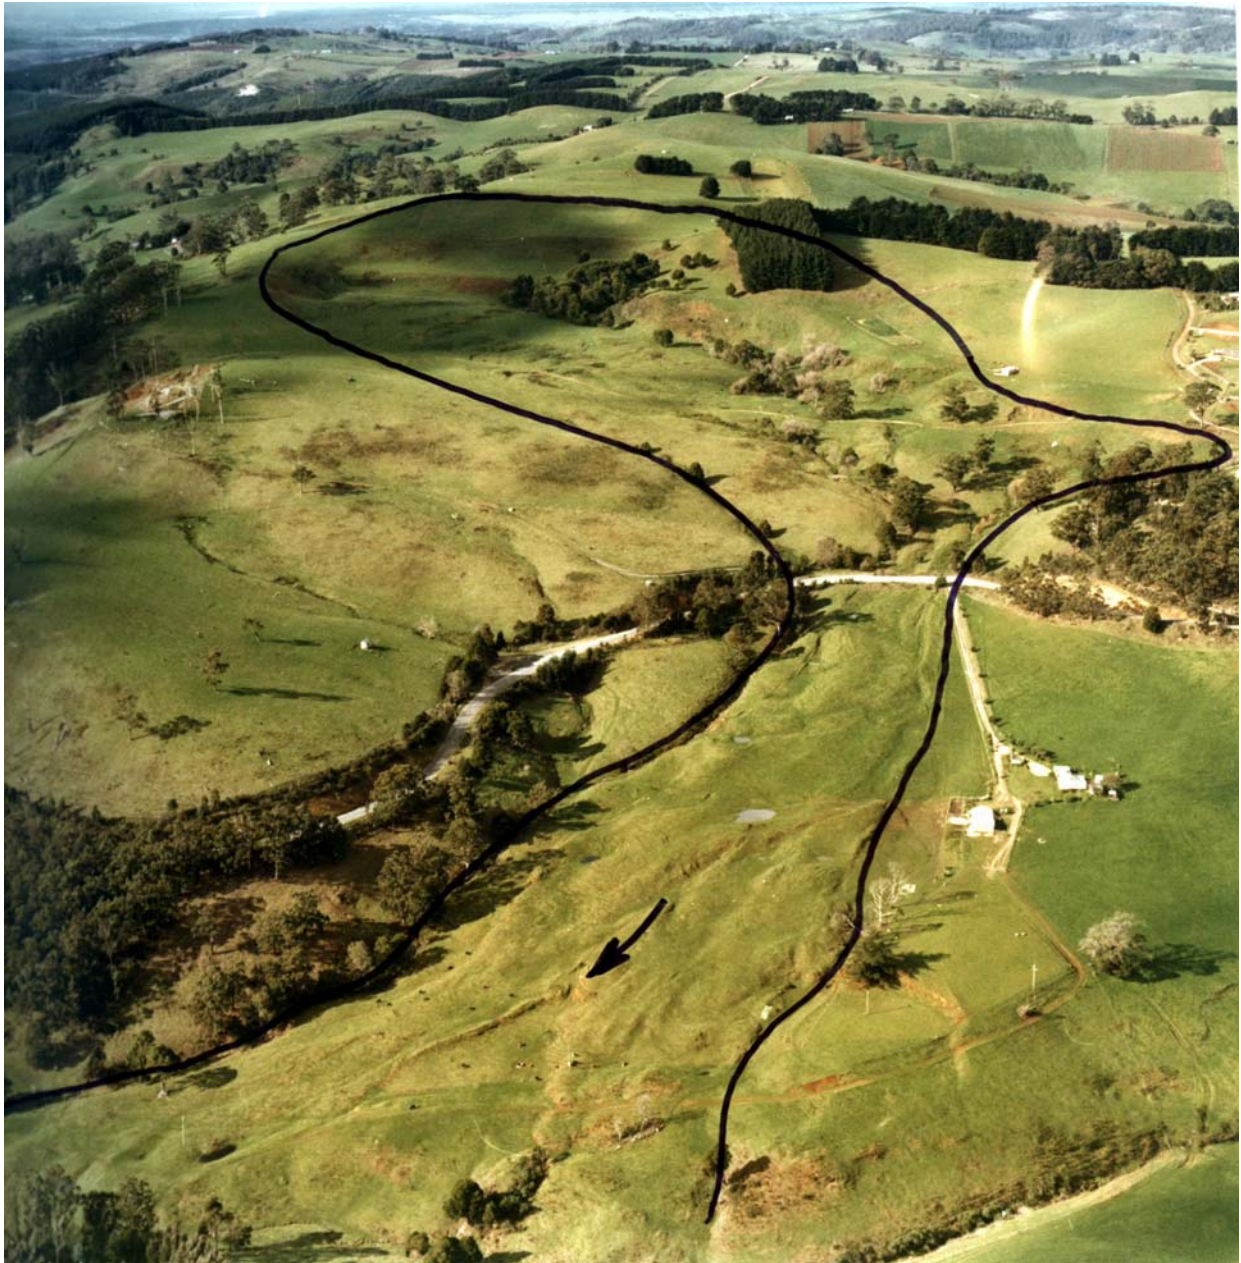
*Figure 3.8 – Slump-earth flow cutting across Trafalgar-Thorpdale Road. Slump zone above the road, earth flow zone below road. Winter 1978.*

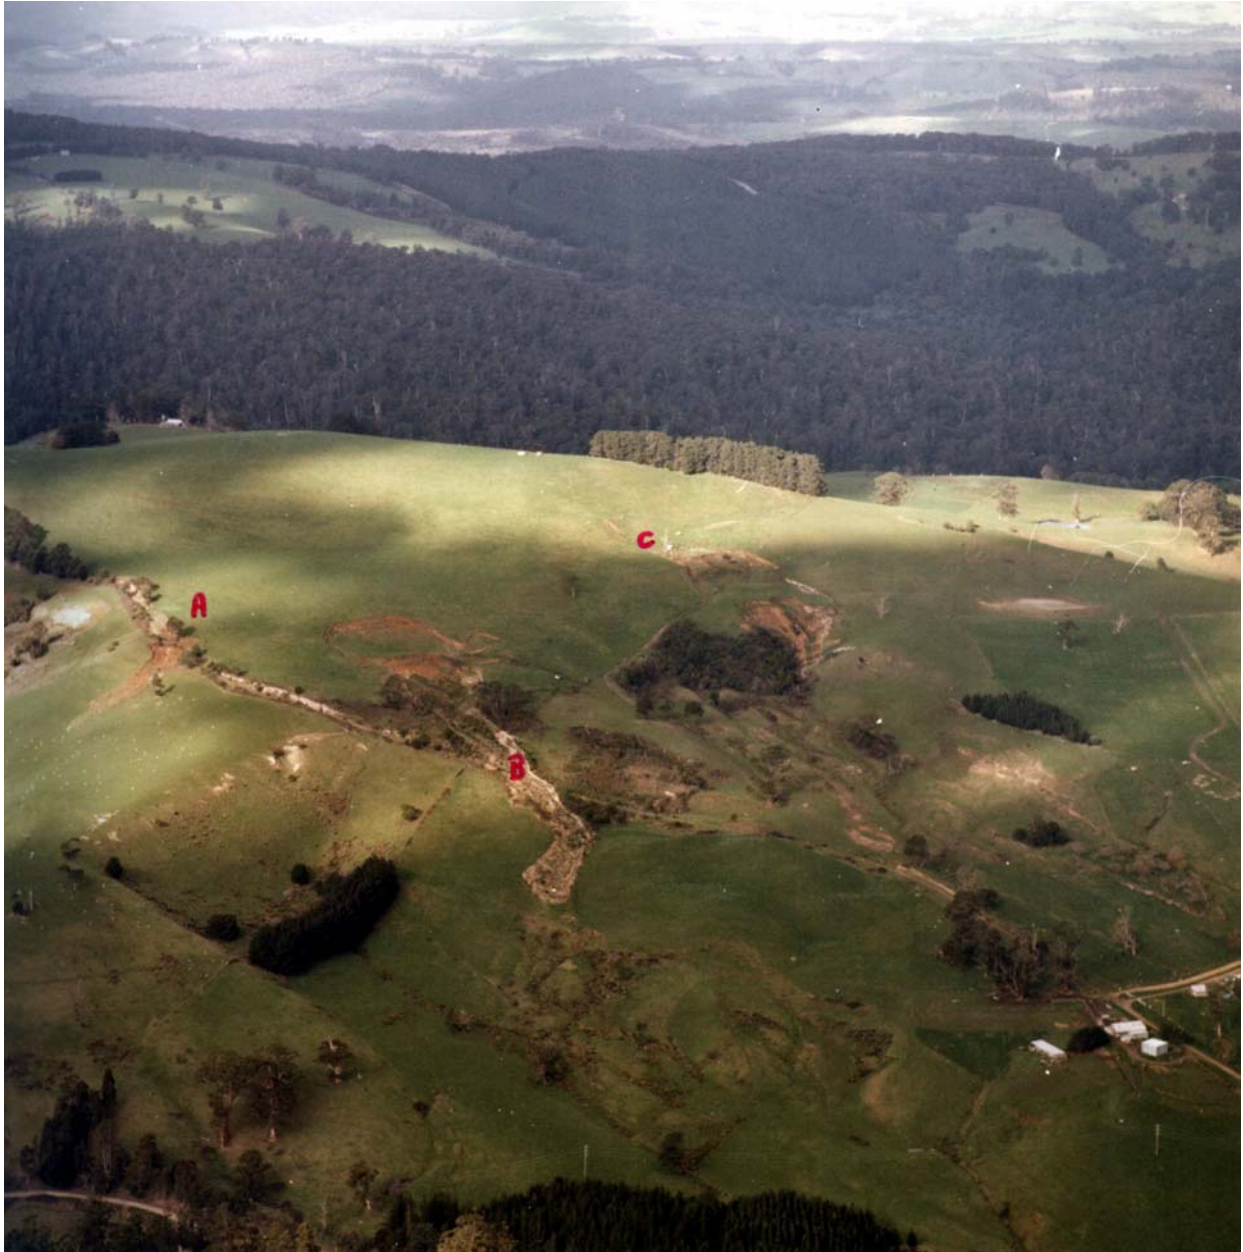
***Figure 3.10 – Dingley Dell landslide complex, consisting of at least 3 generations of multiple slump-earth flows.***

The entire foreground is a fossil landslide, clearly defined by the large arcuate depression at the head of the slump zone. Numerous grassed dormant landslides are superimposed on the fossil landslide. The active landslides are obvious from fresh earth scars and earth flows. The Dingley Dell Road traverses the area. At point A, the road is entirely removed by a slump and at point B it is covered by an earth flow. Following heavy rain, further landsliding occurred below a dam (point C) a few week after this photograph was taken in winter 1978.

A dominant characteristic of the landslides is the tendency for progressively smaller landslides to develop on larger pre-existing ones. In the Dingley Dell landslide complex, at least 3 generations of landsliding can be observed. Fossil, dormant and recent landslides are all present as shown in Figure 3.10. The recent landslides affect less than 10% of the fossil landslide area, nevertheless they have caused considerable damage to farm land and have closed the Dingley Dell Road.
