Appendix 1 Hydrographs of Bet Bet monitoring bores

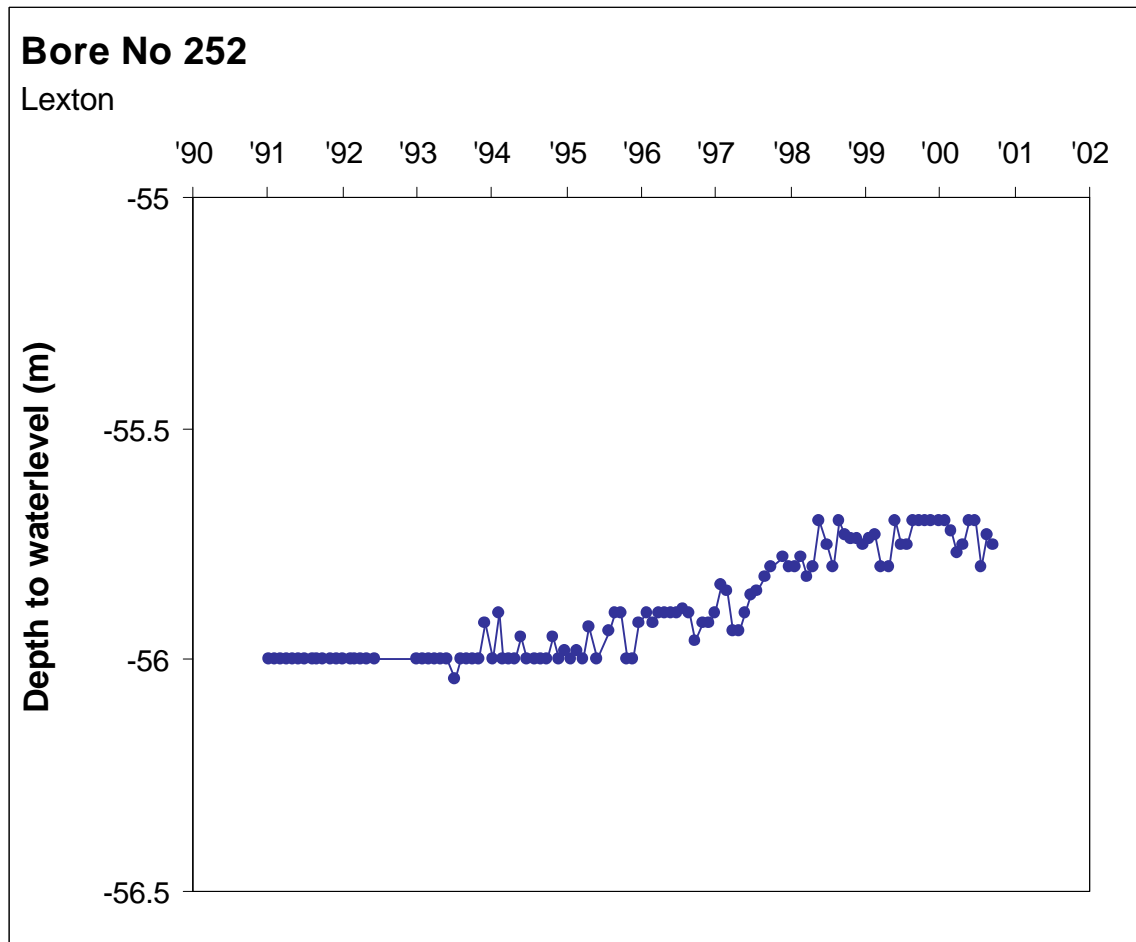
CLPR No:	252	Bore monitor:	Dal McErvale
Locality description:	Lexton, Ben Major Top of hill, crest		
Geological description:	Devonian granite and associated metamorphic rocks Clay, silt overlying hard granite/metamorphic rock		
Bore depth (m):	91.5	Average rainfall (mm/yr):	611
Current water depth 2003 (m):	56 (March 2001)	Salinity (EC) (µS/cm):	-
Groundwater trend:	Shows an overall rising groundwater trend, regardless of low rainfall years. Recharge to this aquifer is not reliant on local rainfall. Recharge is possibly occurring from a regional source.

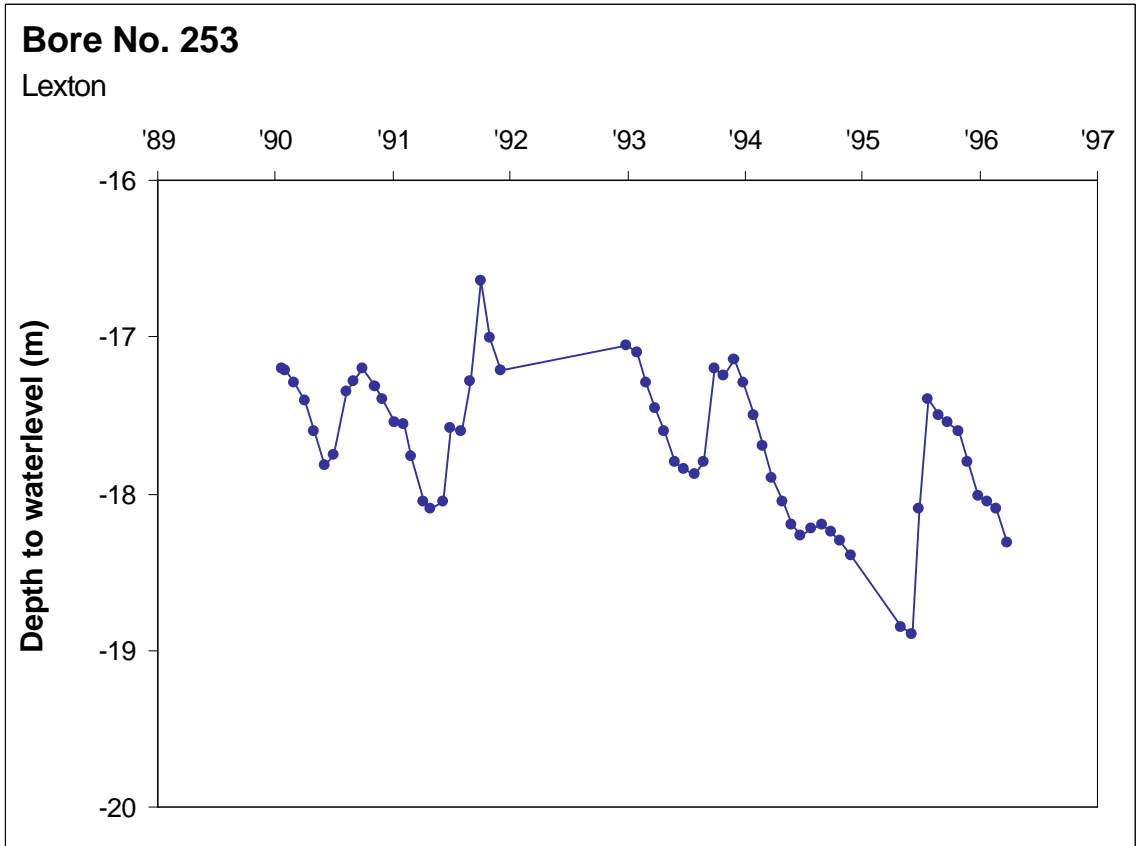
CLPR No:	253	Bore monitor:	DPI
Locality description:	Top of the hill on a steep slope		
Geological description:	Ordovician sedimentary rock Hard fractured marine shale and sandstone		
Bore depth (m):	53	Average rainfall (mm/yr):	611
Current water depth 2003 (m):	18.5 (in 1996)	Salinity (EC) (µS/cm):	-
Groundwater trend:	No readings since 1996. In process of reinstating monitoring of this bore.

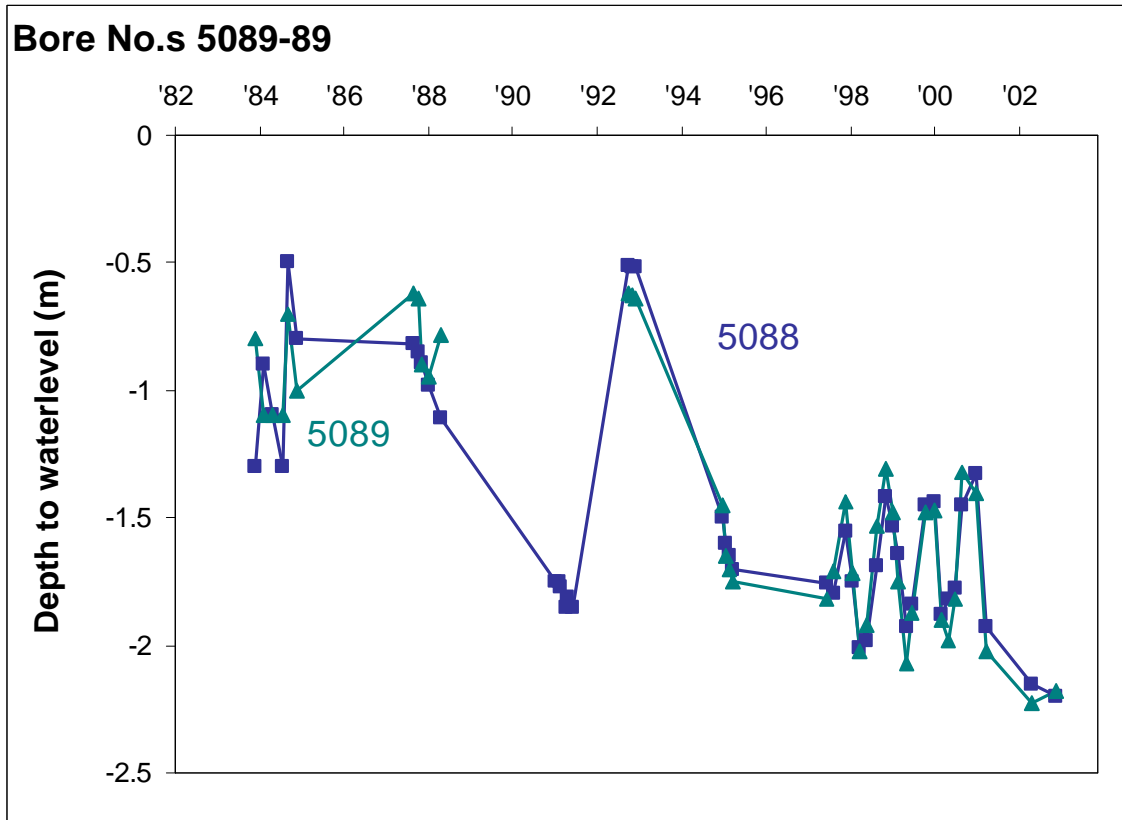
CLPR No:	5088, 5089	Bore monitor:	DPI
Locality description:	Lexton. On discharge site.		
Geological description:	Colluvium outwash, on top of fluvial clays, silts, sands and gravels		
Bore depth (m):	5088 = 18.2 5089 = 6	Average rainfall (mm/yr):	611
Current water depth 2003 (m):	5088 = 2 5089 = 2	Salinity (EC) ($\mu\text{S}/\text{cm}$):	
Groundwater trend:	Erratic hydrograph behaviour due to the lack of regular reading in the early 1990s. Very responsive to local climatic variation with an overall falling groundwater trend.

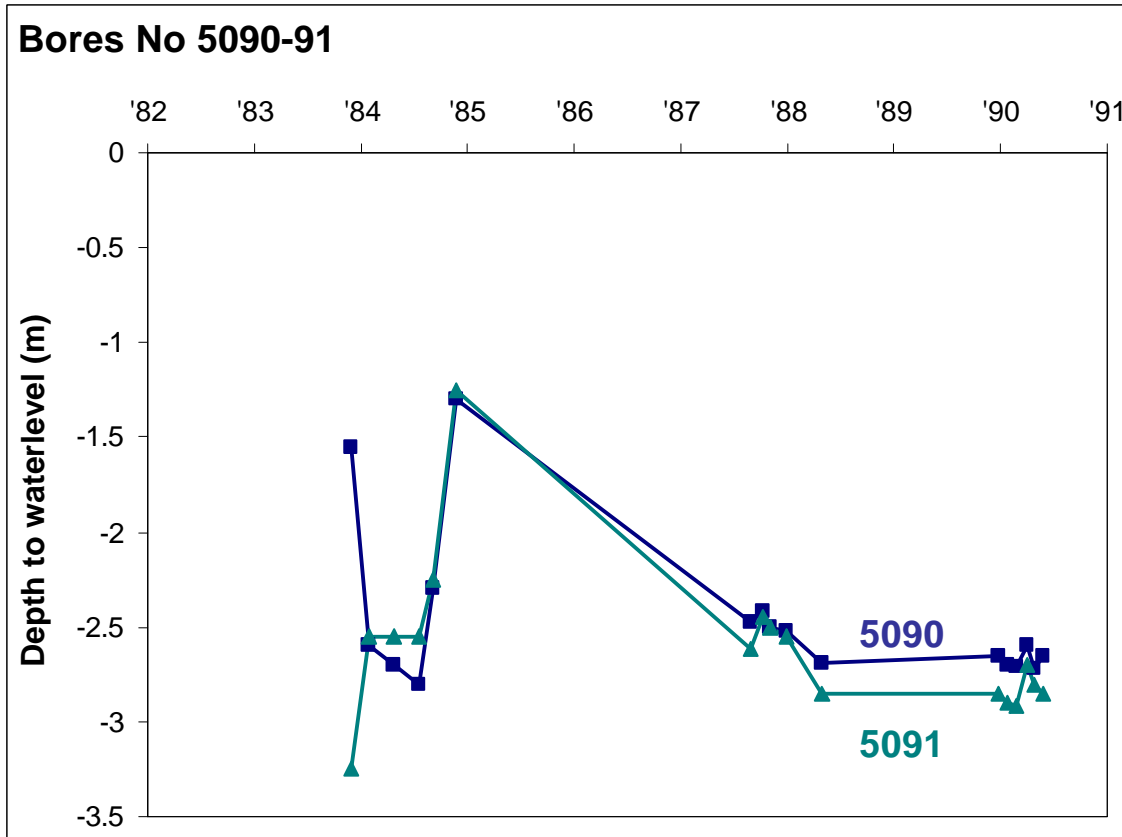
CLPR No:	5090, 5091	Bore monitor:	A. Hobson
Locality description:	Lexton. Just above discharge site off Blackbottom Road		
Geological description:	Colluvium outwash, on top of fluvial clays, silts, sands and gravels		
Bore depth (m):	5090 = 20 5091 = 7	Average rainfall (mm/yr):	611
Current water depth 2003 (m):	5090 = 2.5 5091 = 2.7	Salinity (EC) (µS/cm):	-
Groundwater trend:	Erratic hydrograph behaviour due to lack of recorded information between 1985–88. Sporadic readings throughout the 1980s. No readings since 1991. Shows an overall falling trend responding to climatic variation. Would be worth reinstating.

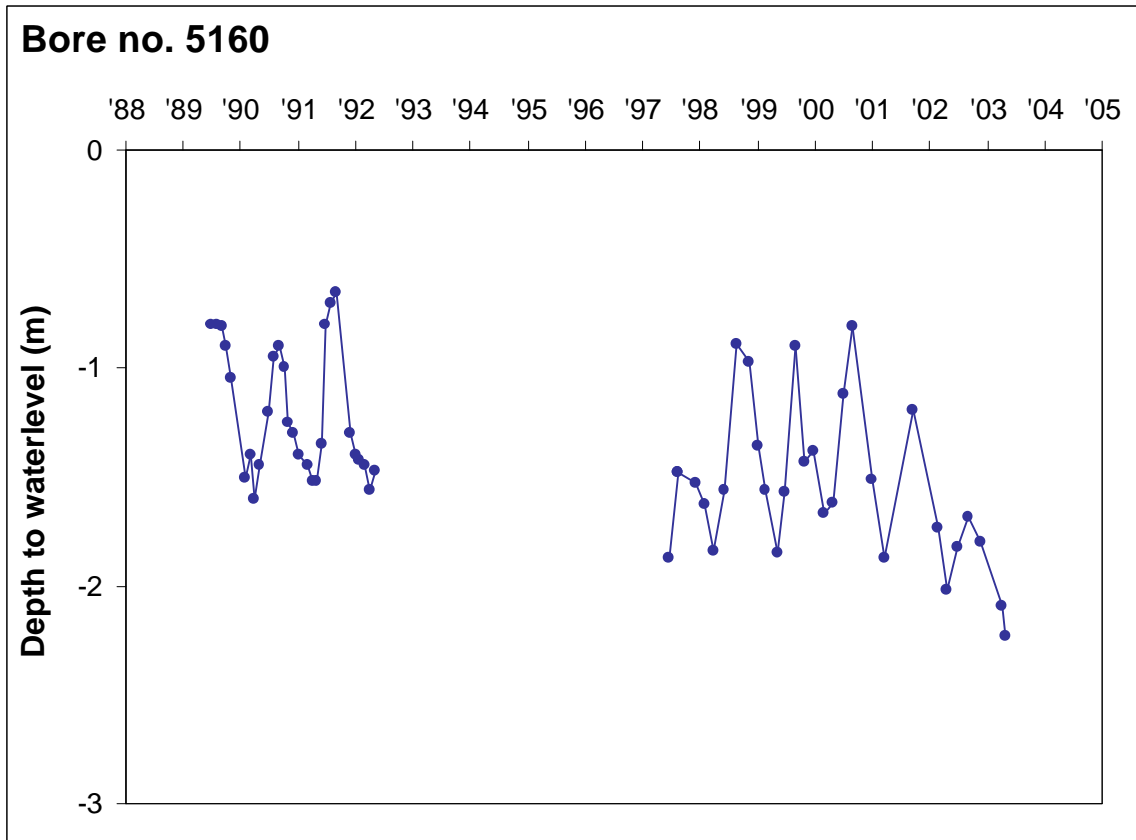
CLPR No:	5160	Bore monitor:	DPI
Locality description:	Lexton Monitors discharge site		
Geological description:	Ordovician granite and associated metamorphic rocks Clay, sands overlying hard granite/metamorphic rock		
Bore depth (m):	3.3	Average rainfall (mm/yr):	611
Current water depth 2003 (m):	2	Salinity (EC) (µS/cm):	-
Groundwater trend:	Missing data between 1993–1997. Strong response to local rainfall variation. Slightly falling groundwater level overall.

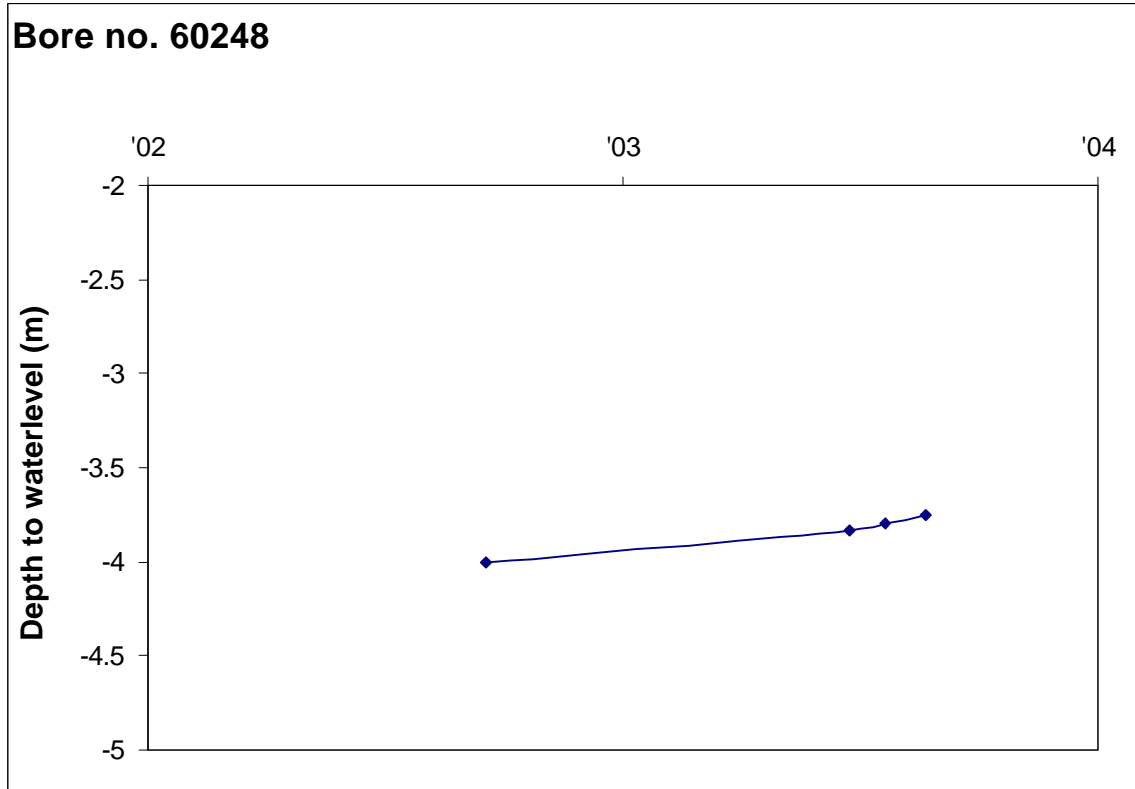
CLPR No:	60248	Bore monitor:	DPI
Locality description:	Roadside Lexton Sunraysia Highway Lower slope		
Geological description:	Fluvial clay, silt sand and gravel		
Bore depth (m):	17.5	Average rainfall (mm/yr):	611
Current water depth 2003 (m):	3.8	Salinity (EC) (µS/cm):	4850
Groundwater trend:	An overall rising groundwater trend. Limited data. New bore.

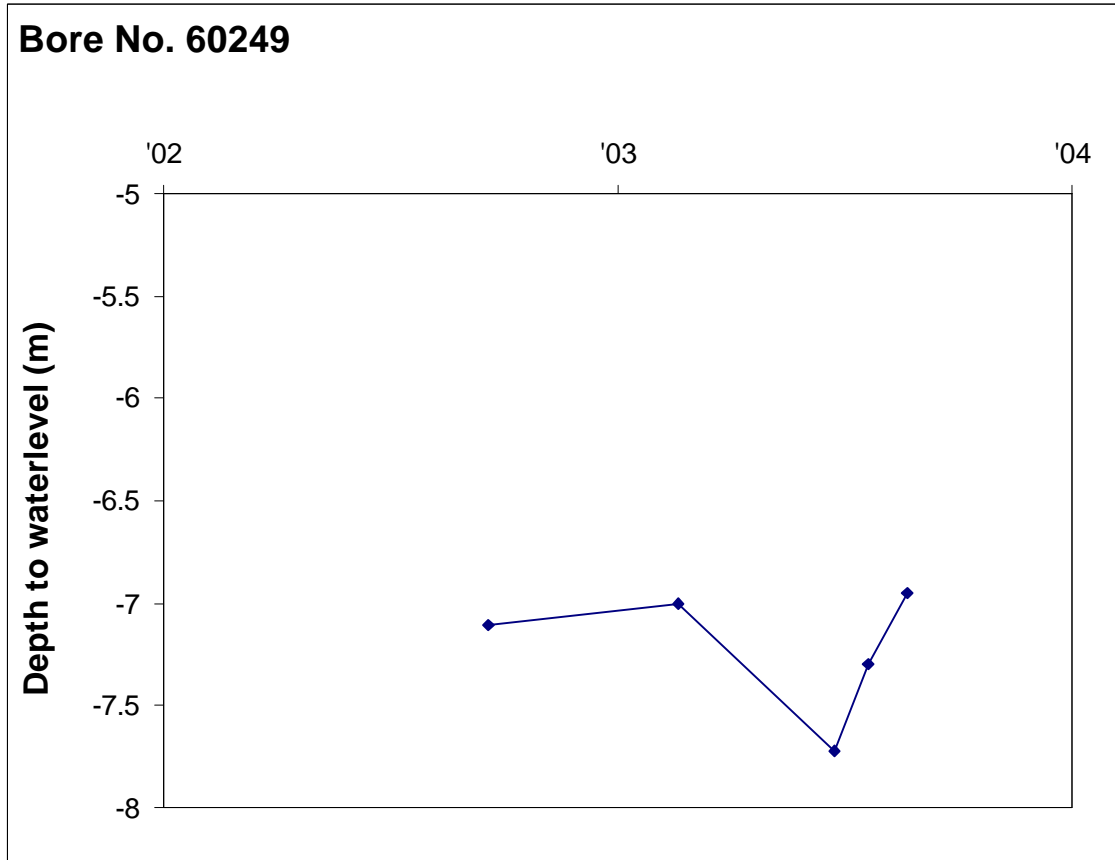
CLPR No:	60249	Bore monitor:	DPI
Locality description:	Roadside Lexton Rifle Range Road Mid-lower slope		
Geological description:	Ordovician sedimentary rock Hard fractured marine shale and sandstone		
Bore depth (m):	17.5	Average rainfall (mm/yr):	611
Current water depth 2003 (m):	7.7	Salinity (EC) (µS/cm):	14 420
Groundwater trend:	Responsive to climatic variation. An overall falling groundwater trend. New bore.
