General Description:

Site No. 77

Land Unit symbol: Dgb1

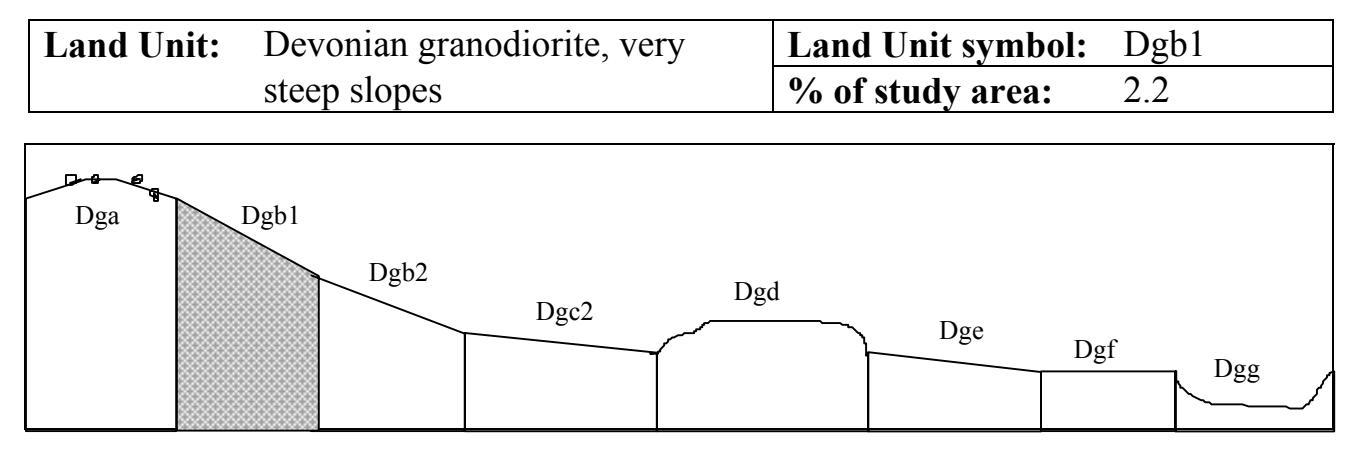
These very steep slopes leading up to the Blue Range plateau are clearly visible in the distance to the east, from the highway at Taggerty. Granitic outcrops are common and the soil varies considerably in depth. Tree roots penetrate into the weathered zone and along the jointing planes of the underlying bedrock. The slopes are inherently unstable and the hazard of mass movement increases dramatically with clearing and excavating activities.
