General Description:

Land Unit symbol: Dsb2

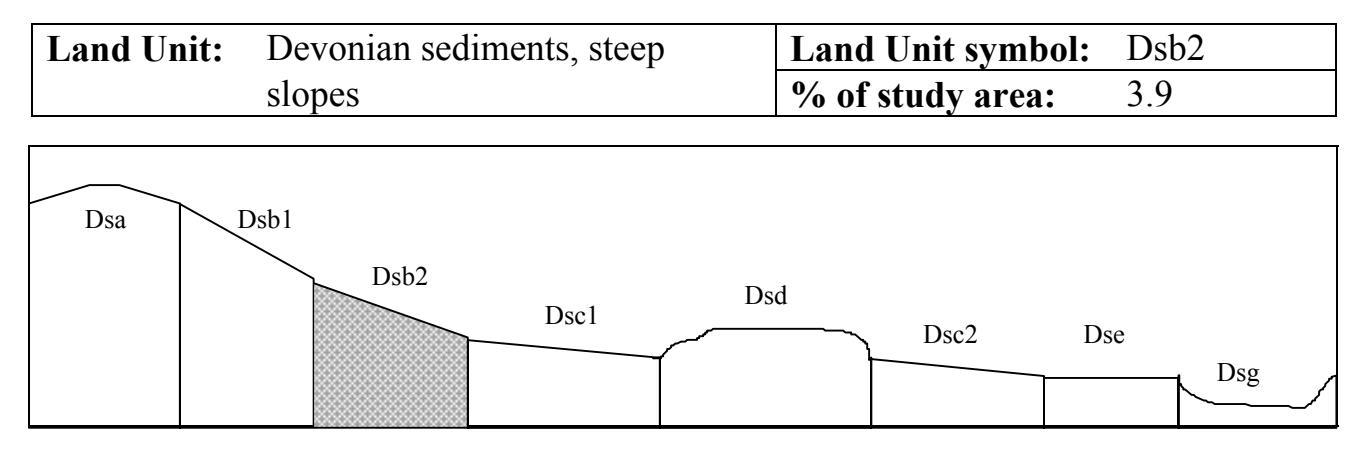
Situated throughout the study area, these steep slopes on Devonian sandstone and siltstones have, in their natural condition, a dense forest cover which helps protect the inherently - unstable slopes from erosion and mass movement (landslips). Logging operations invariably cause increased erosion and instability, and, depending on the location, can detract from the scenic value of the area. Any land disturbance in this unit is likely to adversely affect the quality of water flowing from the catchment.
