6.10 Kangaroo Ground Land System

This very small land system occurs on an area of basalt capping at Kangaroo Ground. It covers 2.8 km^2 or 0.1% of the study area.

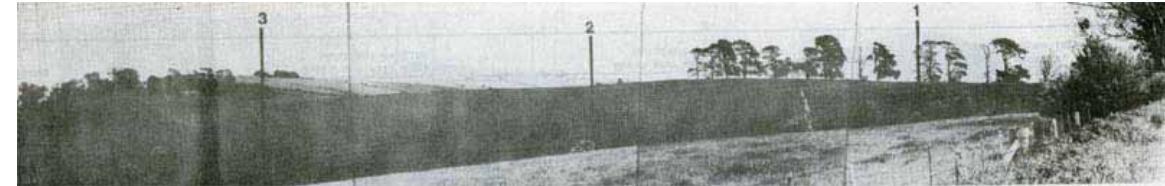
The topography is an undulating plain with slopes ranging from 3-9%. The area has been completely cleared except for *a few* remaining Candlebarks. The major soil is the black clay of uniform texture and coarse structure.

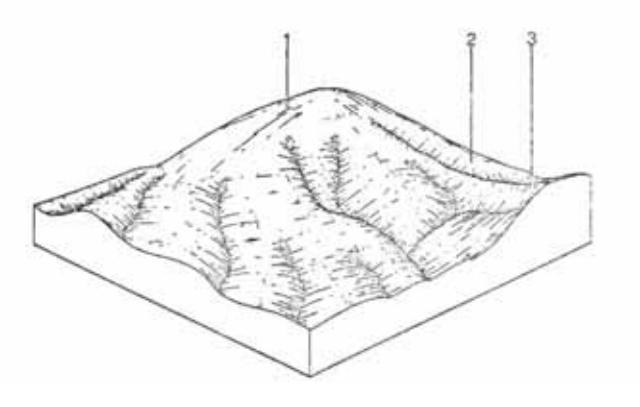
Schematic Block Diagram

Approx. 2.25 km
