6.20 Mt. William Land System

This land system occurs on the Cambrian sediments which outcrop east of Lancefield in a north-south direction. It covers 51.7 km^2 or 2.0% of the survey area.

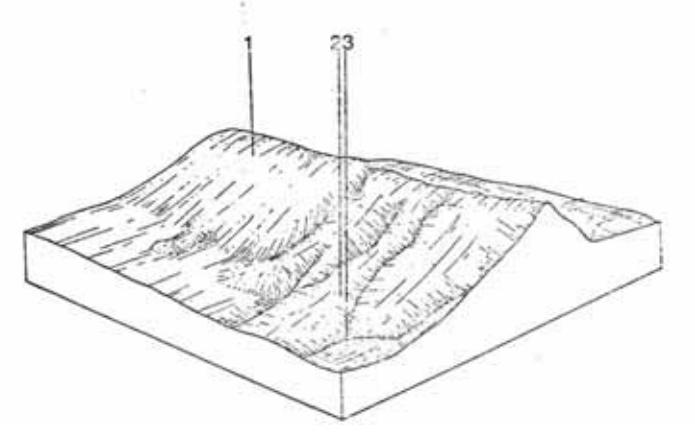
Schematic Block Diagram

The soils of the crests and steeper slopes are shallow stony gradational soils with a weakly structured topsoil grading into a heavier clay, well-structured subsoil. The red duplex soils of the slopes have a subsoil which is characterized by heavy texture and strong structure.

The hazard of land slips in this land system is high. They occur readily in areas where a heavy clay subsoil rests on parent material. However, before slippage can occur the subsoil has to contain enough water to sufficiently lubricate the slip surface - the amount of crater needed decreased with an increase in slope. Therefore slope, vegetation cover, which influences the amount of water reaching the subsoil and position in the landscape, which also affects water availability are also important factors.
