MAP UNIT Ordovician, steep

SYMBOL Ors

**GENERAL DESCRIPTION**

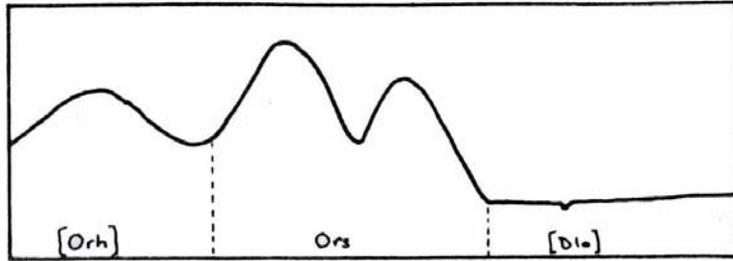
Map Unit is 1.8 % study area Ref. Plate 8

This map unit contains the steepest slopes of the site underlain by Ordovician rocks.  
It occurs adjacent to and drains directly into the Cosgrave Reservoir.

High: steep slopes and shallow stoney soil draining directly into the Cosgrave Reservoir
