# Urban Salinity in Bendigo

## What is urban Salinity?

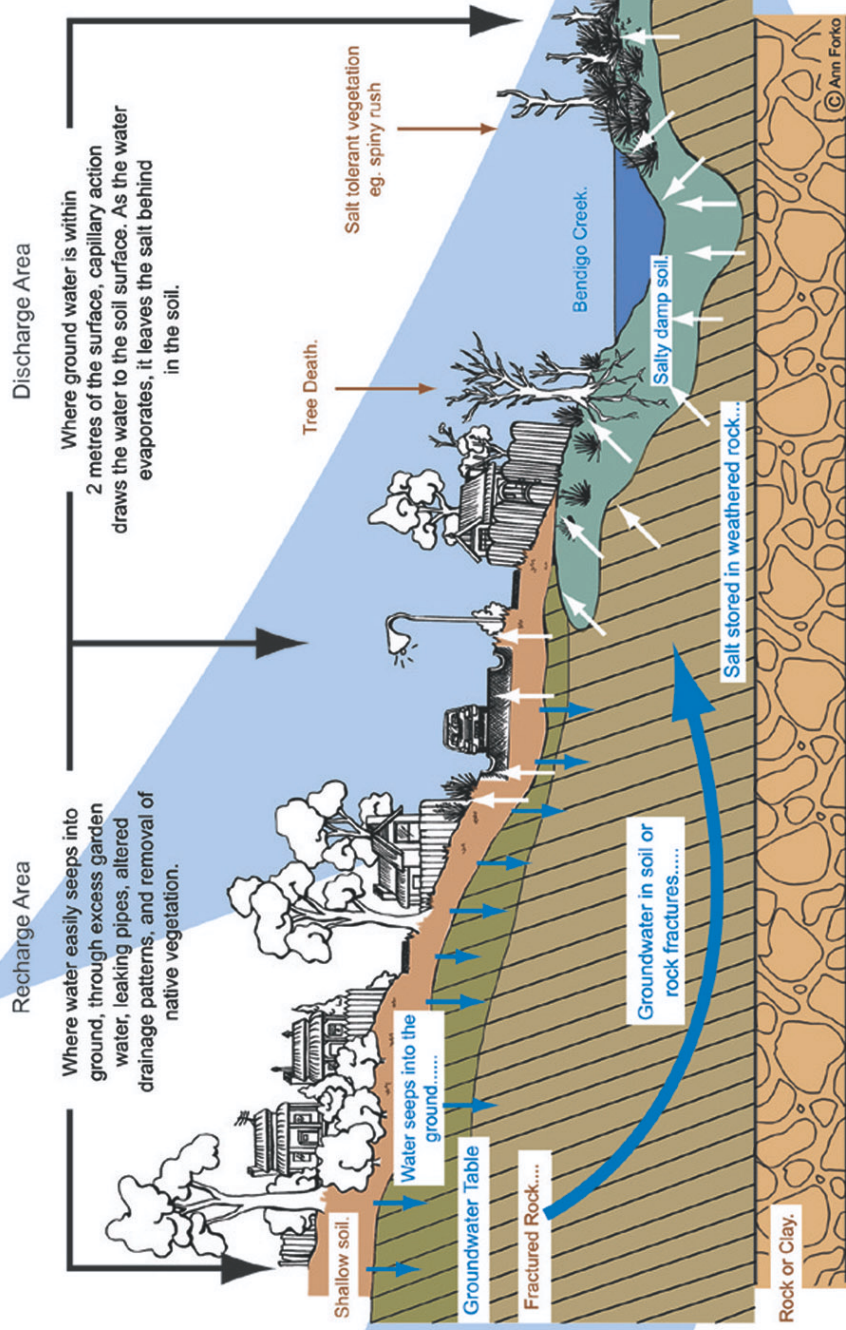
## Urban Groundwater Salinity Process

Over time, the groundwater system underneath the city has filled and groundwater has risen close to the surface in low-lying areas, bringing with it dissolved salt stored in the weathered rocks deep below the ground.

This is called 'saline groundwater discharge'. Salty groundwater is also seeping into the Bendigo Creek, resulting in a salt load of approximately 4500 tonnes per annum.

As with dryland salinity, urban salinity has occurred because of the clearing of deep-rooted native vegetation.

The replacement of native vegetation with shallow-rooted garden plants and lawns has created an imbalance in the water cycle.

These plants are unable to use the excessive amounts of water we apply, allowing large amounts of water to escape past the root zone and into the ground.

Other factors leading to urban salinity include leaking sewerage, stormwater and water pipes and altered drainage patterns due to the installation of roads, buildings and other infrastructure.
