# Urban Salinity in Bendigo

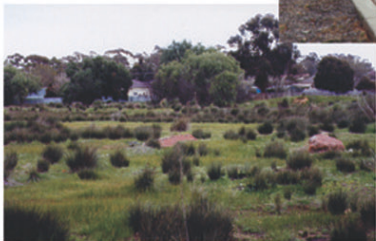
In Bendigo 'saline groundwater discharge' is impacting in many ways:

- Waterlogged soil
- Growth of salt tolerant species such as spiny rush
- Bare patches of ground often with a white crust on the surface
- Unhealthy or dead trees and other vegetation
- Damage to structures such as pavements, roads, bricks and mortar
- Corrosion and damage to underground pipes

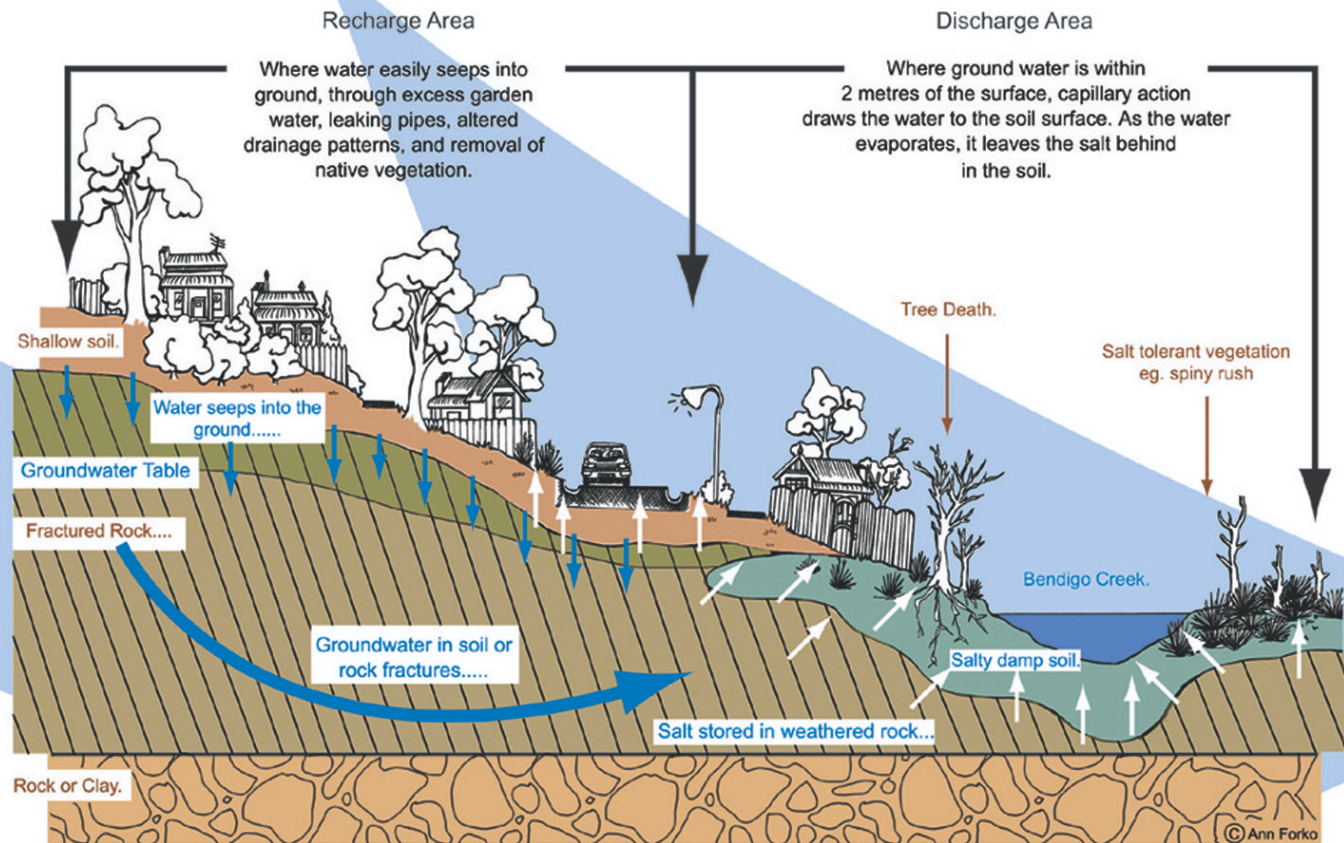
## Urban Groundwater Salinity Process

Over time, the groundwater system underneath the city has filled and groundwater has risen close to the surface in low-lying areas, bringing with it dissolved salt stored in the weathered rocks deep below the ground.

This is called 'saline groundwater discharge'. Salty groundwater is also seeping into the Bendigo Creek, resulting in a salt load of approximately 4500 tonnes per annum.

These plants are unable to use the excessive amounts of water we apply, allowing large amounts of water to escape past the root zone and into the ground.

Other factors leading to urban salinity include leaking sewerage, stormwater and water pipes and altered drainage patterns due to the installation of roads, buildings and other infrastructure.
