Hi-Grain

U P D A T E

RAISED BED HEADLAND MANAGEMENT

Research News
October 2003

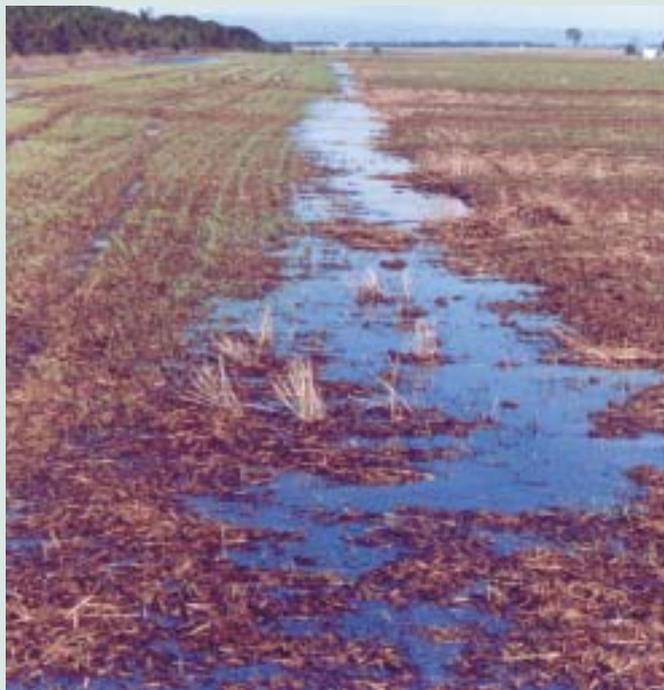
Poorly drained collector drain

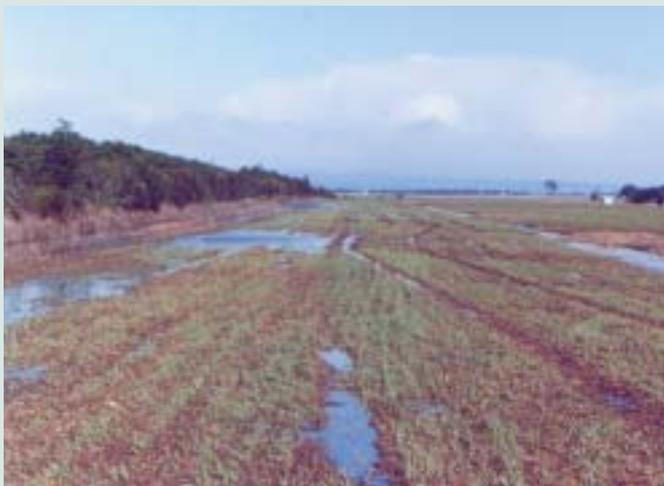
Flat, poorly drained headland

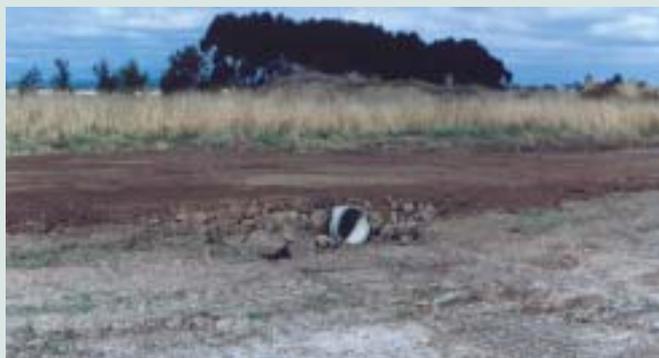
Culverts at lowest point in paddock

In the first year of the project (2002) the headland in one of the concept farm paddocks was redesigned. A road grader was engaged to widen (25m) and heighten (650mm) the existing rather flat and wet headland. The next task was to try some techniques on the collector drains to help remove puddles and other surface water. At the same time culverts were placed under the headland at the lowest point in the paddock to help make the paddock totally trafficable.

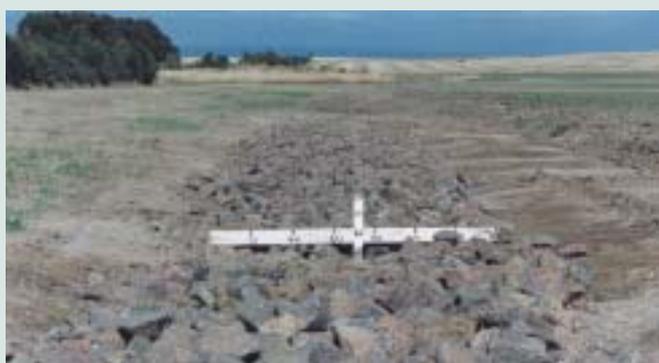
One of the finished large crushed rock treatments.

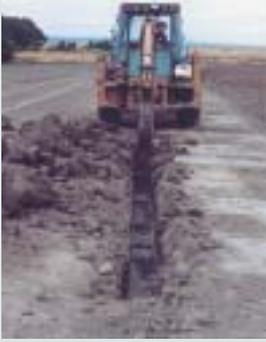
A backhoe digs a trench about 400mm deep ready to install the underground pipe for our second treatment. Although we used a 300mm wide bucket, probably only a 100mm wide trench would be required.

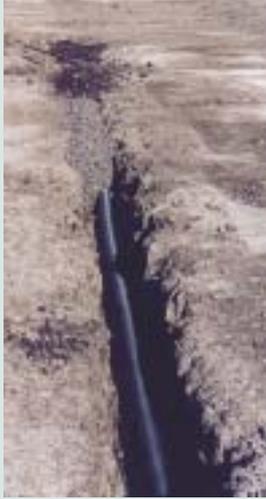
The 100mm slotted agricultural drainage pipe laid in the trench.

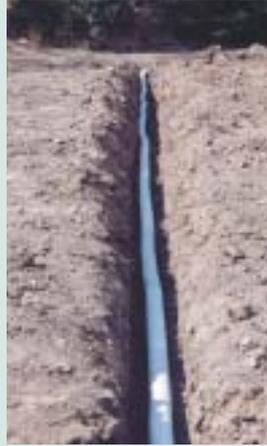
To relieve the drainage water from each treatment, a drainage pipe was taken across the headland to the fence line.

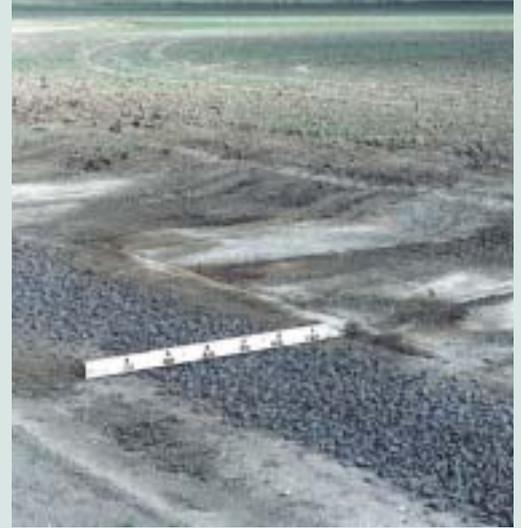
One of the finished underground drainage sections backfilled with 40mm clean gravel.

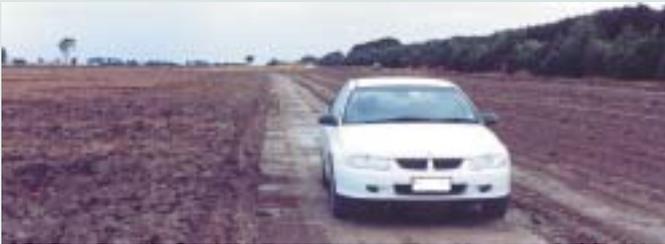
Using a dumpy level we determined the falls we had to play with and engaged a road grader to widen (25m) and heighten (650mm) the existing wide raised bed headland. With the road grader we placed a slope (1%) on the apron between the ends of the beds and the main drain. For our purposes, the main drain is "V" shaped and not flat as normally recommended.

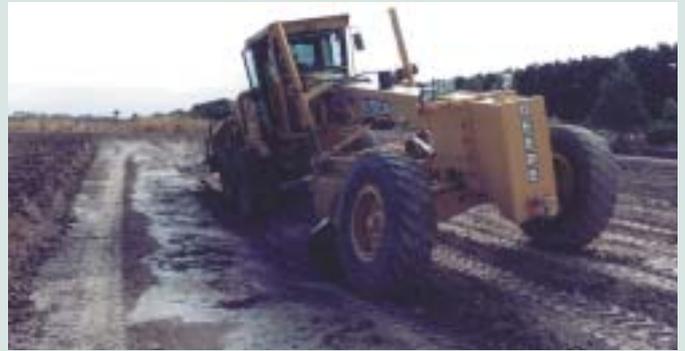
The road grader deepening the "V" drain by about 300mm ready to backfill with large crushed rock.

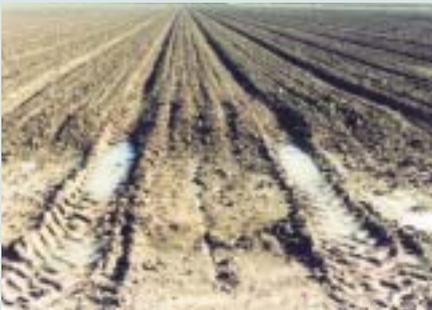
At sowing time conditions were moist and the collector drains on the control treatment instantly showed the effects of tractor and airseeder weight.

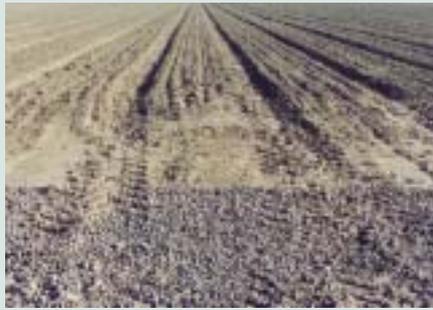
The underground treatment removed water very well and remained dry and withstood the tractor weight very easily.

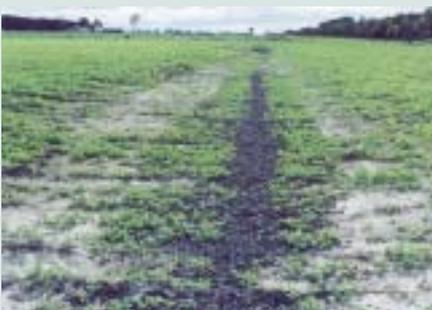
The underground treatment in late winter. Note the slightly wet areas between the gravel and the beds in the foreground. This apron had a slope of approximately 1%.

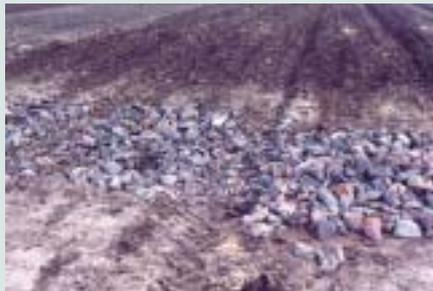
The large crushed rock treatment took the weight of the machine but the rocks squashed into the mud. The tractor driver said he needed to slow down to cross the collector drains. He was also worried about potential damage to the tractor tyres.

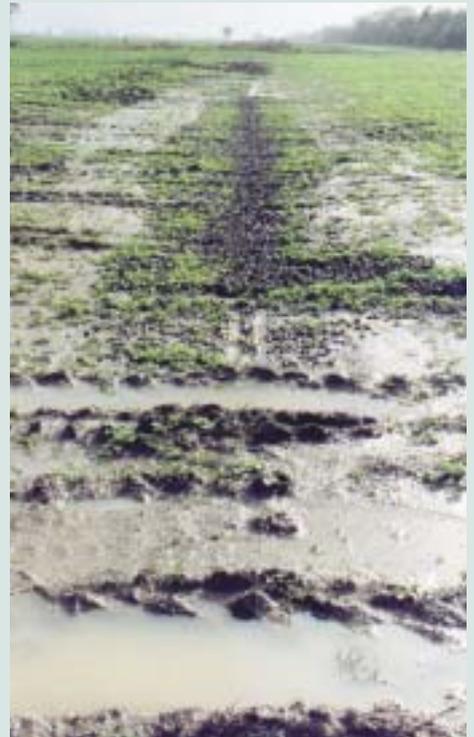
During the winter it became very apparent that the underground drainage treatment was far superior. This photo shows the control (foreground) compared to the underground treatment (background).

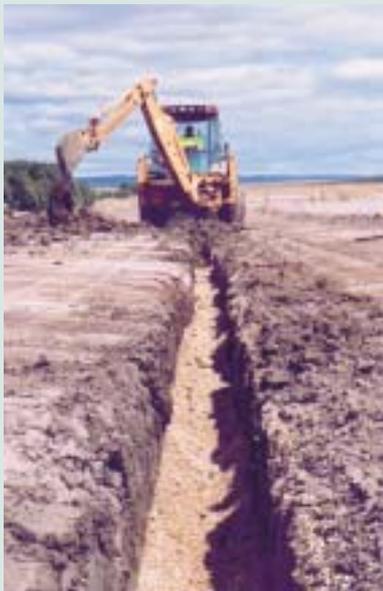
The backhoe digging the 450mm deep and 300mm wide trench. Note the spoil was removed while the backhoe was working and a gravel base added to the trench.

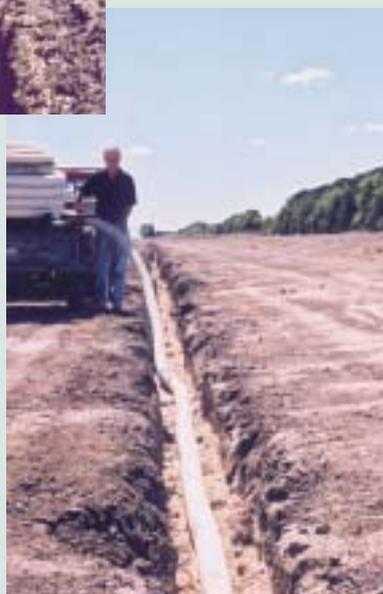
Pipe was fed off a reel directly into the trench. Note we have not used a fitter sock over the pipe. We will have to wait and see if that was a good idea. A small length of pipe with sock was installed to compare the difference over time.

Note how the collector drain has been returned to 'flat' using the gravel. Of course it is too early to offer sound advice about the techniques employed even if these treatments work. The cost of approximately \$10/metre needed to reconstruct the headland and place the underground pipes in place may be will be too expensive for some farmers. For a 25 hectare square paddock, the headland is 500m long. The total cost is therefore around \$5,000 to establish this system.

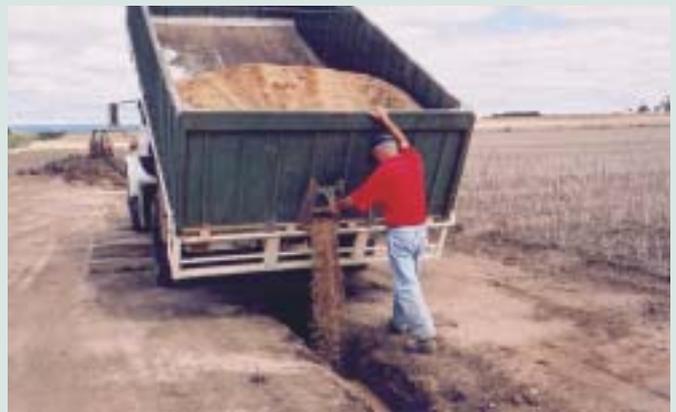
This season we became mechanised. Here the farmer's grain truck was used to add the gravel base.

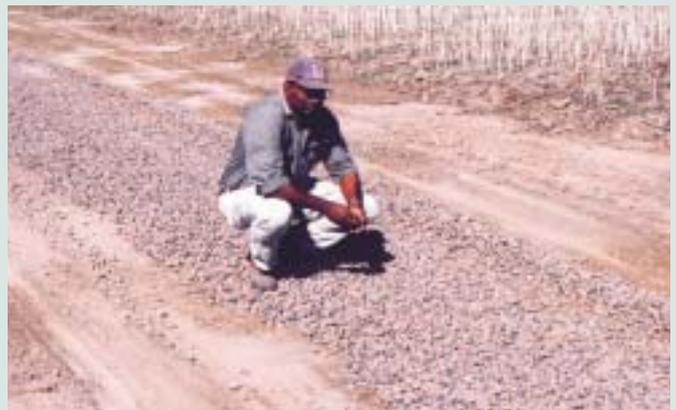
Gravel 40-50mm was placed over the pipe again using the grain truck. However this time a much larger chute had to be constructed for the truck to handle the larger diameter and angular gravel. Our photo shows Southern Farming Systems Soil Scientist, Renick Peries admiring the finished job.

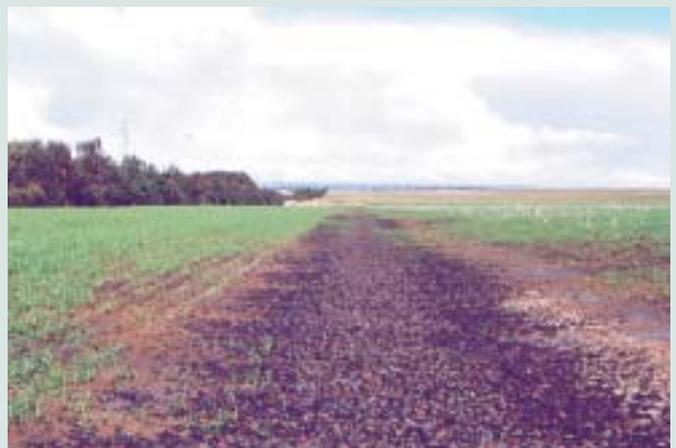
This is the same collector drain shown on page 2, again after approximately 50mm of rain.
