### A. GENERAL DESCRIPTION

### B. SOIL PROFILE

## C. LAND CAPABILITY ASSESSMENT

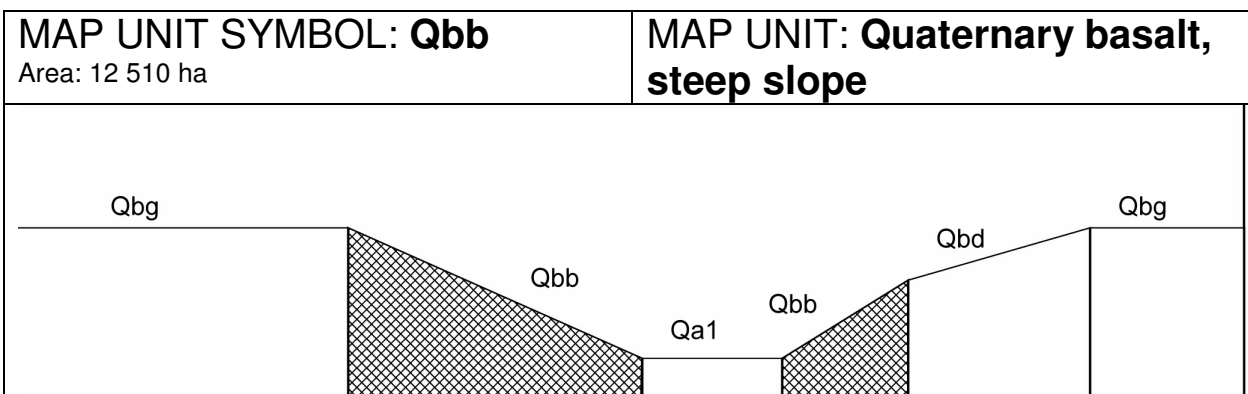
The majority of this component consists of the steep slopes formed by the down cutting of streams. They generally occur between the very gentle slopes and the drainage course. The soils are commonly shallow brown duplex, with a clay loam topsoil and a light clay subsoil, with weathered basalt fragments throughout the profile. Minor variants include dark duplex soils and uniform clays. Potential recharge to groundwater is high due to the very rapid permeability, although the runoff potential is also high.
