## SHORELINE EROSION AND SALINITY INCREASE

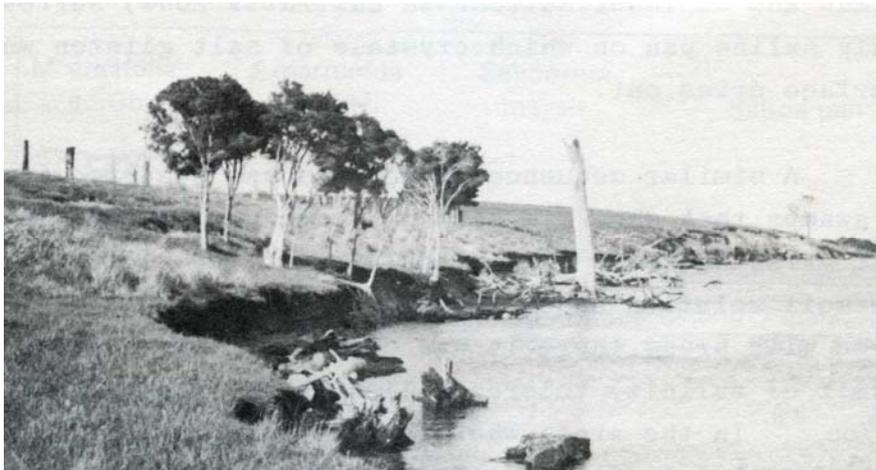
Plate 20 – Erosion on the north shore of Lake King (ECF Bird)

At the present time the larger proportion (about 75%) of the shoreline of Lake King, Lake Victoria, and to a lesser extent Lake Wellington, is being eroded: approximately 136 kilometres of the Lake King shoreline (total length estimated at 160 kilometres); 80 kilometres of the Lake Victoria shoreline (Total length 104 kilometres) and 22 kilometres of the shoreline of Lake Wellington (total length 60 kilometres). The rest is either stable or advancing, local accumulation of beach deposits, the growth of deltas, and swamp land encroachment accounting for the advance. Erosion is in progress on an abnormally high proportion of the shoreline (Plates 20 and 21), a sharp contrast with the situation that Gregory recorded in 1903, when encroachment of the shoreline was widespread.

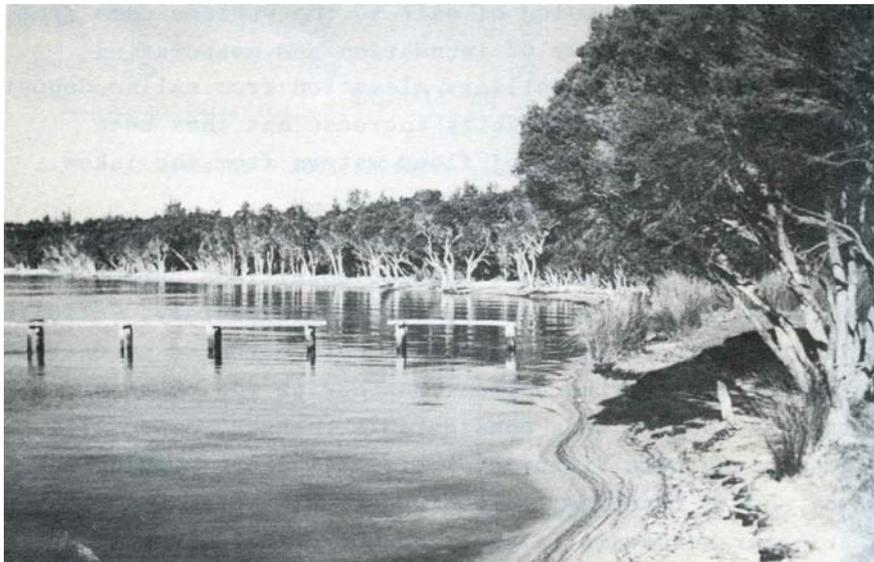
Plate 21 – Erosion on the inner barrier south of Metung (ECF Bird)
