6. CAUSES AND REMEDIAL MEASURES

6.2 Remedial Measures

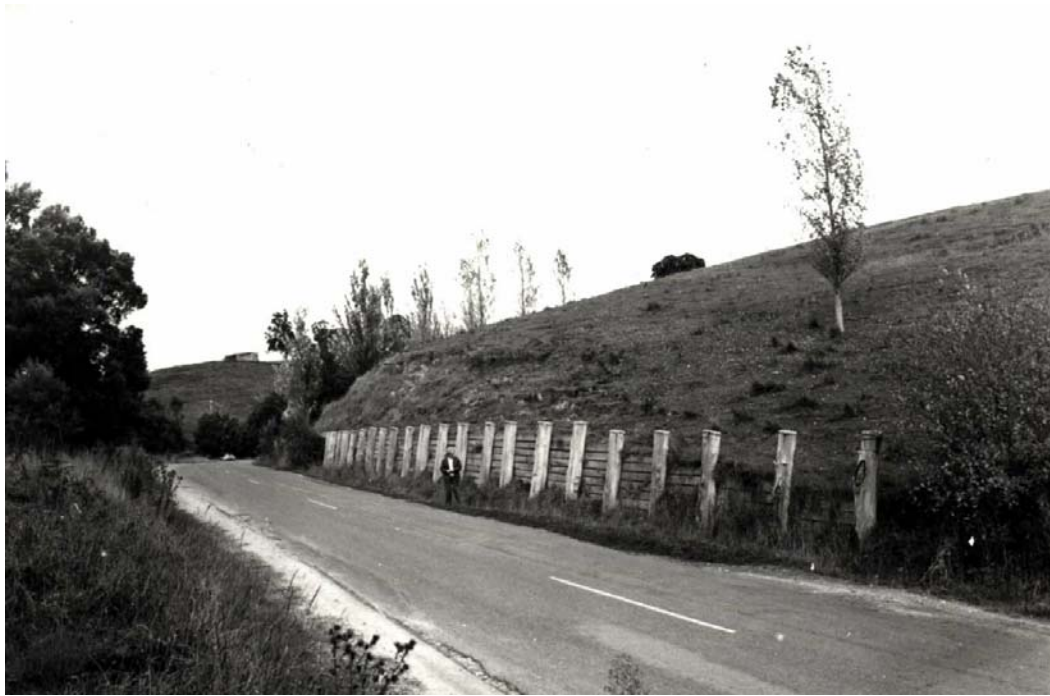
Figure 6.1 – Landslide no. 12, 1978. Stabilised by wooden retaining wall. Poplar trees have been planted to aid stabilization.

The Shire have successfully used retaining walls to stabilize earth flows on roadsides. For example, landslides no. 12 as shown below in Figure 6.1 and landslide no. 13 as shown in Figure 4.5.

It is important that effective drainage is incorporated in the remedial work and that the pile foundations of the retaining structure are founded in sound material beneath the failure zone. Poorly designed retaining structures commonly fail and may even push the failure surface deeper. A detailed site investigation should be carried out prior to designing and constructing any large retaining wall. Hutchinson (1977) lists selected references to restraining structures consisting of retaining walls, piles and soils and rock anchors. Rock and reinforced earth buttresses are also used to prevent slope movement. Each system must be adequately designed to prevent overturning and failure through or beneath the structure. The ultimate choice of restraining structure must be based on the site conditions and available finance.
